InspectorTx.com®

Inspection Report

PROPERTY INSPECTION REPORT FORM

<i>Name of Client</i>	11/12/2022 <i>Date of Inspection</i>
<i>Address of Inspected Property</i> BRYON A. PARFFREY llc.	
<i>Name of Inspector</i>	Texas #7408 <i>TREC License #</i>
<i>Name of Sponsor (if applicable)</i>	<i>TREC License #</i>

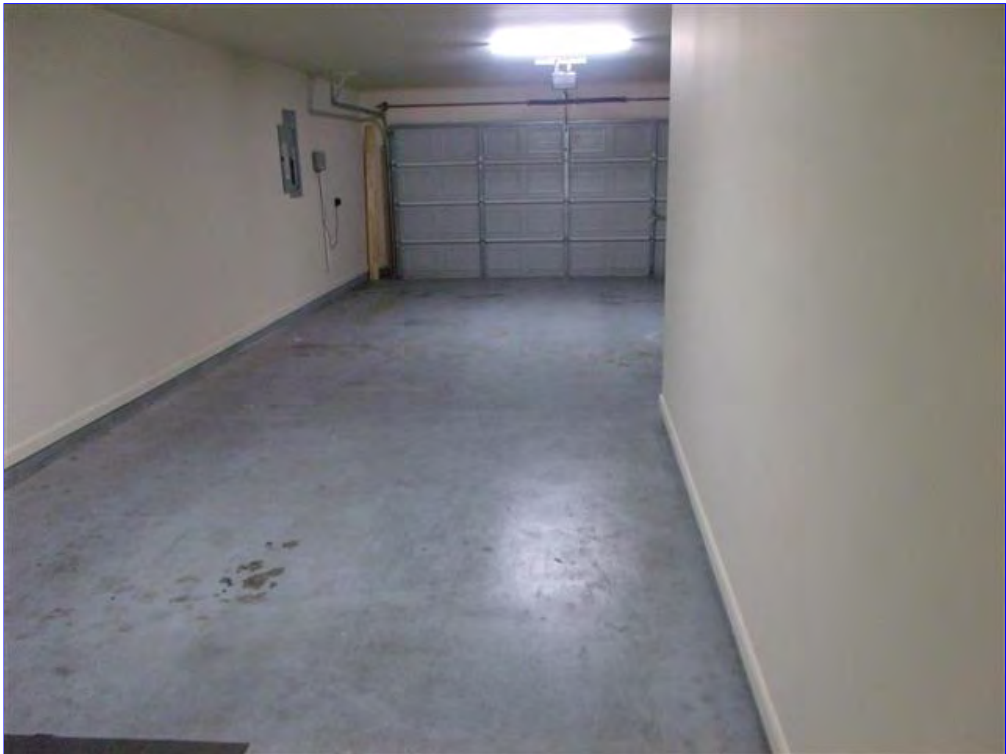
A. Item 1(Picture) Shrinkage cracks on the garage slab.

Recommend sealing shrinkage cracks with epoxy to prevent water damage.

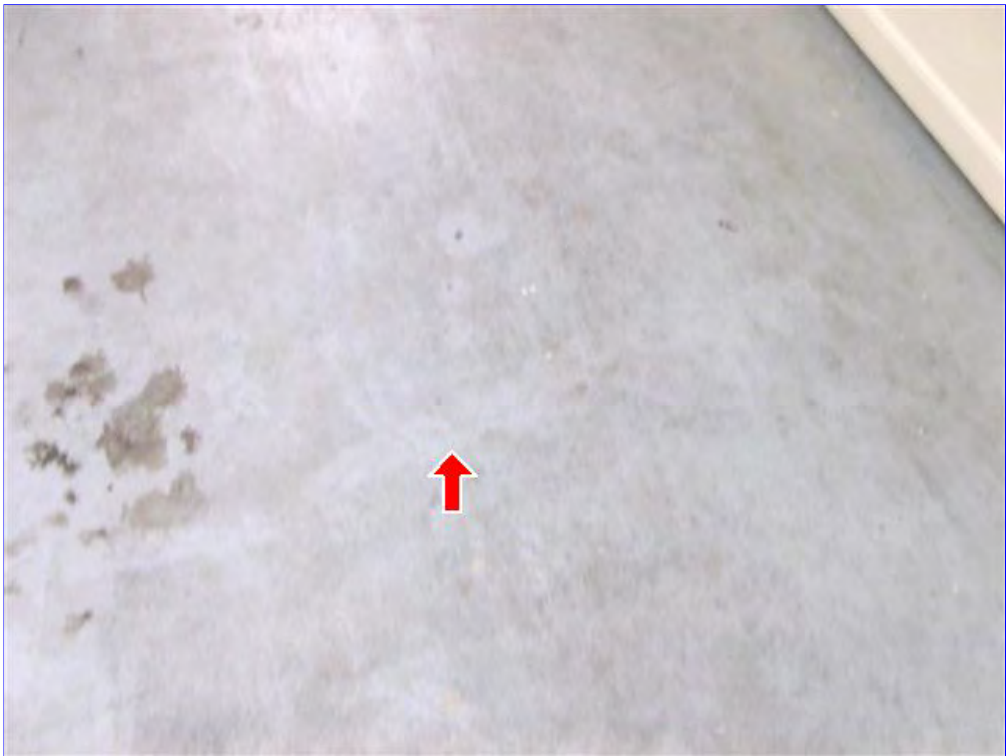
A. Item 2(Picture) Shrinkage crack.

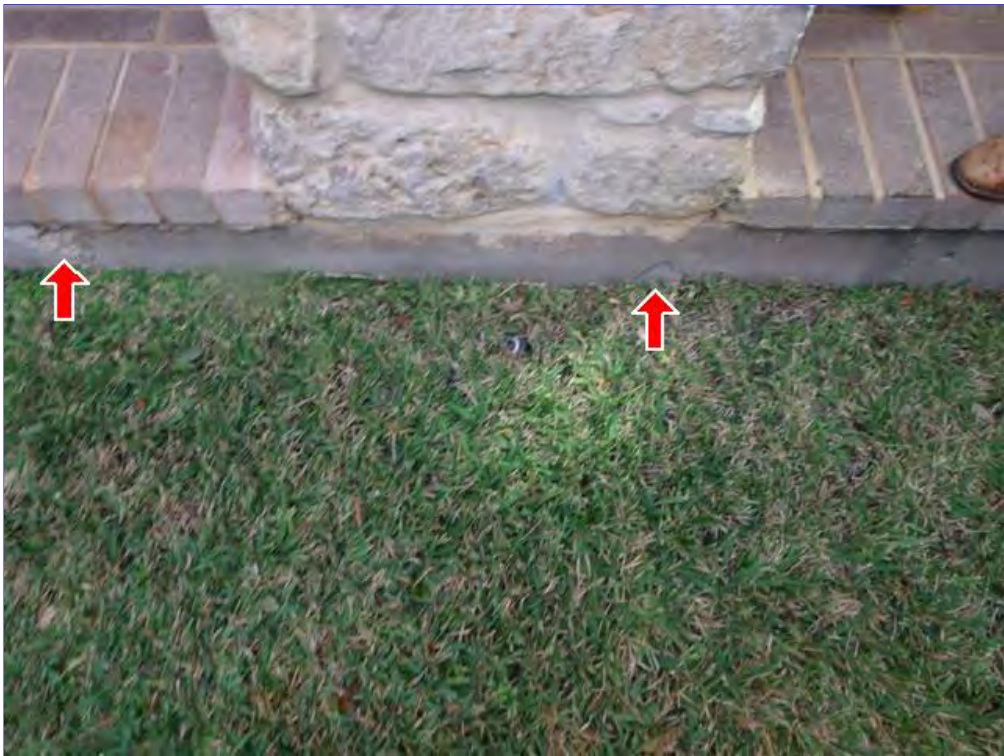
A. Item 16(Picture) Concrete spalling. Recommend sealing with epoxy to prevent water intrusion.

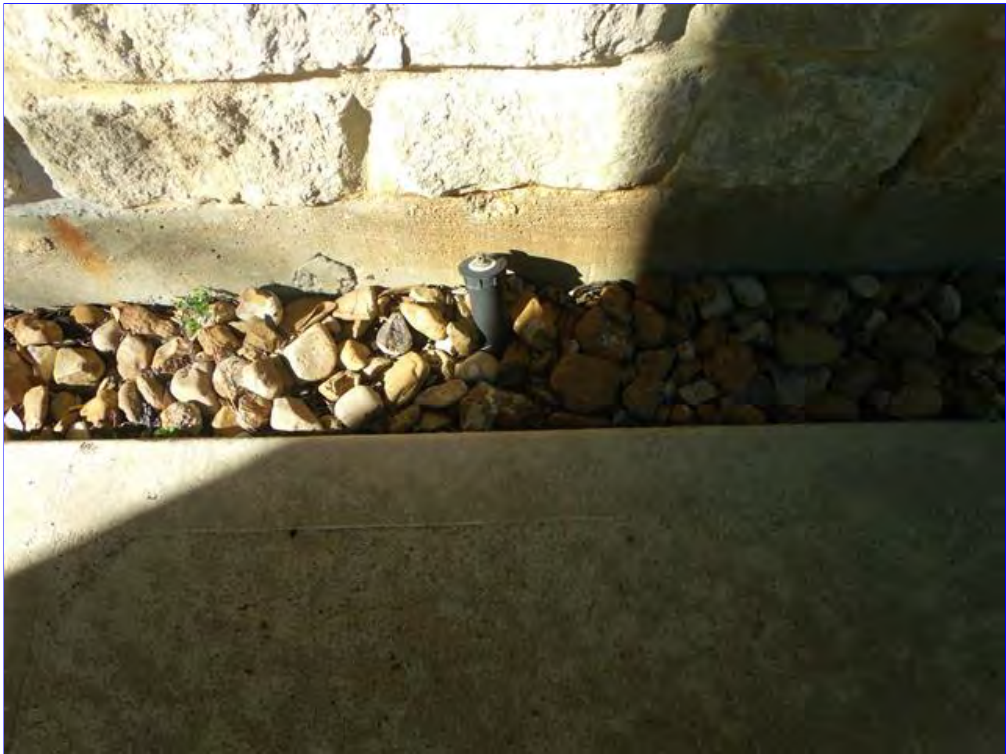
A. Item 19(Picture) Sprinkler head located to close to the founation.

Sprinklers should be located a minimum of twelve inches away from the foundation so the foundation is not constantly wet.

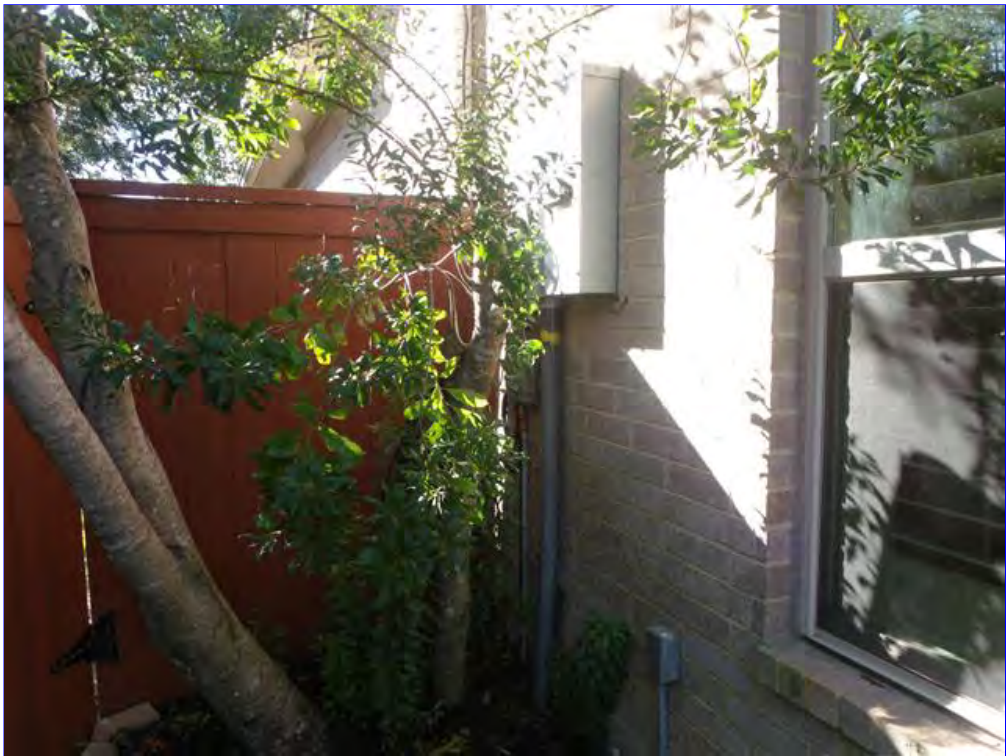
A. Item 20(Picture) Best practice is to have trees located a minimum fifteen feet away from the house.

Trees should be located a minimum fifteen feet away from the house. Tree roots can cause damage to the foundation.

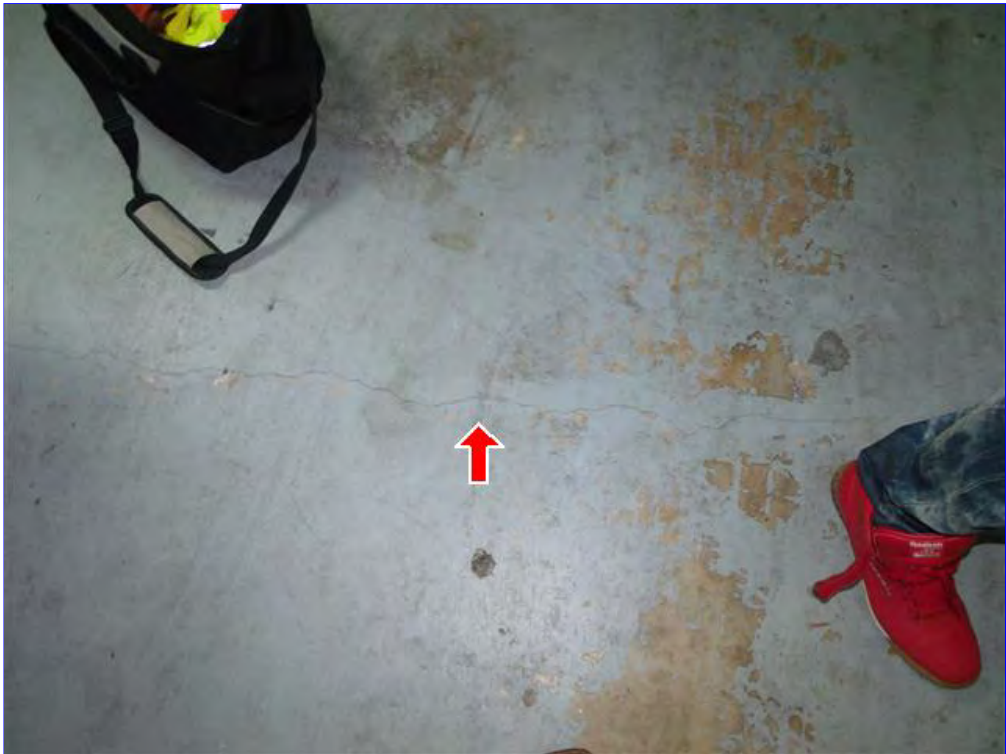
A. Item 21(Picture) Shrinkage crack on the garage floor recommend sealing with epoxy.

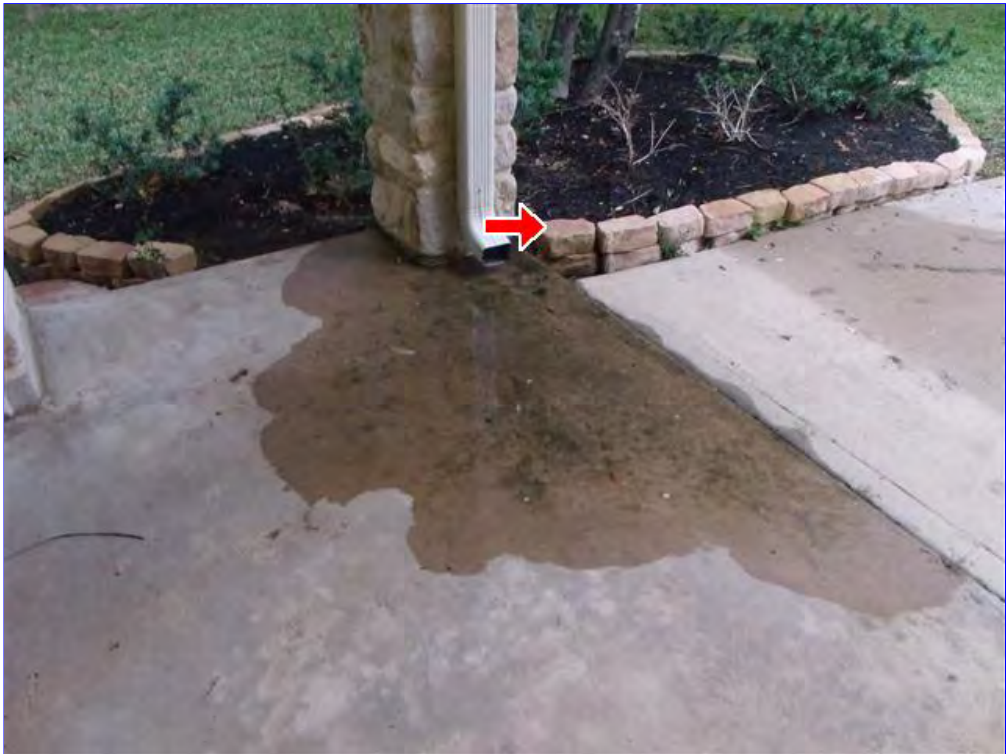
B. Item 1(Picture) Downspouts should drain water a minimum five feet away from the foundation. Turn the downspout towards the grass or add tubing to keep excessive water away from garage and driveway

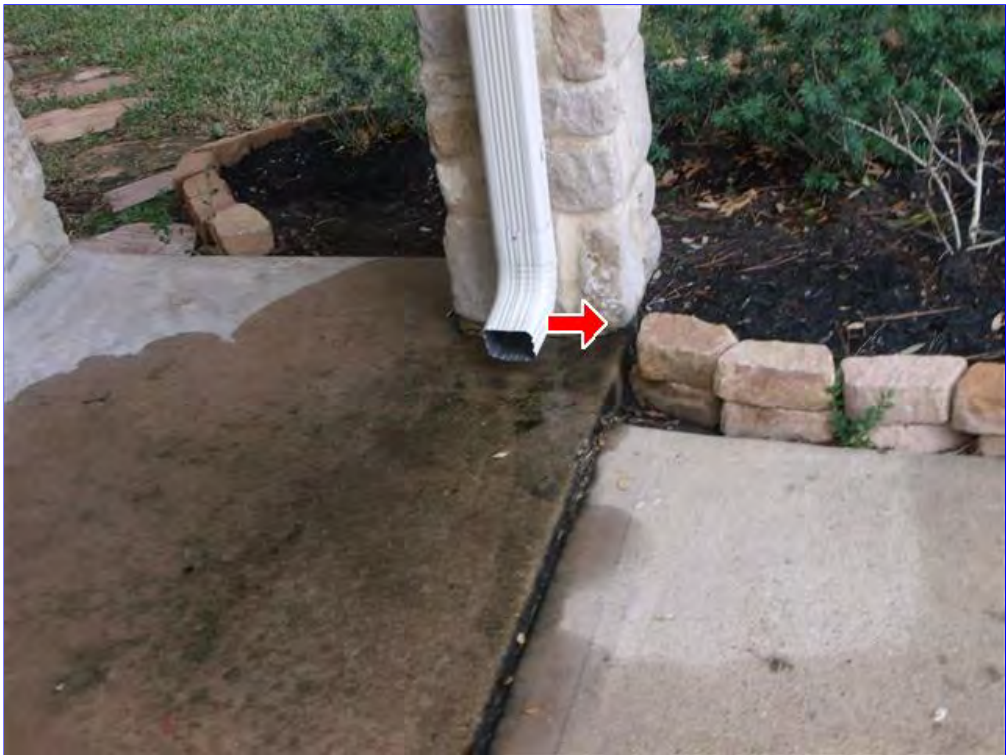
B. Item 2(Picture) Sugest turning the downspout away

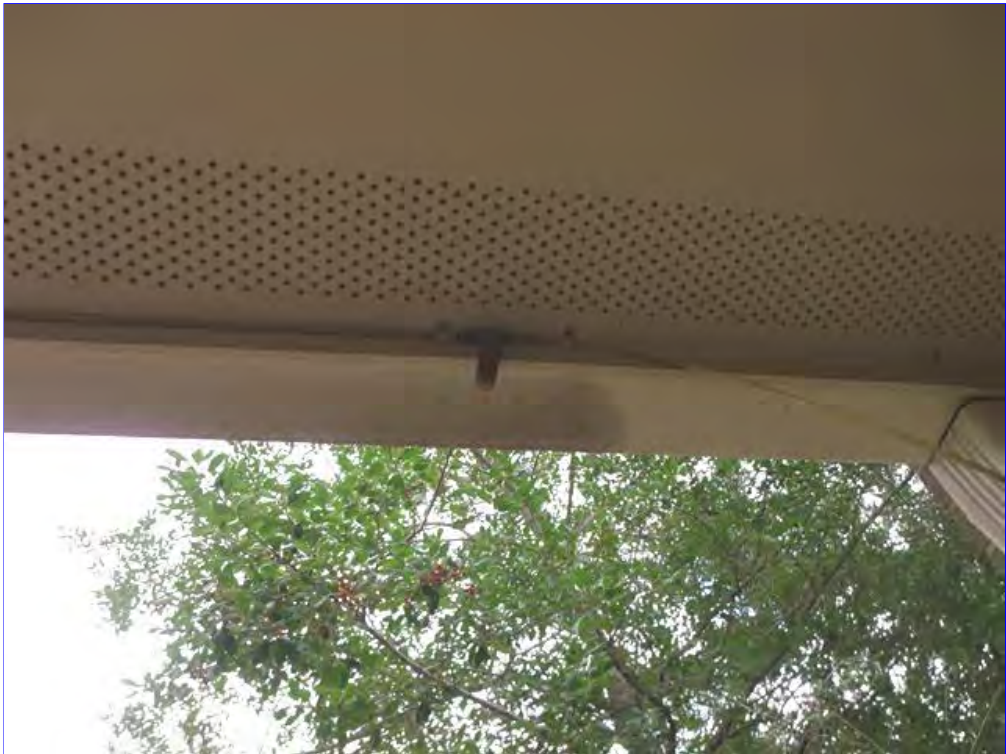
B. Item 7(Picture) Water damage on the fascia.

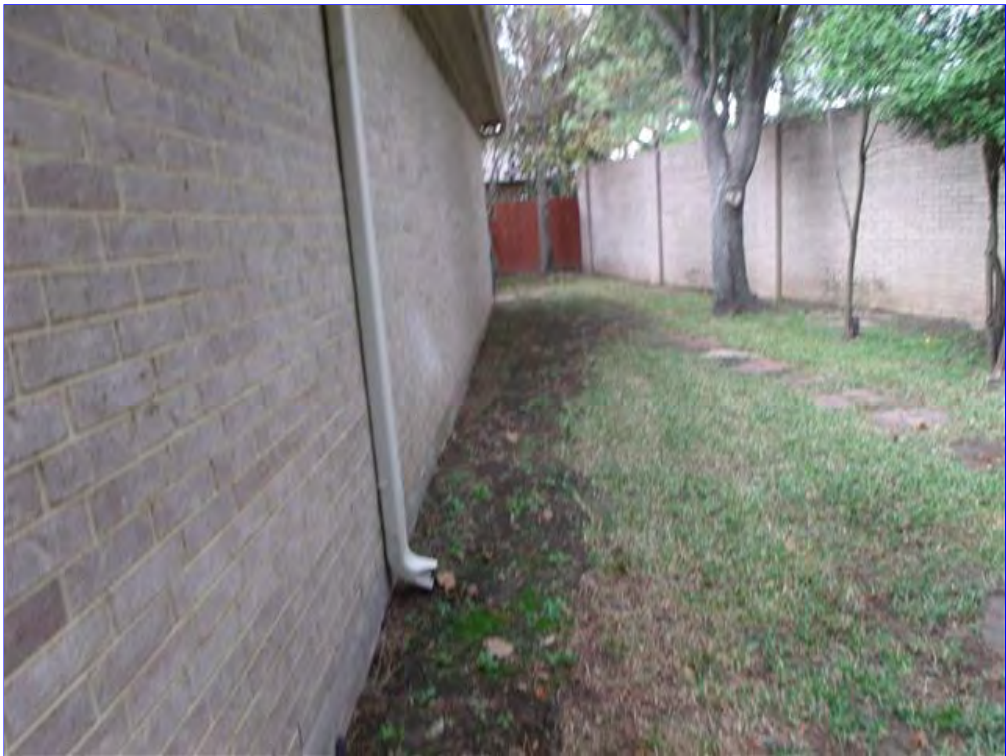
B. Item 8(Picture) Downspouts should drain water a minimum five feet away from the foundation.

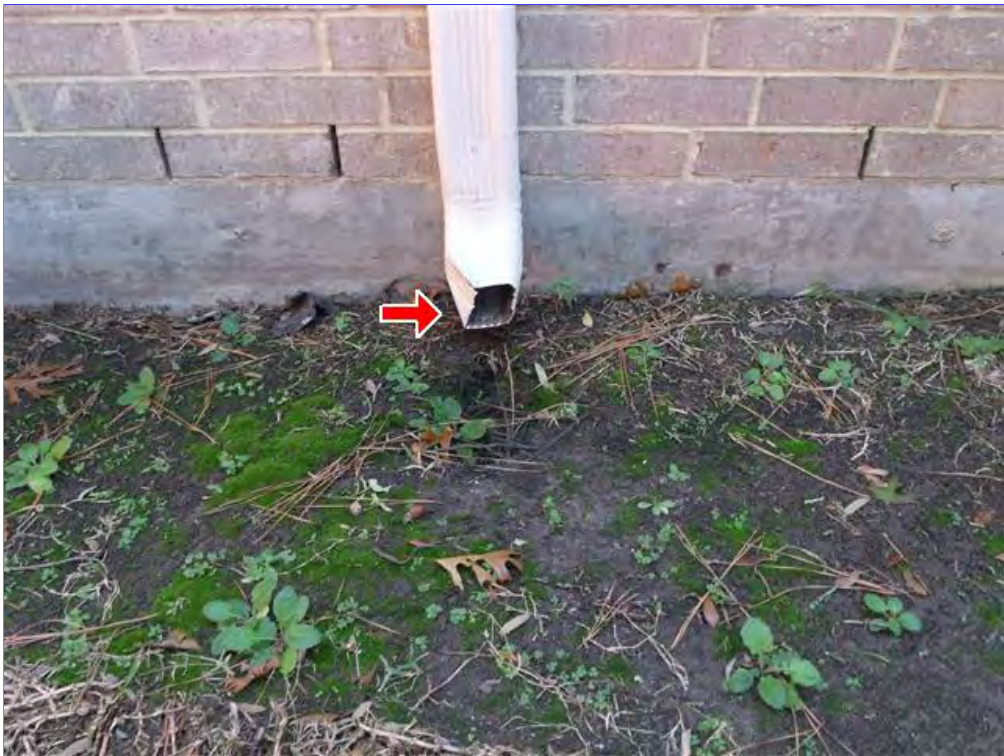
B. Item 10(Picture) Damaged downspout. Water is ponding below downspout. Recommend all downspouts discharge water a minimum five feet away from the foundation to prevent damage to the foundation.

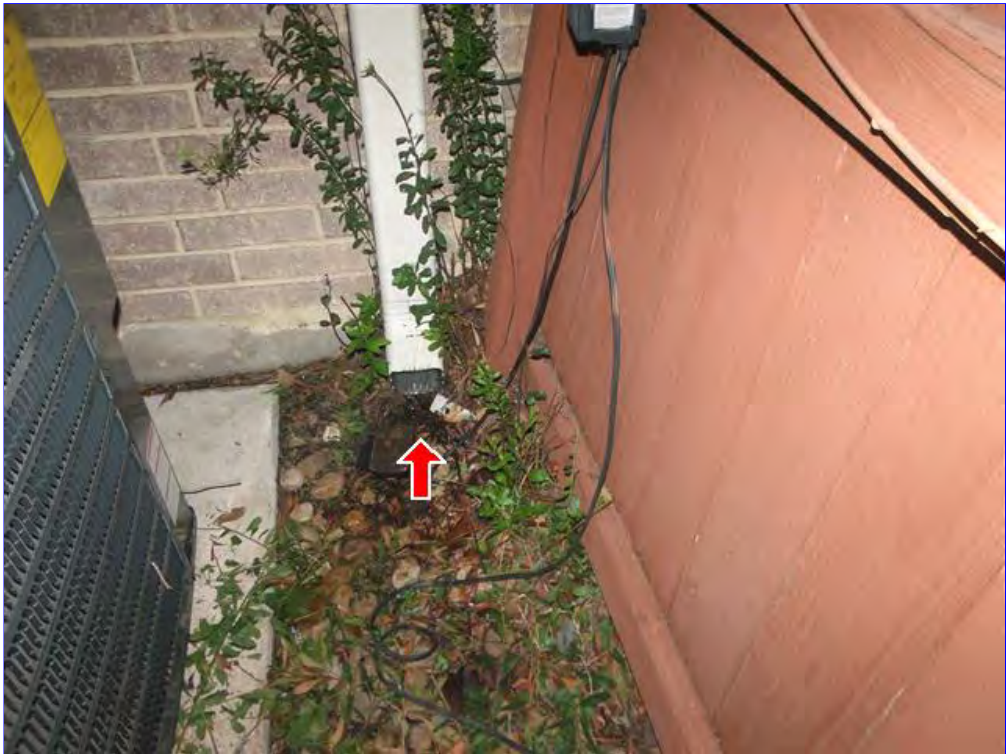
B. Item 13(Picture) Downspout should discharge away from the foundation and electrical equipment.

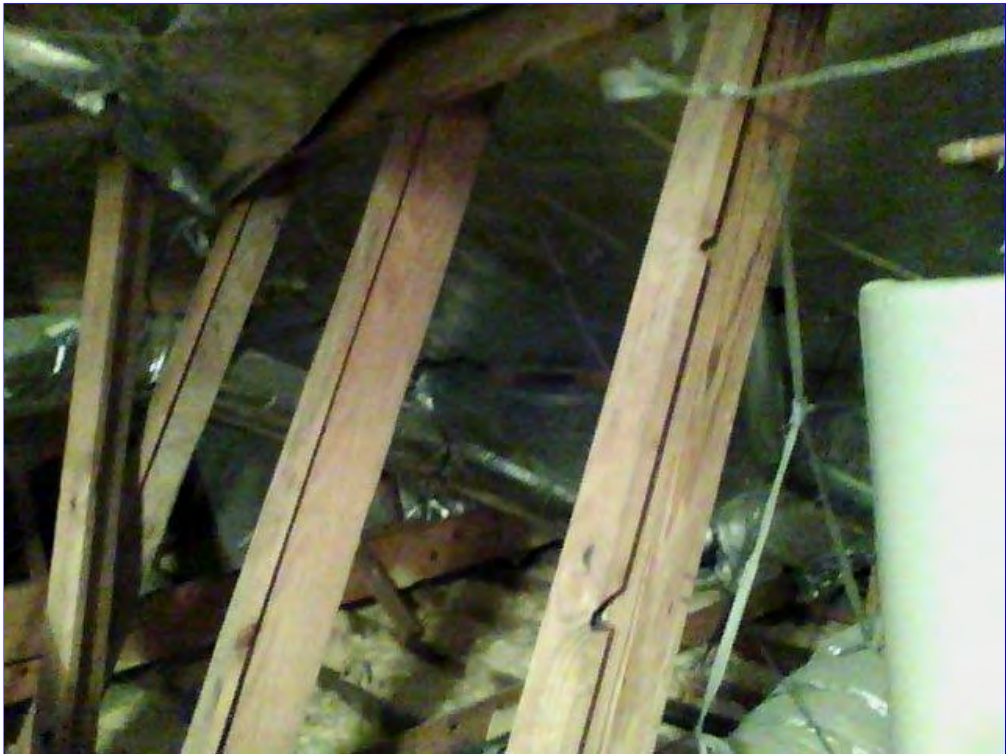
C. Item 7(Picture) Attic appears braced properly yet not all areas can be seen due to the second radiant barrier covering areas of attic.

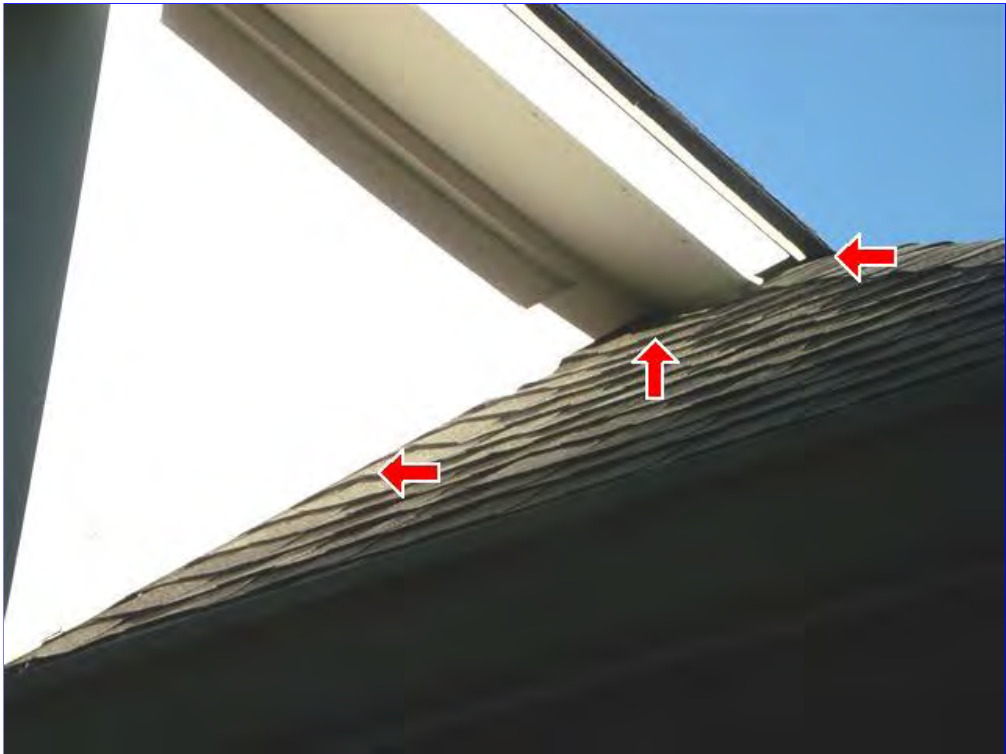
C. Item 9(Picture) Recommend to have a one inch gap between the siding and the roof covering. Recommend adding rodent flashings. Example of rodent flashing is 24 gauge. See example of rodent flashing.

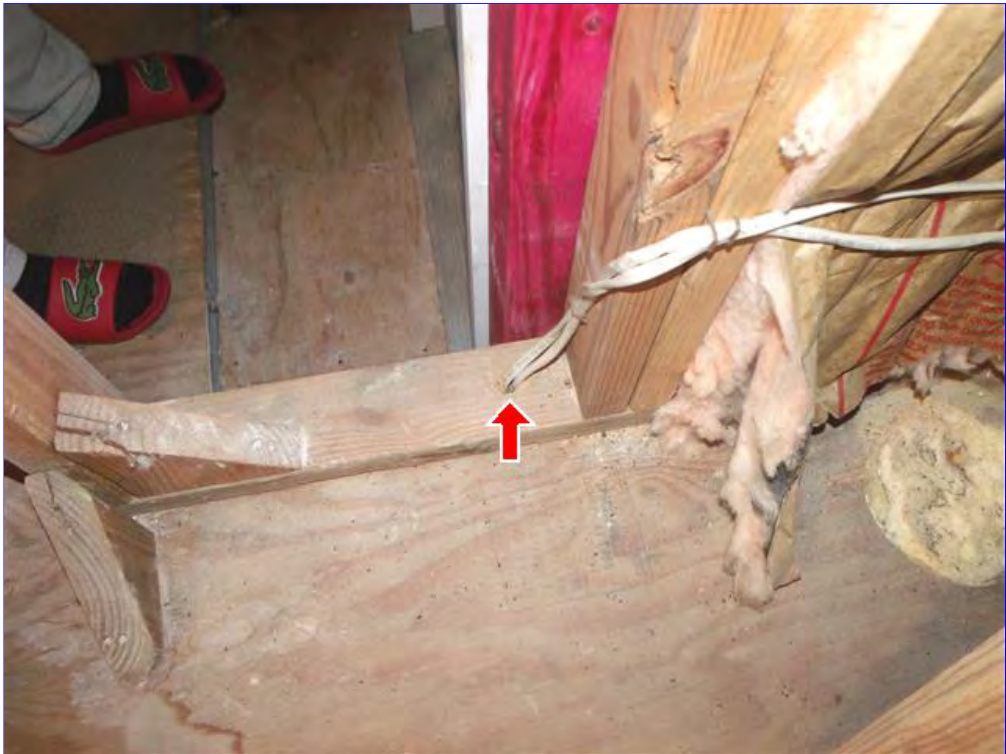
C. Item 13(Picture) Recommend sealing all penetrations

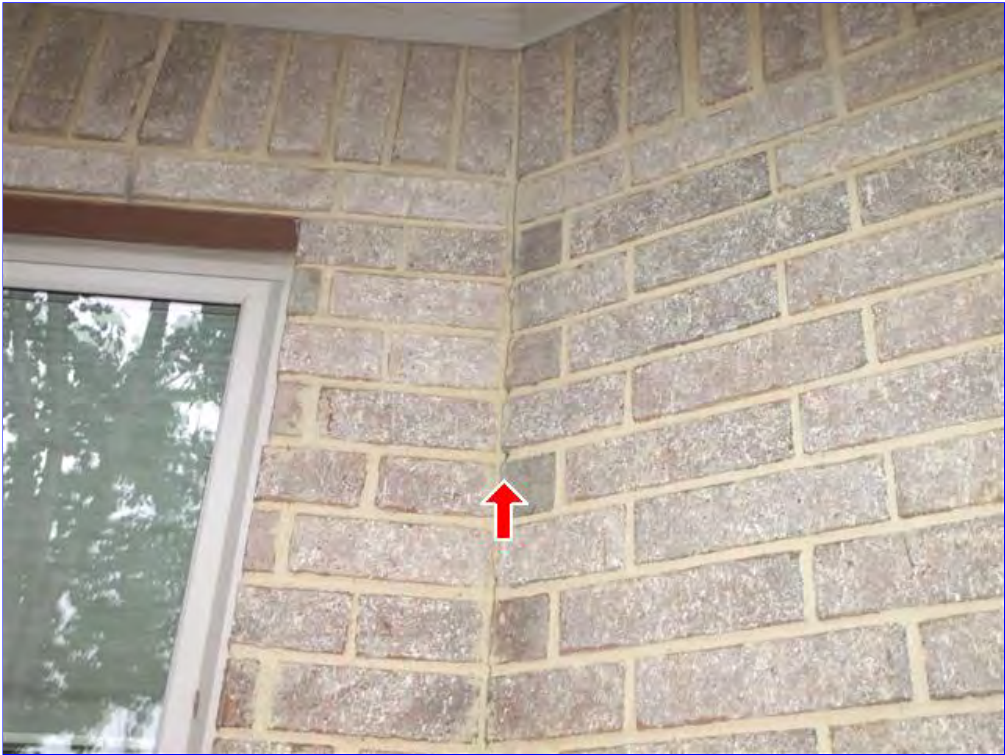
D. Item 10(Picture) Crack in the brick veneer.

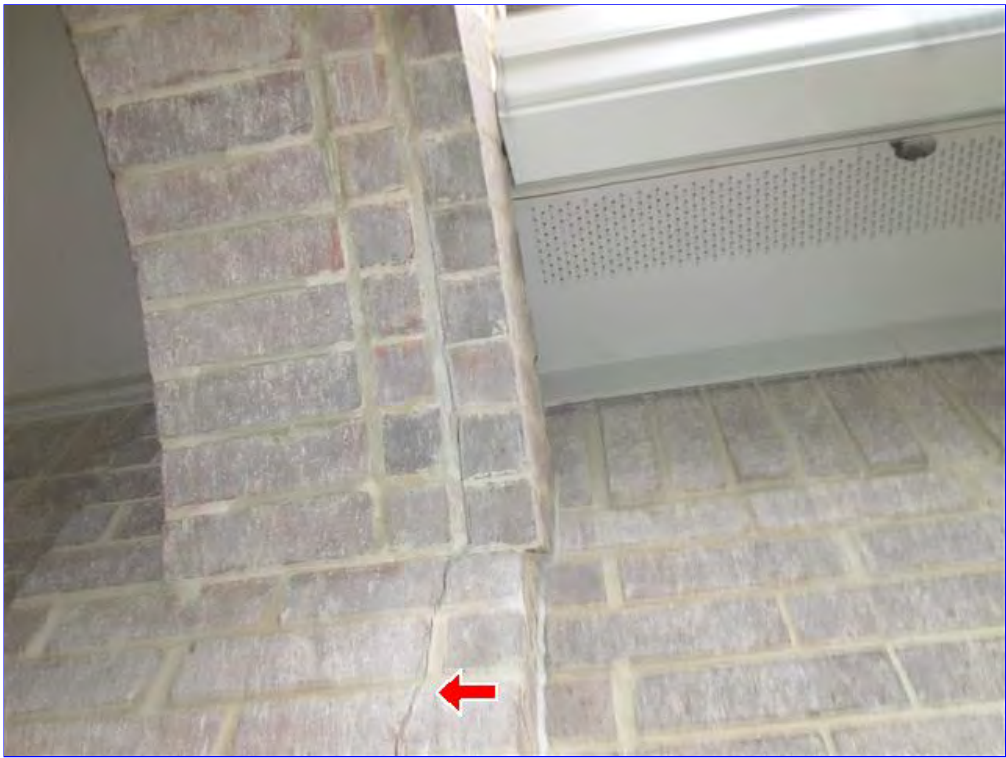
D. Item 12(Picture) Crack under the archway.

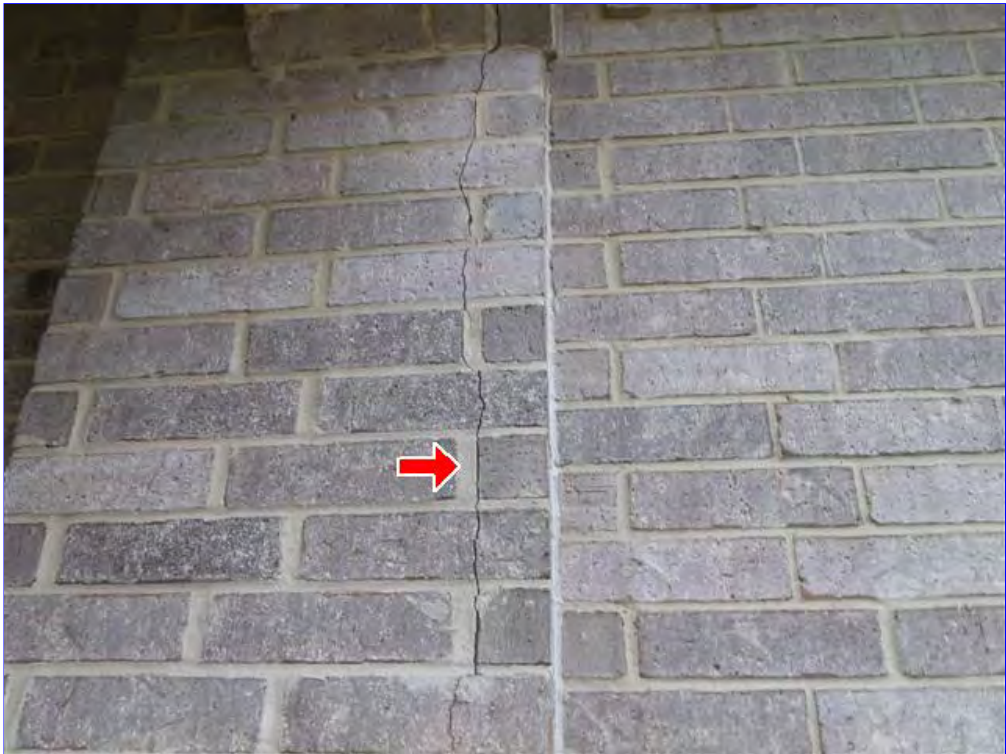
D. Item 13(Picture) Crack under the archway.

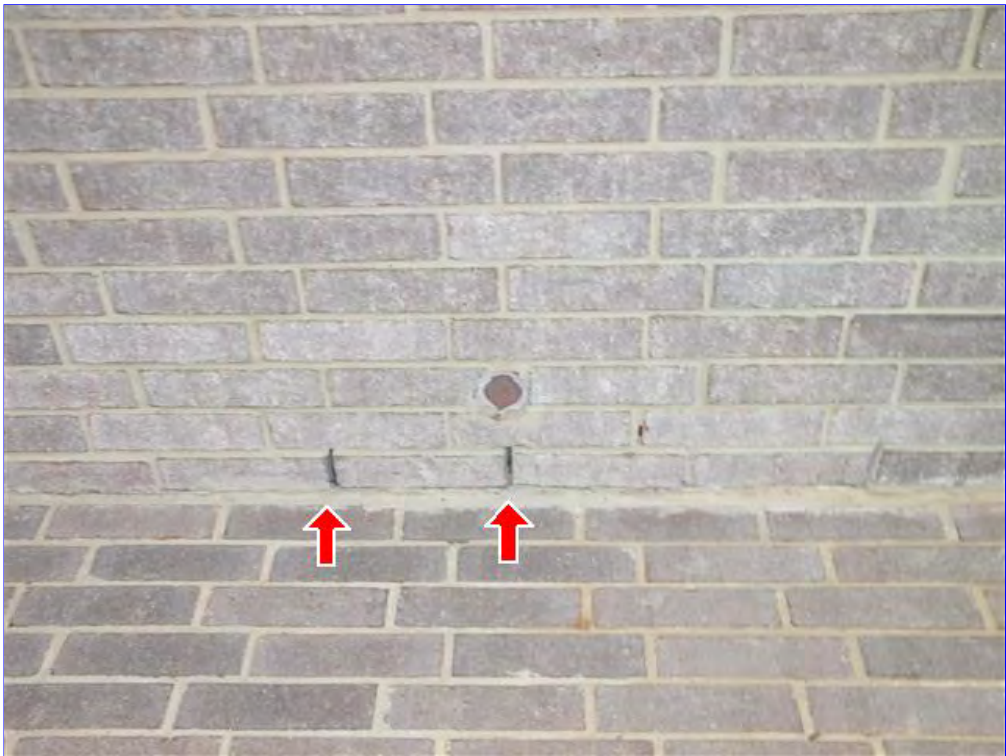
D. Item 14(Picture) Be sure to keep weep holes unobstructed so moisture can drain from behind the brick veneer.

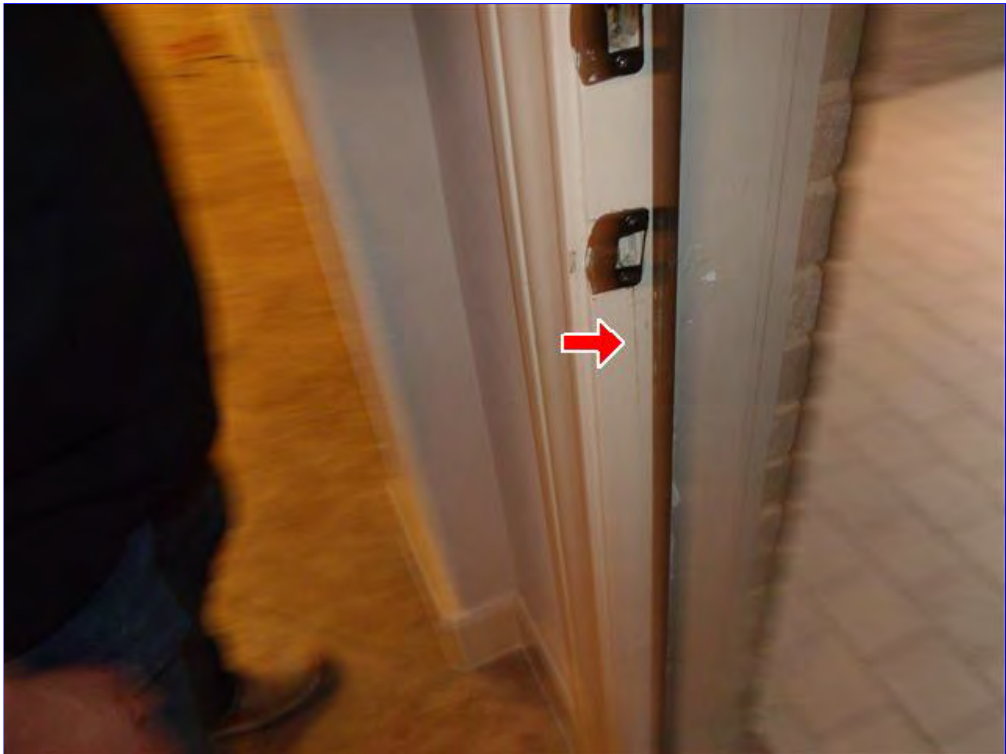
F. Item 1(Picture) Damaged latch. Recommend repair.

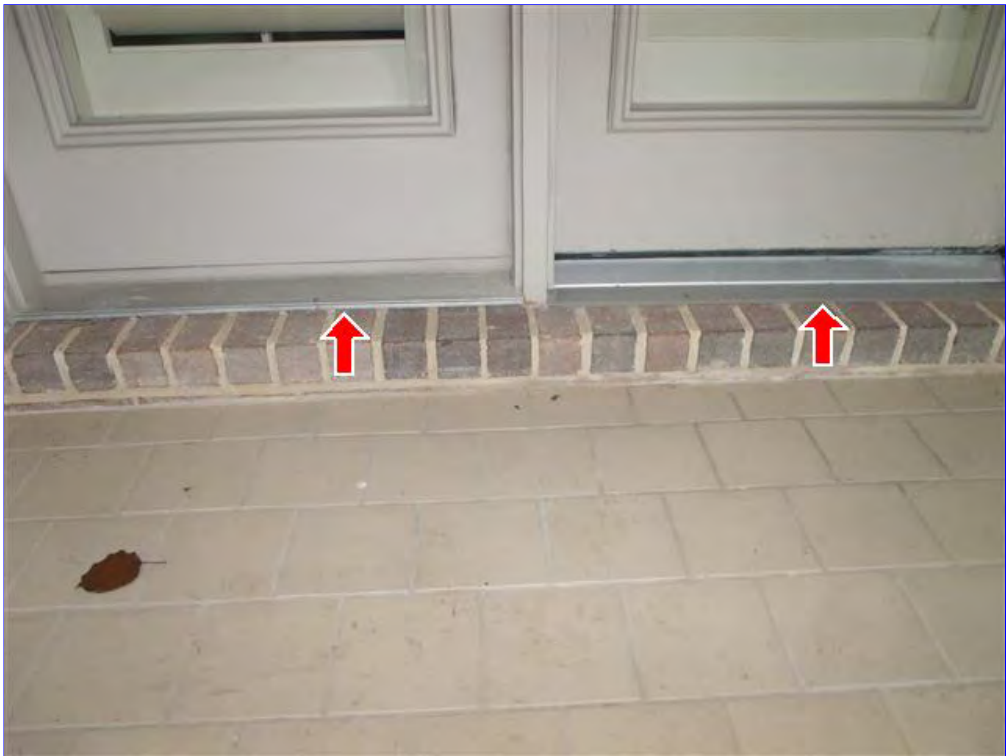
F. Item 2(Picture) Recommend foam caulking underneath thresholds at the backdoors to prevent air intrusion.

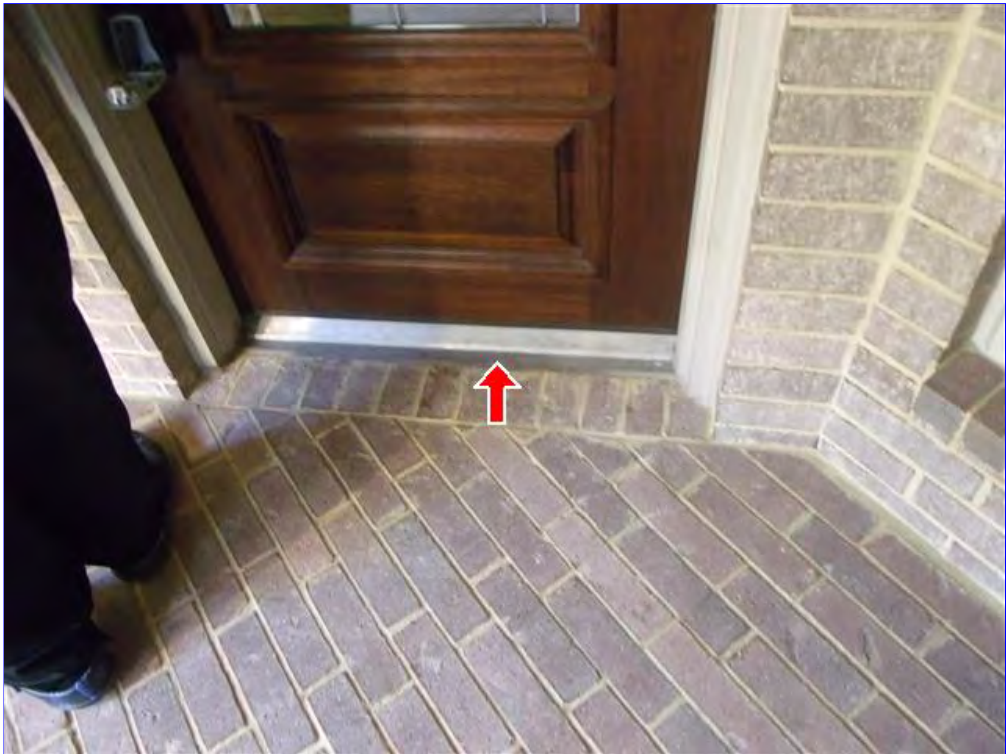
F. Item 3(Picture) Recommend foam caulking underneath thresholds at the frontdoor to prevent air intrusion.

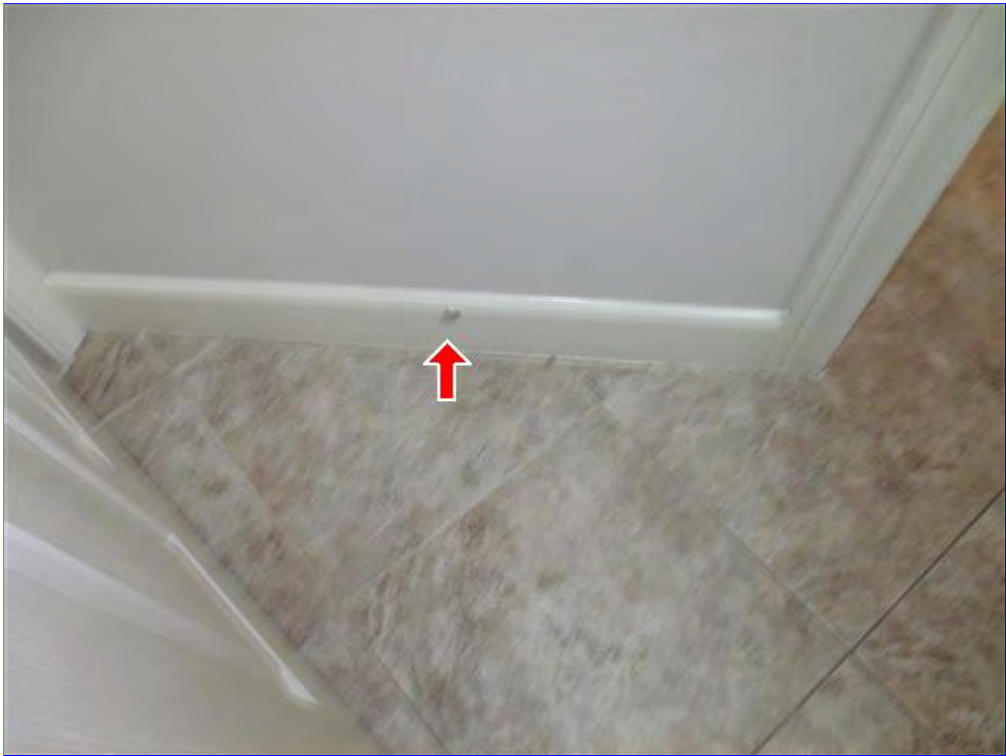
F. Item 5(Picture) Door stopper is absent.

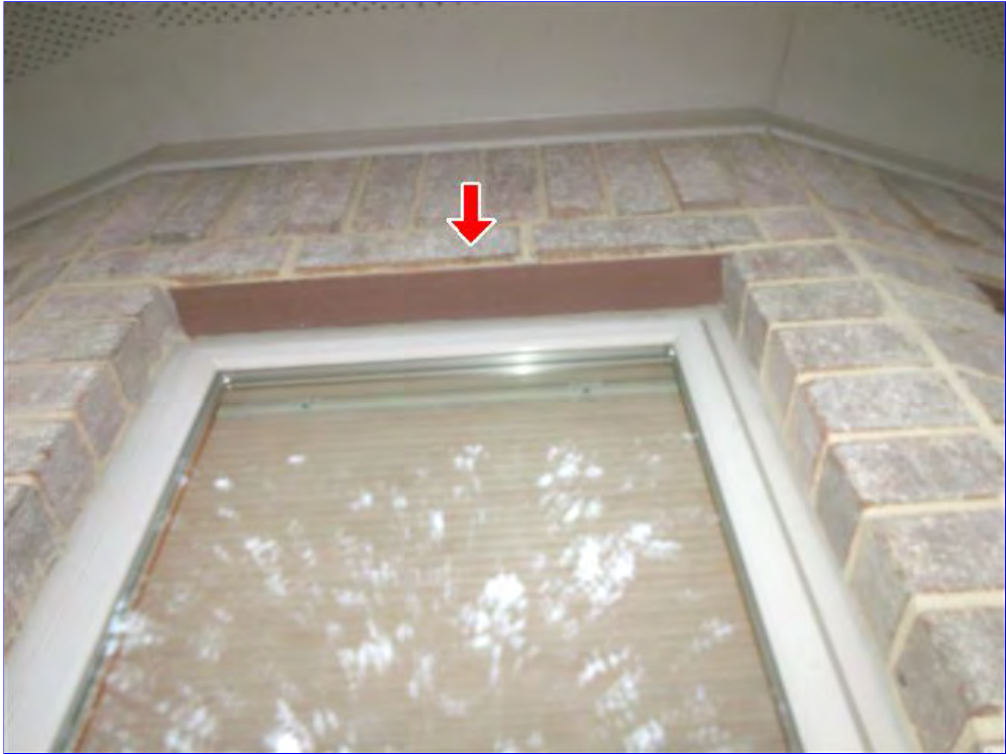
G. Item 4(Picture) Rusted lentils.

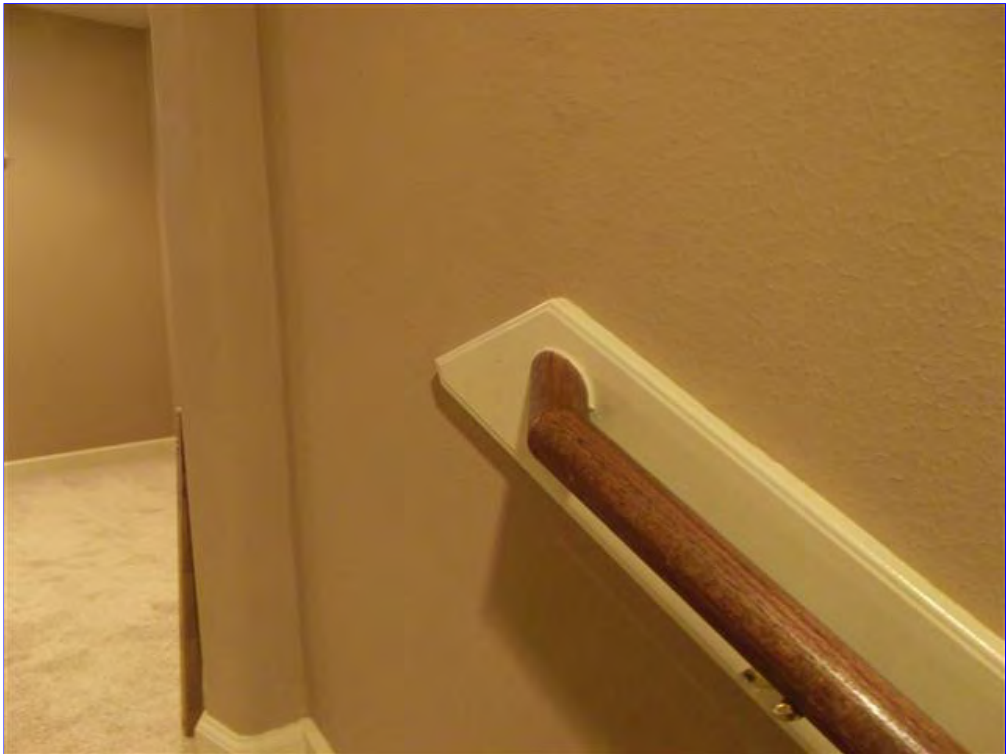
H. Item 1(Picture) Handrails need to extend past the landing.

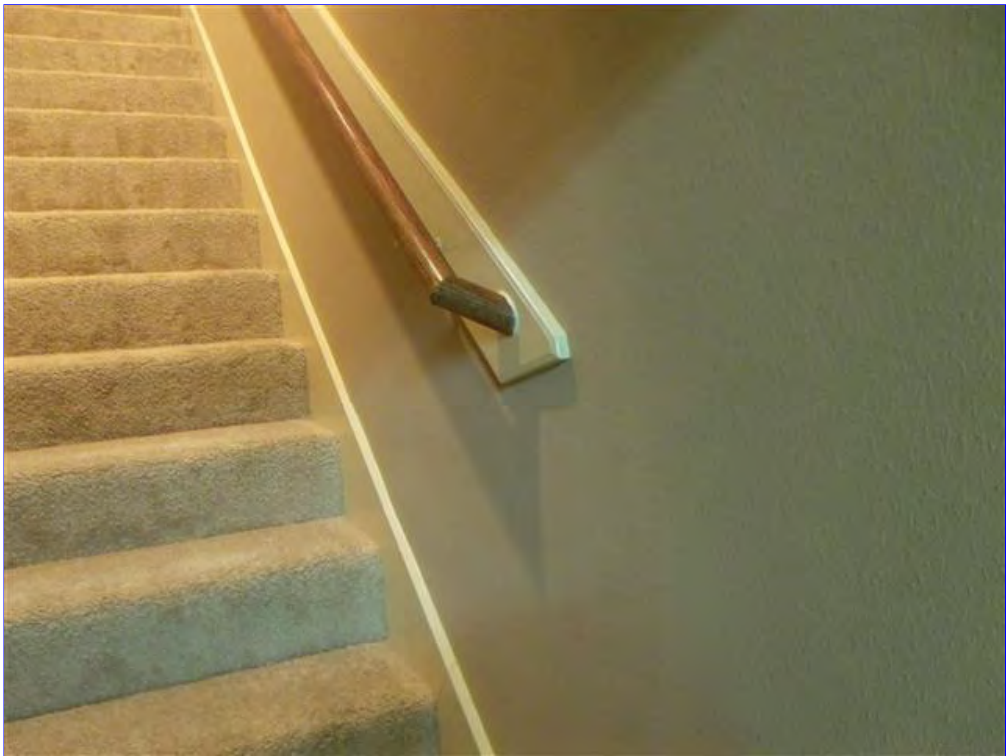
H. Item 2(Picture) Handrail should extend full length of the stairs.

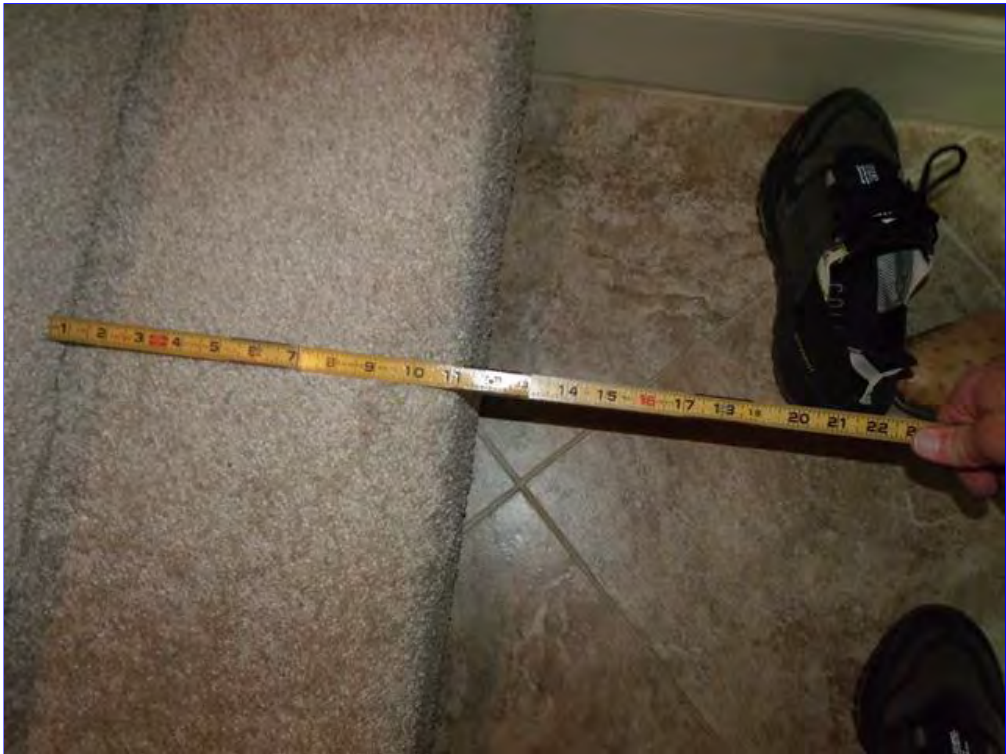
Tread depth is deficient. Should be at least 11 inch tread.

H. Item 5(Picture) Treads are deficient. Tread depth should be eleven inches with no nosing.

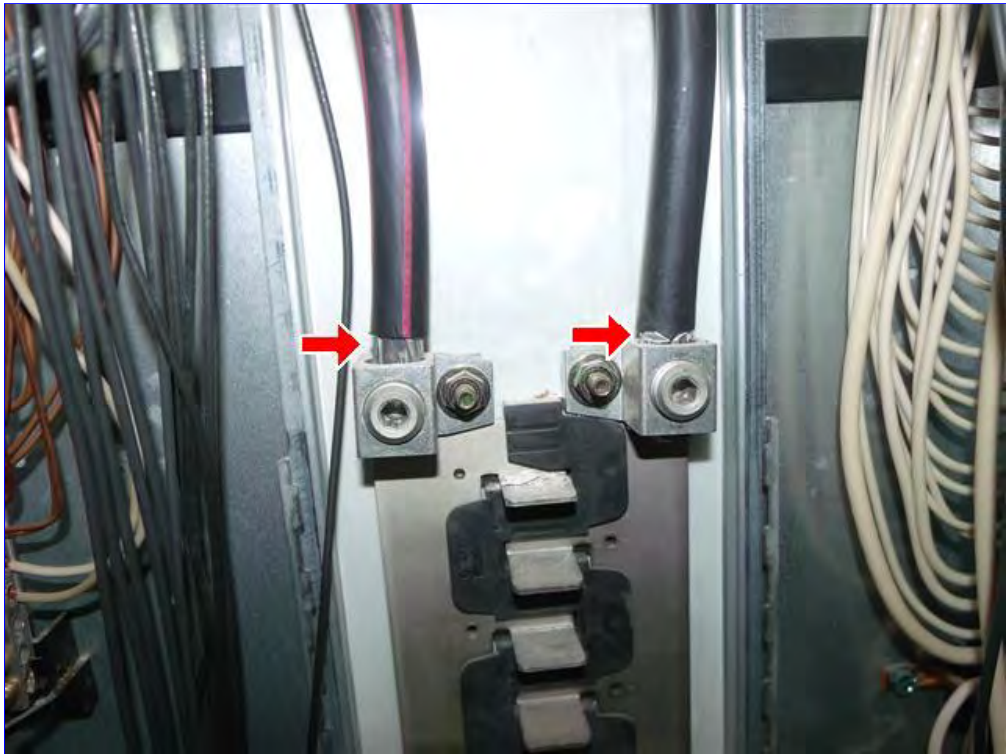
A. Item 3(Picture) Aluminum Feed service conductors. Aluminum conductors are required to anti-oxidant paste. Make sure to have a competen licensed electrician correct this and voids around box.

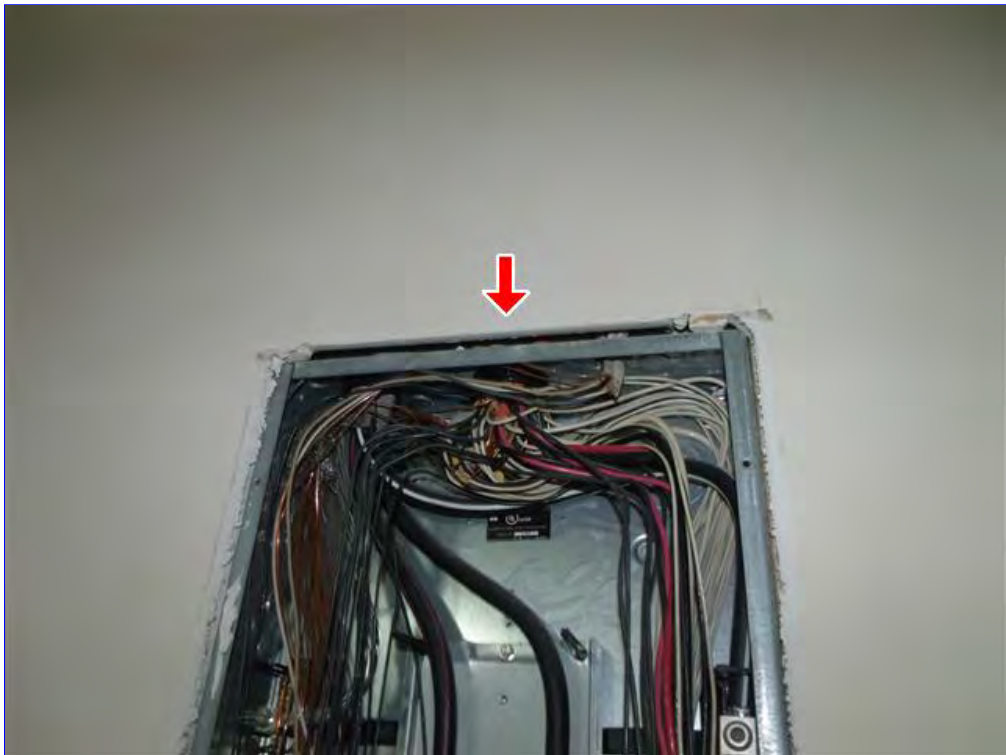
A. Item 4(Picture) Should not have more than one eighth of an inch gap.
