InspectorTx.com®

Inspection Report

PROPERTY INSPECTION REPORT FORM

<i>Name of Client</i>	11/12/2022 <i>Date of Inspection</i>
<i>Address of Inspected Property</i> BRYON A. PARFFREY llc.	
<i>Name of Inspector</i>	Texas #7408 <i>TREC License #</i>
<i>Name of Sponsor (if applicable)</i>	<i>TREC License #</i>

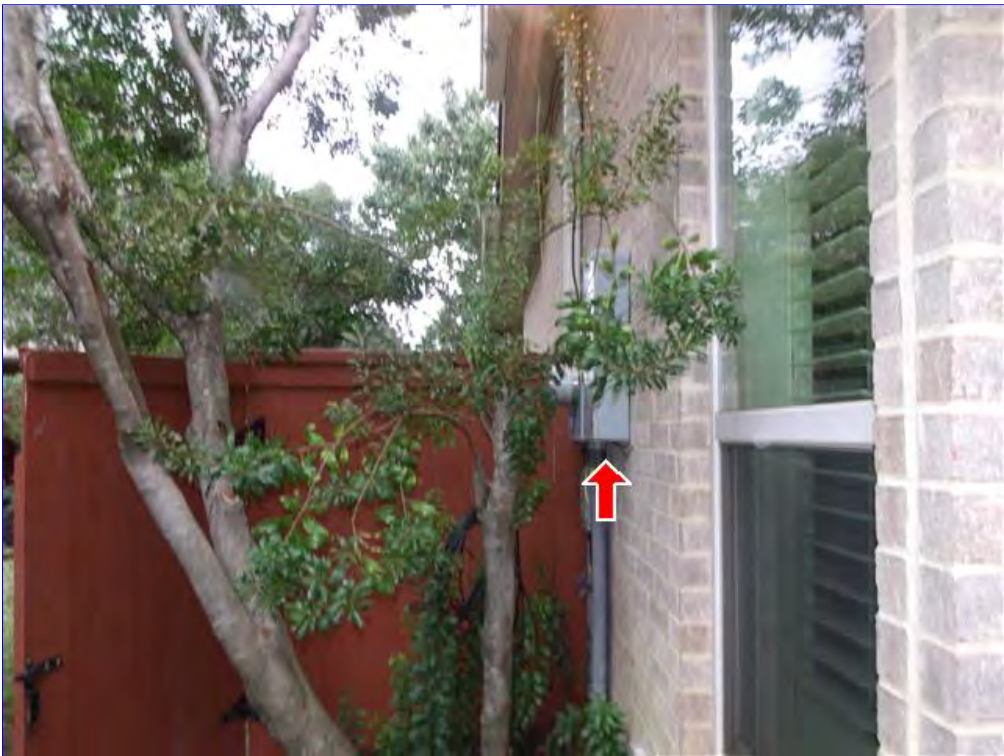
A. Item 6(Picture) Deficient in need of repair.

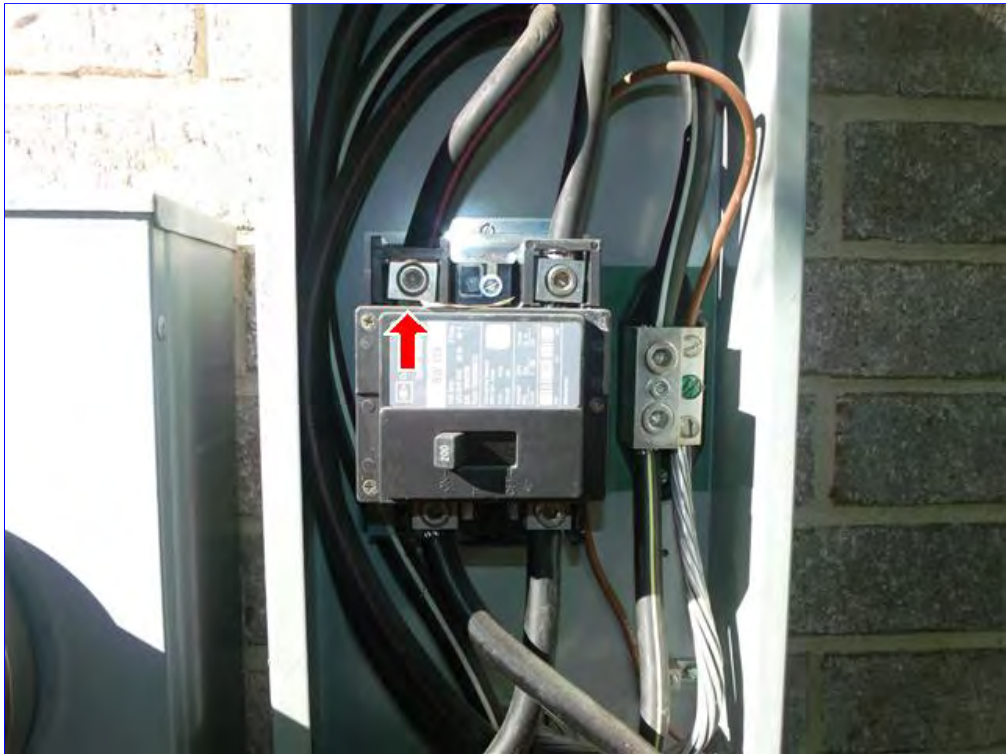
A. Item 9(Picture) Recommend capping service conductor lugs and anti-oxidant paste on aluminum conductors.

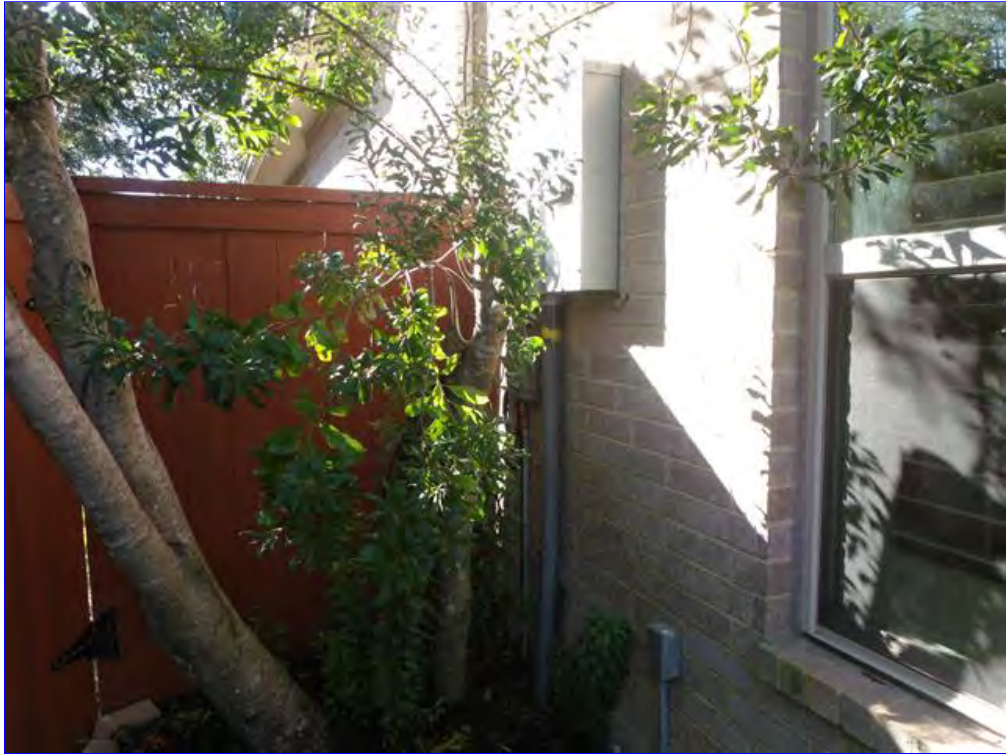
A. Item 10(Picture) Deficient. Electrical panel is obstructed.

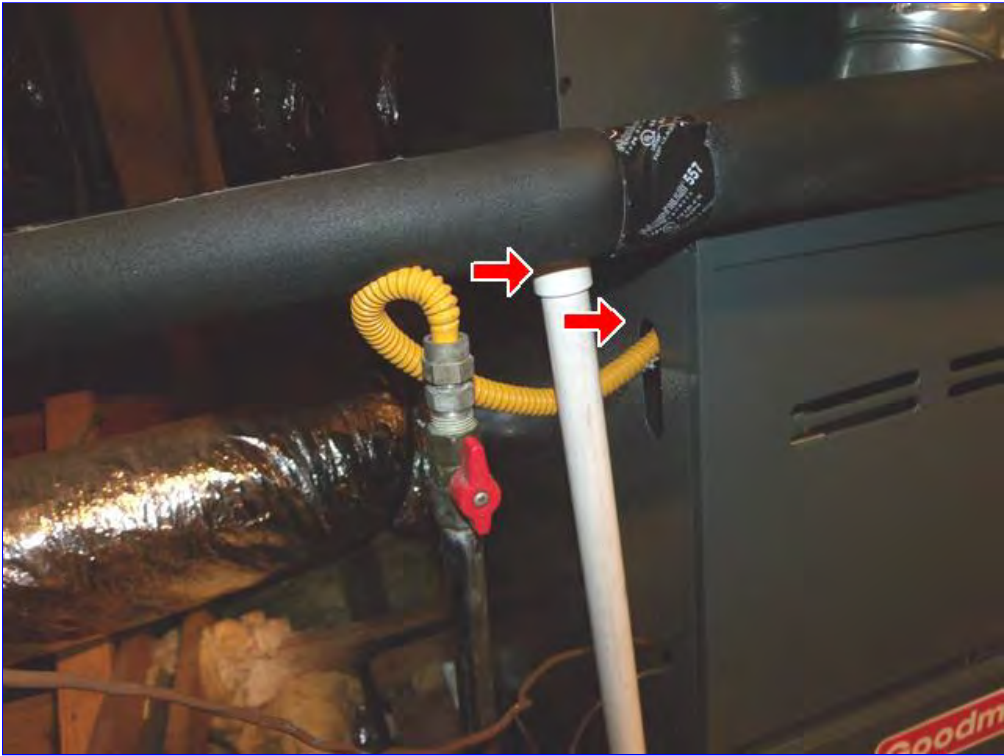
B. Item 10(Picture) Flex line need corrected with solid gas line. Also cap PVC out let line

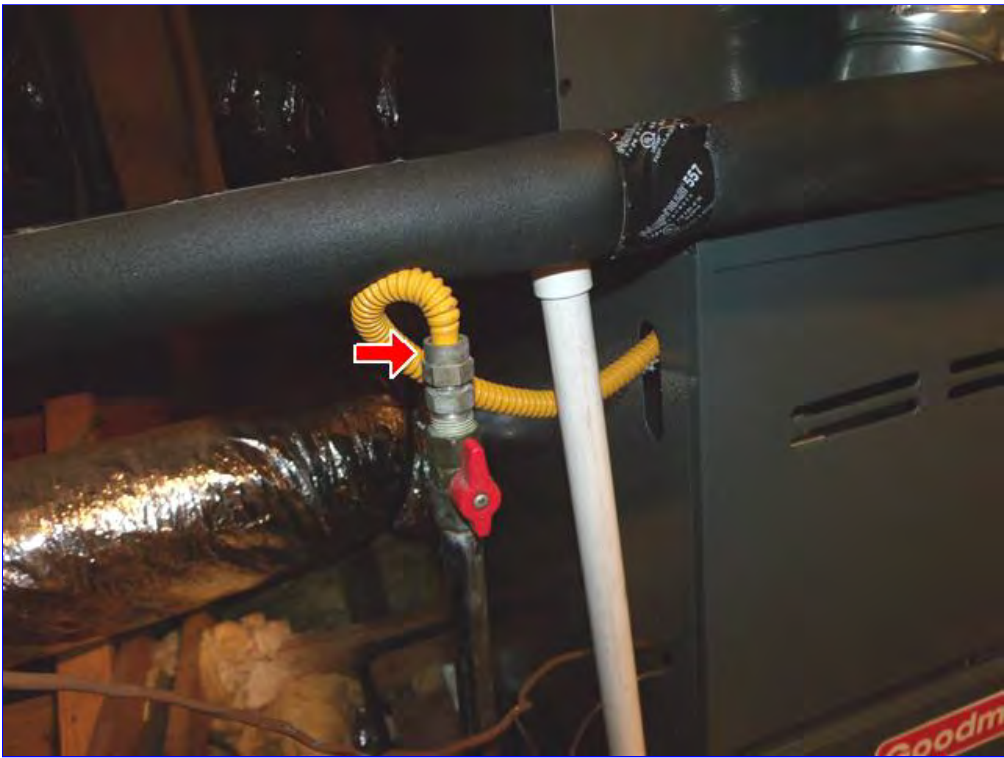
B. Item 2(Picture) Improper connection. In need of repair.

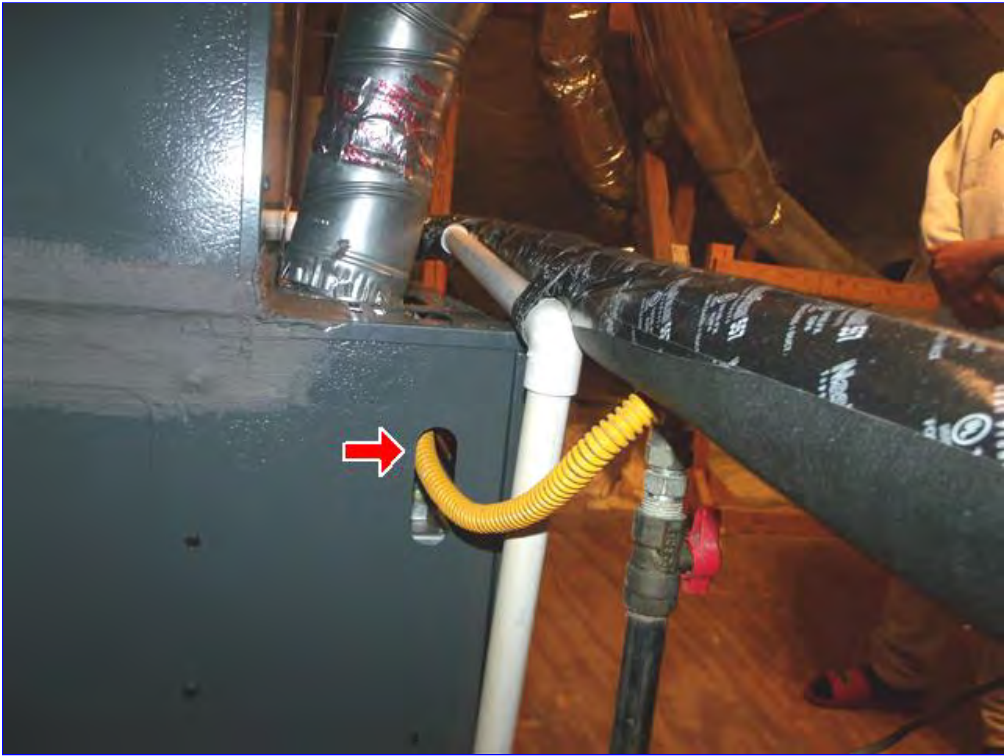
B. Item 4(Picture) Improper connection. In need of repair.

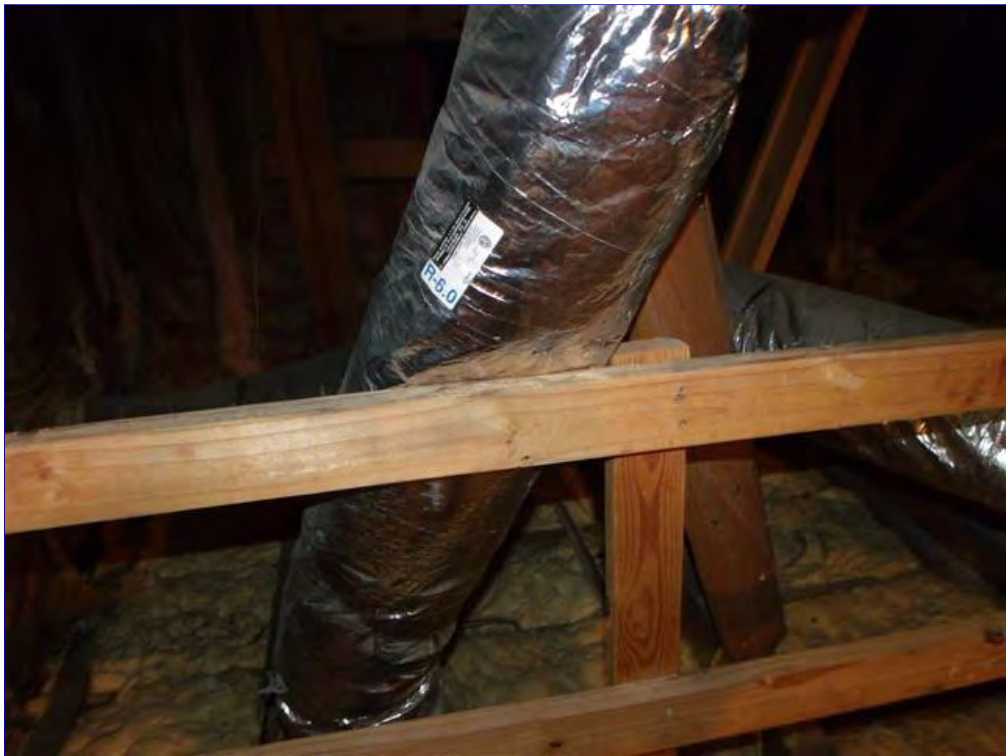
C. Item 2(Picture) Insulation should be installed between the duct and the rail to prevent condensation.

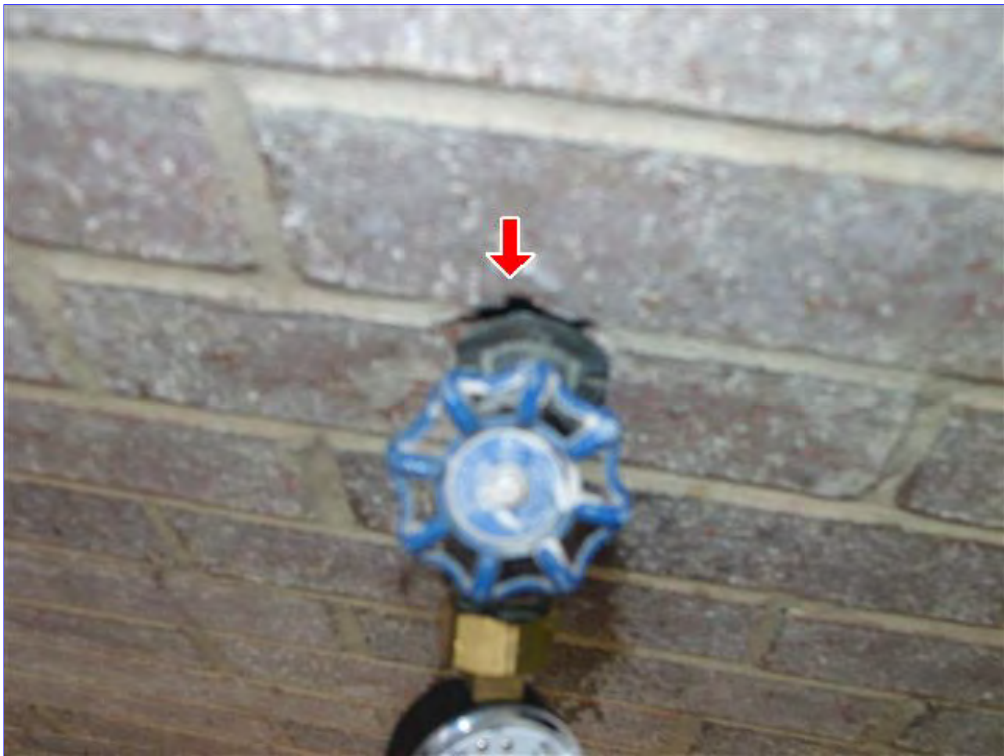
A. Item 12(Picture) Recommend caulking around fixtures.

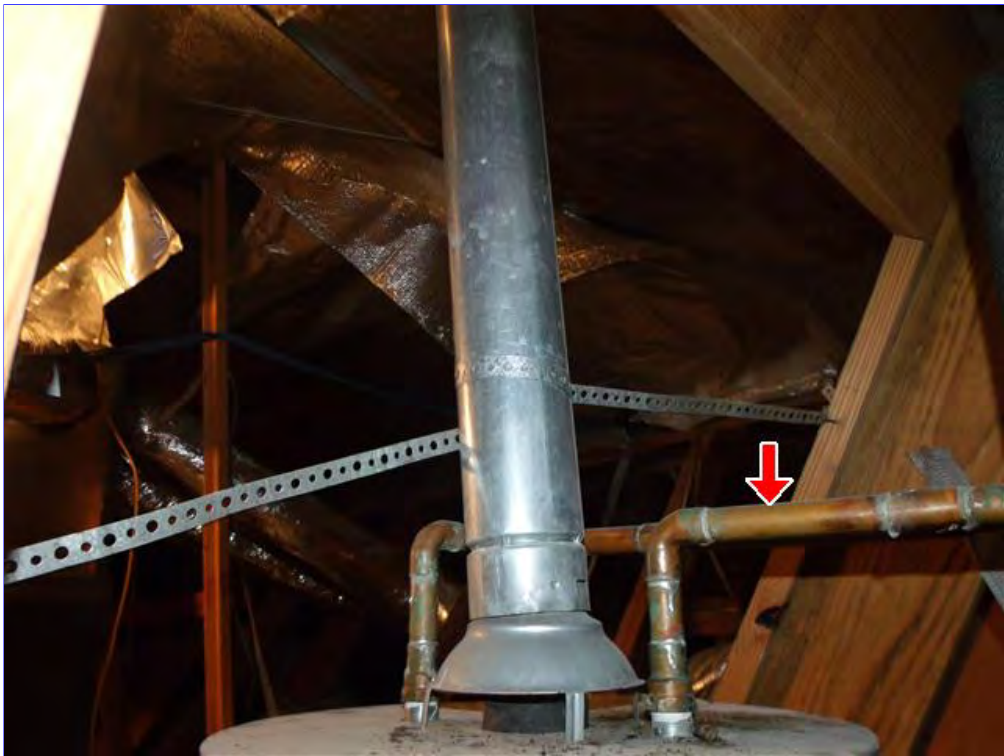
C. Item 2(Picture) Recommend insulation copper tubing starting six inches above water heater.
