InspectorTx.com®

Inspection Report

PROPERTY INSPECTION REPORT FORM

<i>Name of Client</i>	11/12/2022 <i>Date of Inspection</i>
<i>Address of Inspected Property</i> BRYON A. PARFFREY llc.	
<i>Name of Inspector</i>	Texas #7408 <i>TREC License #</i>
<i>Name of Sponsor (if applicable)</i>	<i>TREC License #</i>

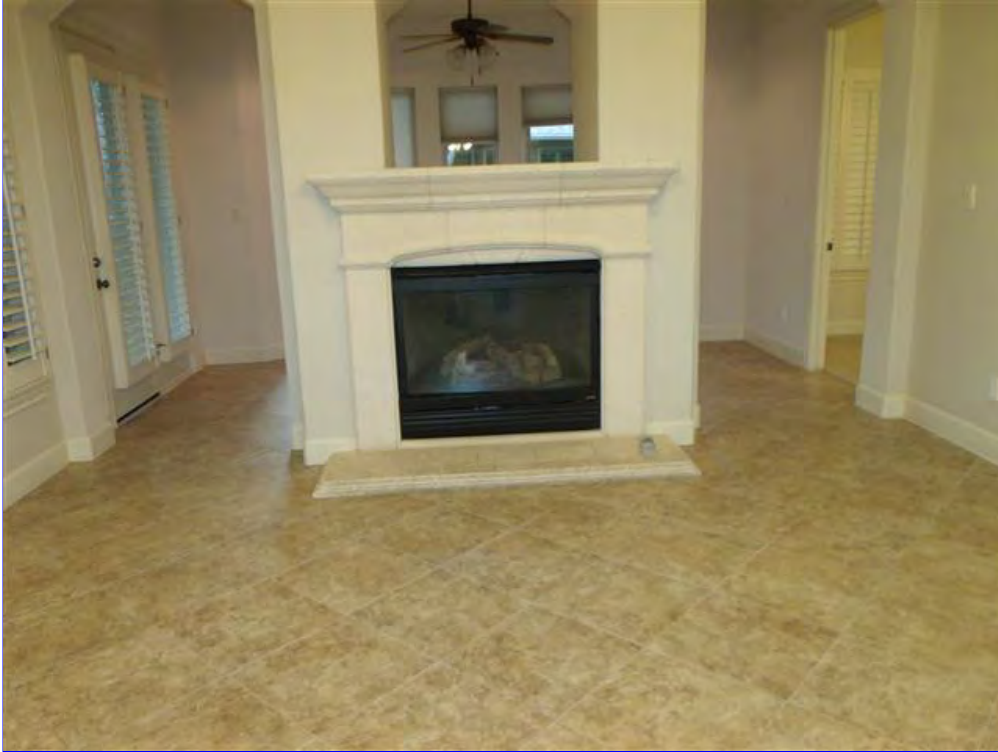
A. Item 3(Picture) Slight humps and dips in the floor. Not a structural issue.

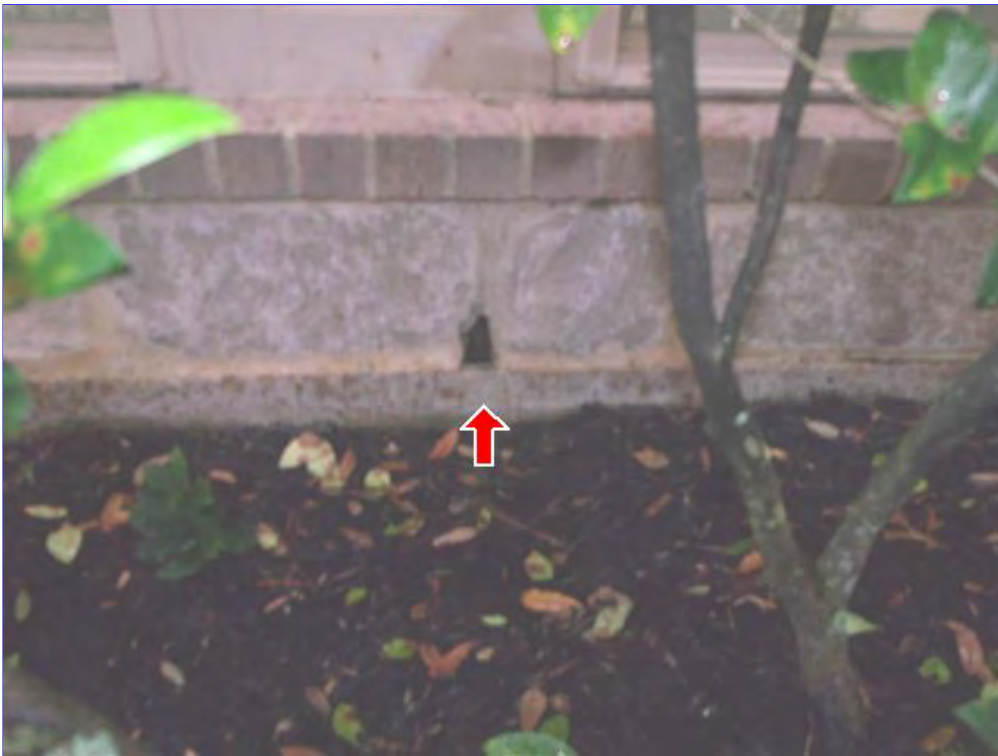
A. Item 4(Picture) Recommend installing weep screens to keep rodents out.

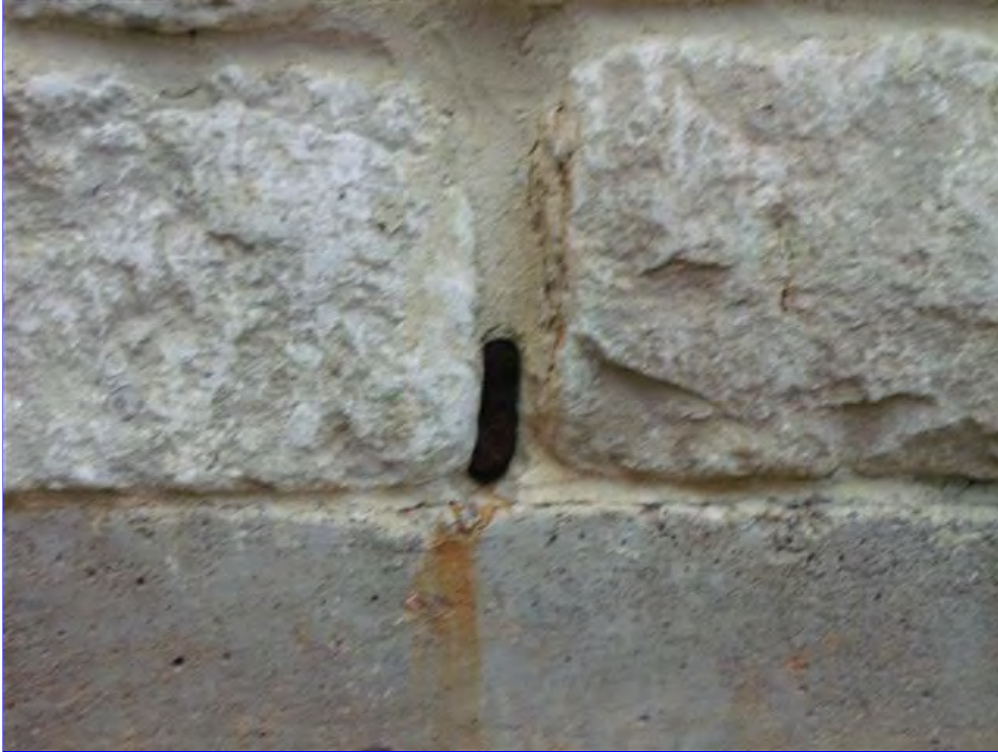
A. Item 5(Picture) Recommend installing weep screens to keep rodents out.

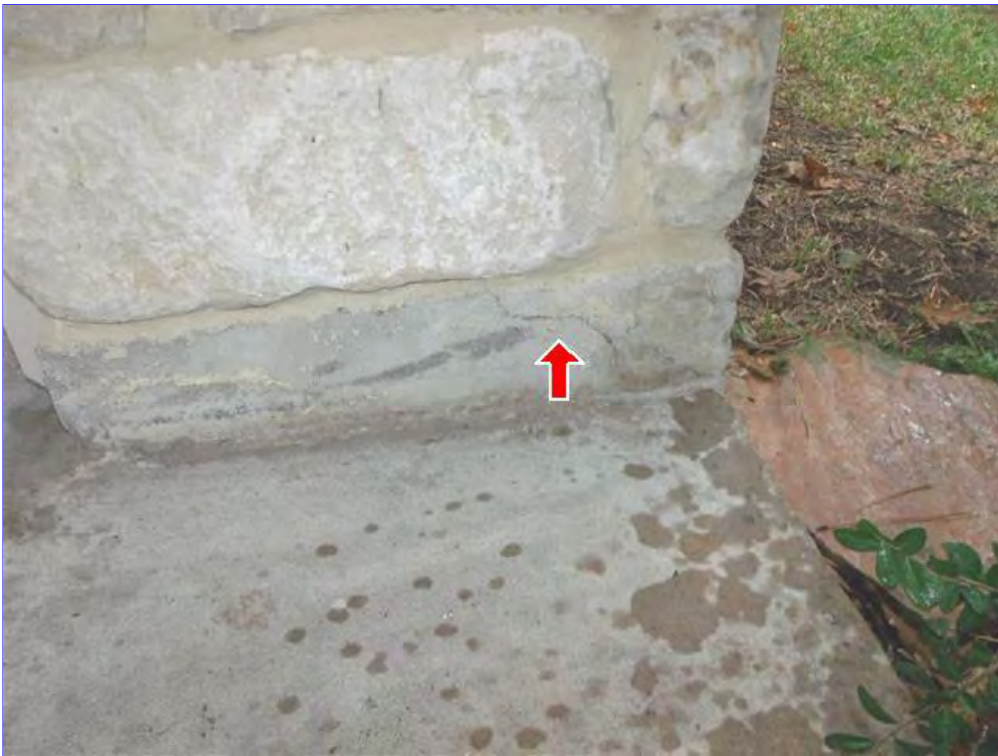
A. Item 6(Picture) Crack. Recommend sealing to prevent water intrusion to prevent damage to the masonry.

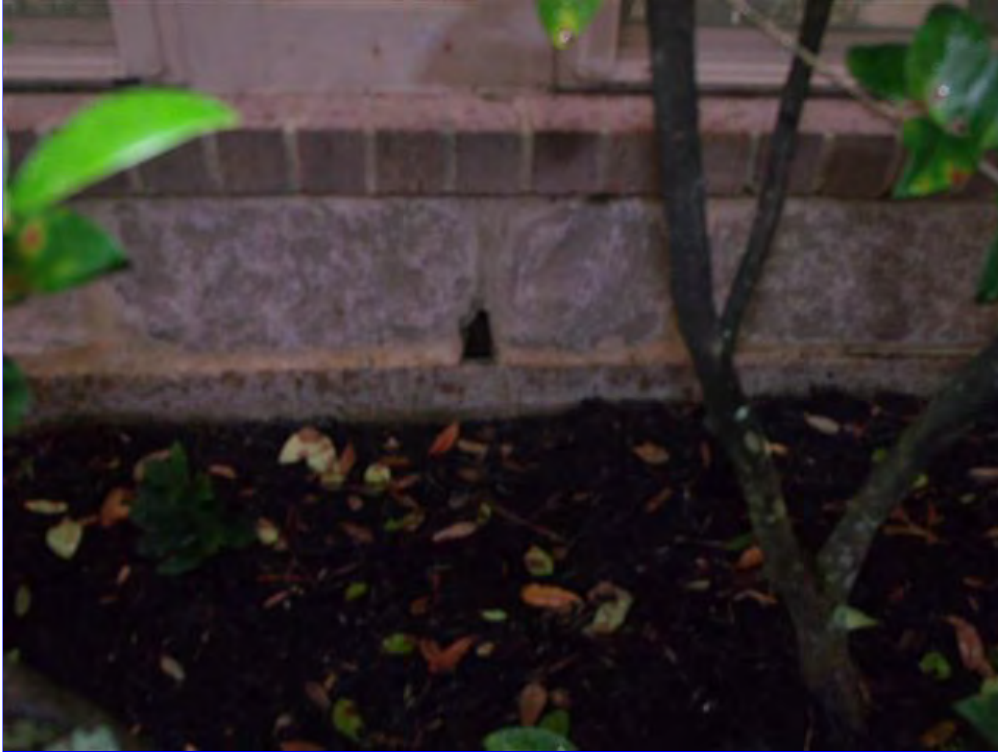
A. Item 7(Picture) Should have a minimum of four inches of exposed slab for masonry.

Recommend having a minimum of four inches of exposed slab for brick siding. Brick can wick up water causing the siding to stay moist.

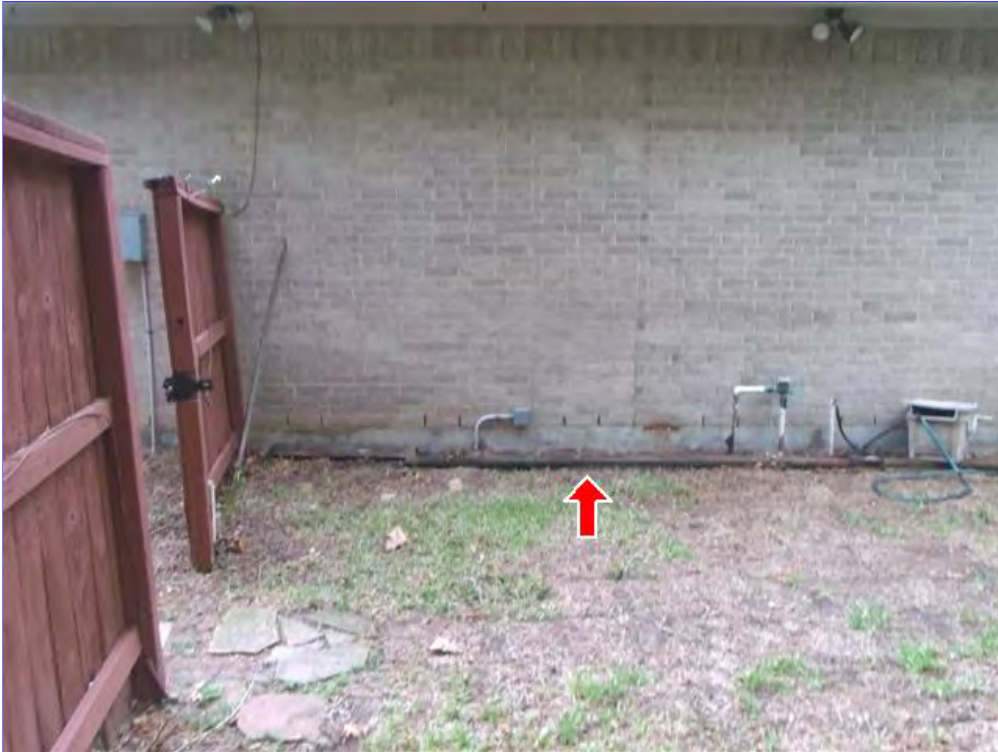
A. Item 8(Picture) Recommend clearing the wood away from the house. This is conducive to wood destroying insects (WDI) and wood destroying organisms (WDO).

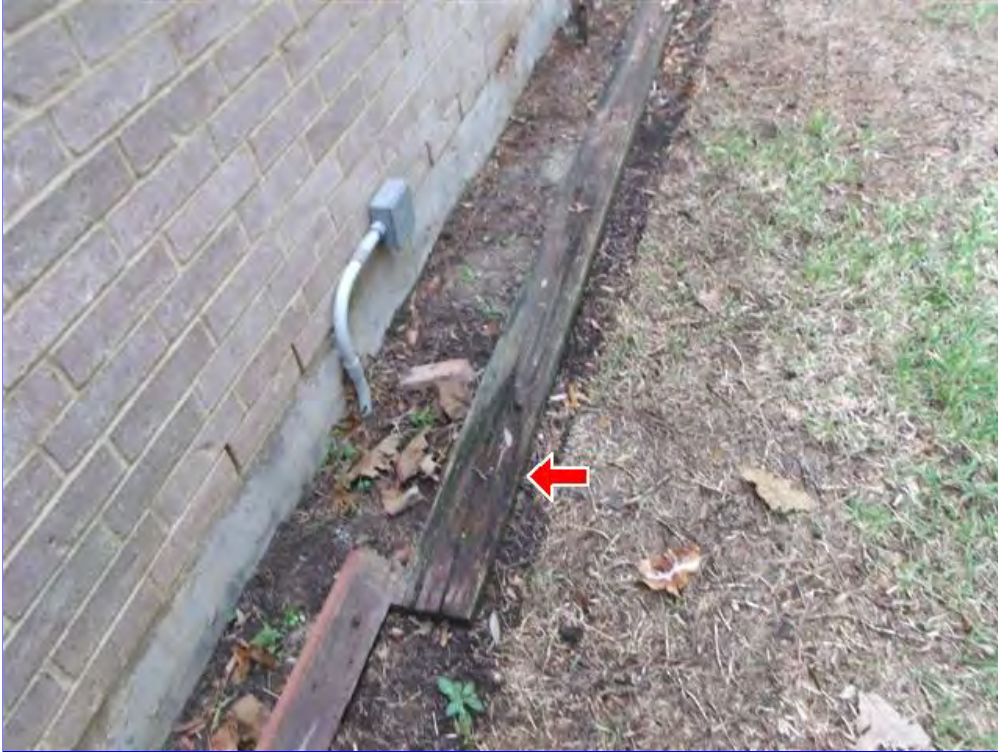
A. Item 9(Picture) Wood is conducive to wood destroying organisms (WDO) and wood destroying insects (WDI).

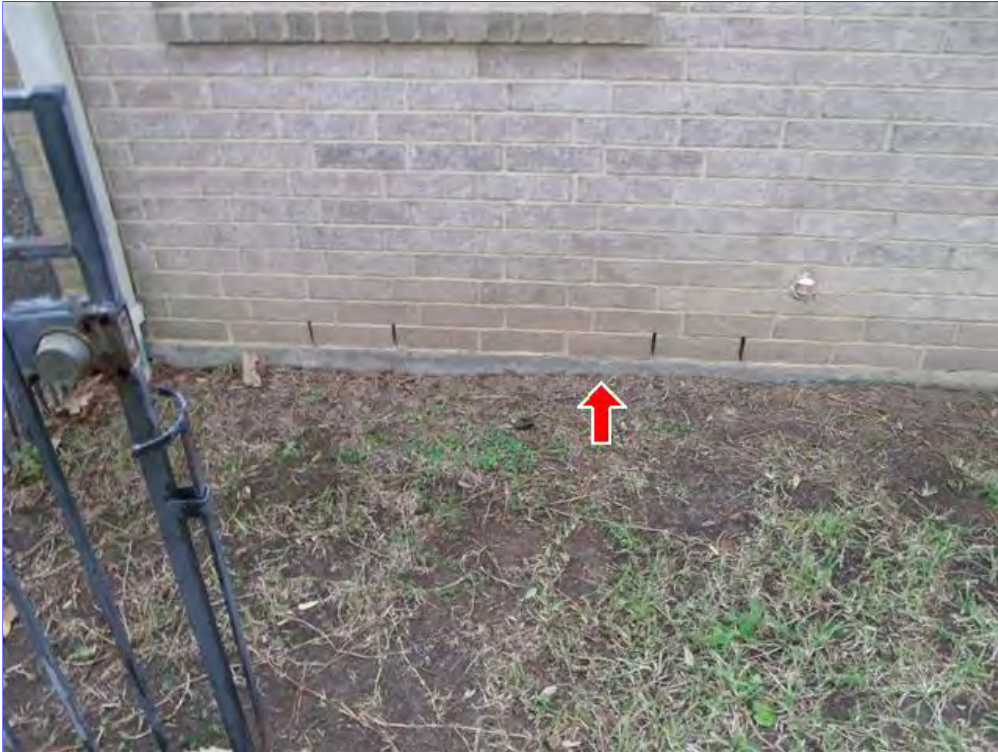
A. Item 10(Picture) Should have a minimum of four inches of exposed slab for brick veneer.

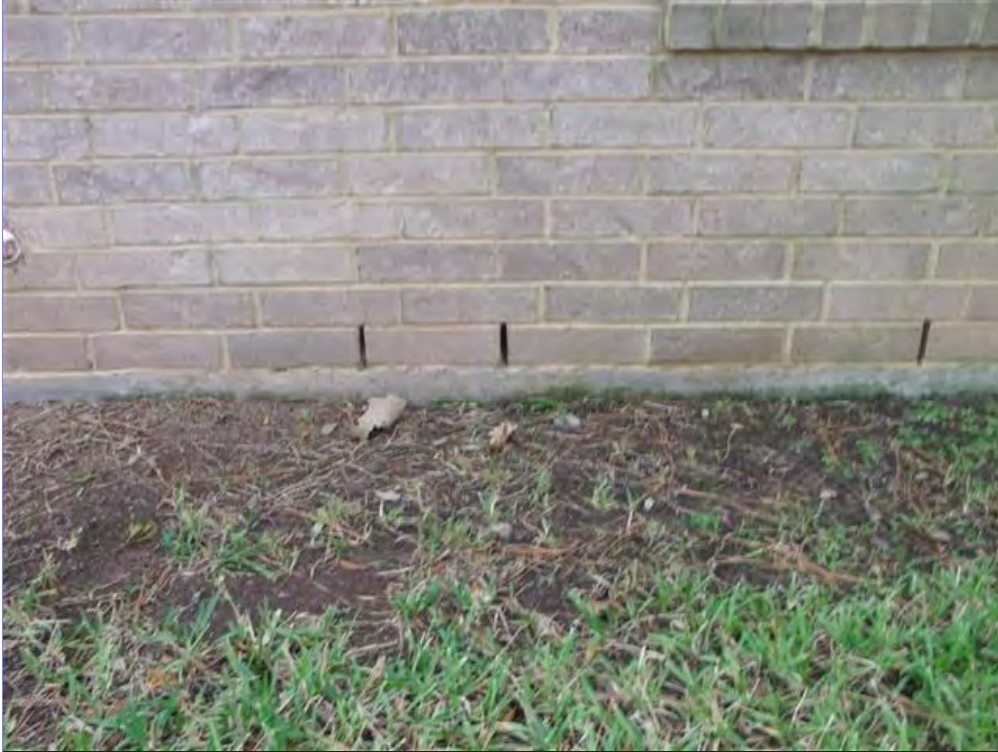
A. Item 11(Picture) Weep holes are excessive in size make sure to add weep hole protectors and mortar in smaller and other blocked weep holes re drill out

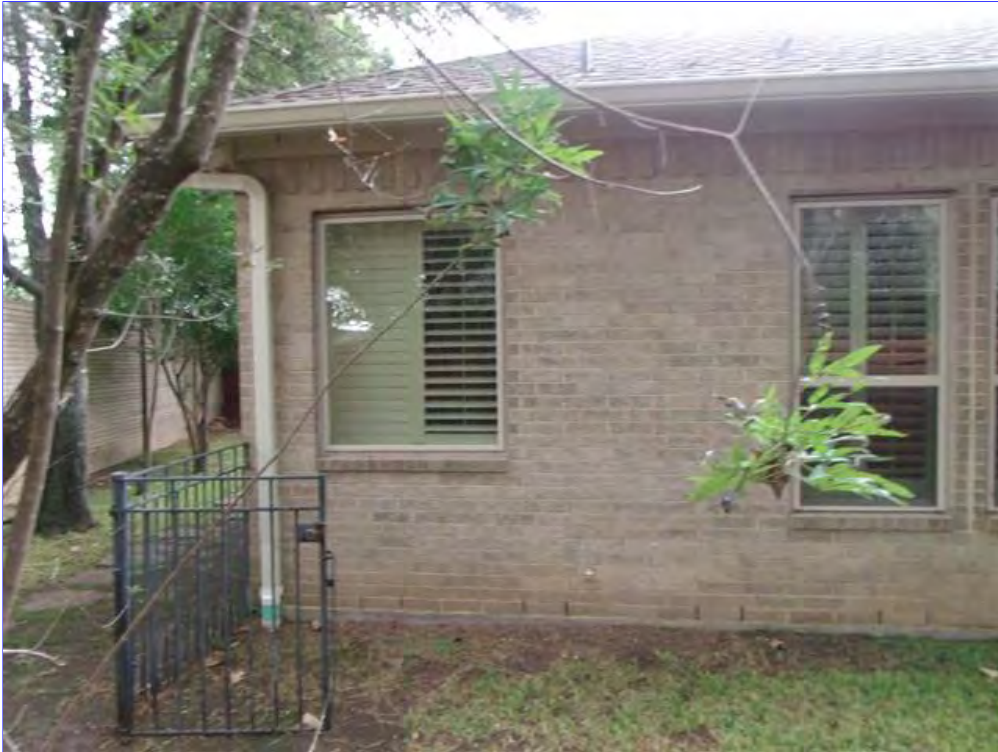
A. Item 12(Picture) Should have a minimum of four inches of exposed slab for brick veneer.

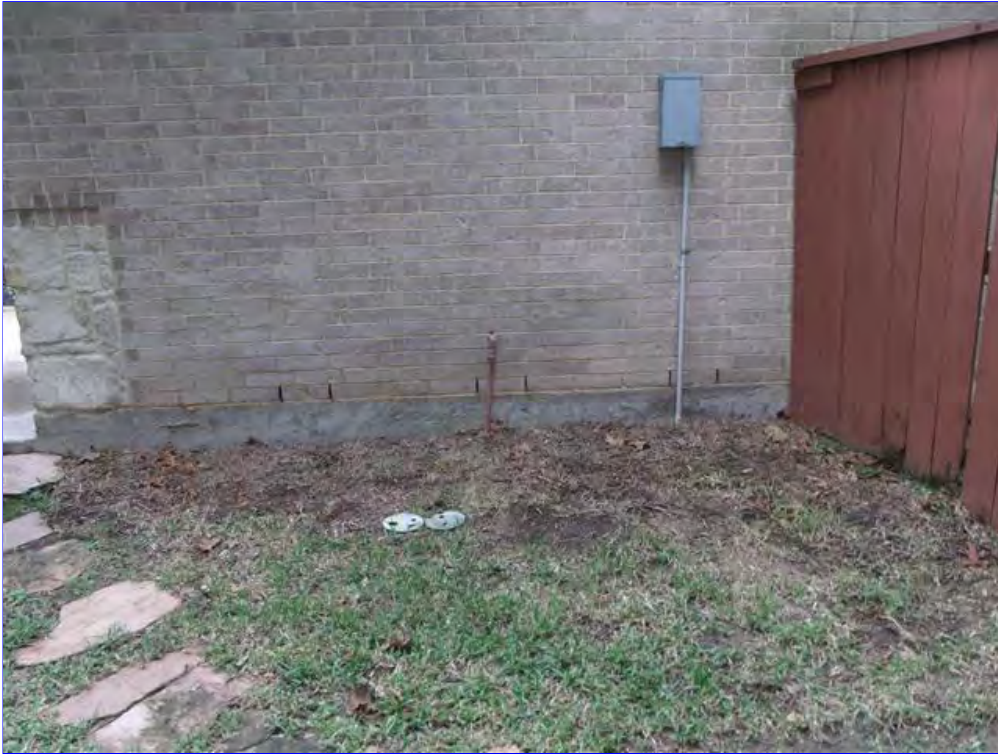
A. Item 13(Picture) Recommend having a six inch slope in ten feet away from the foundation.

Recommend having a six inch slope in ten feet away from the foundation to help prevent damage to the foundation.

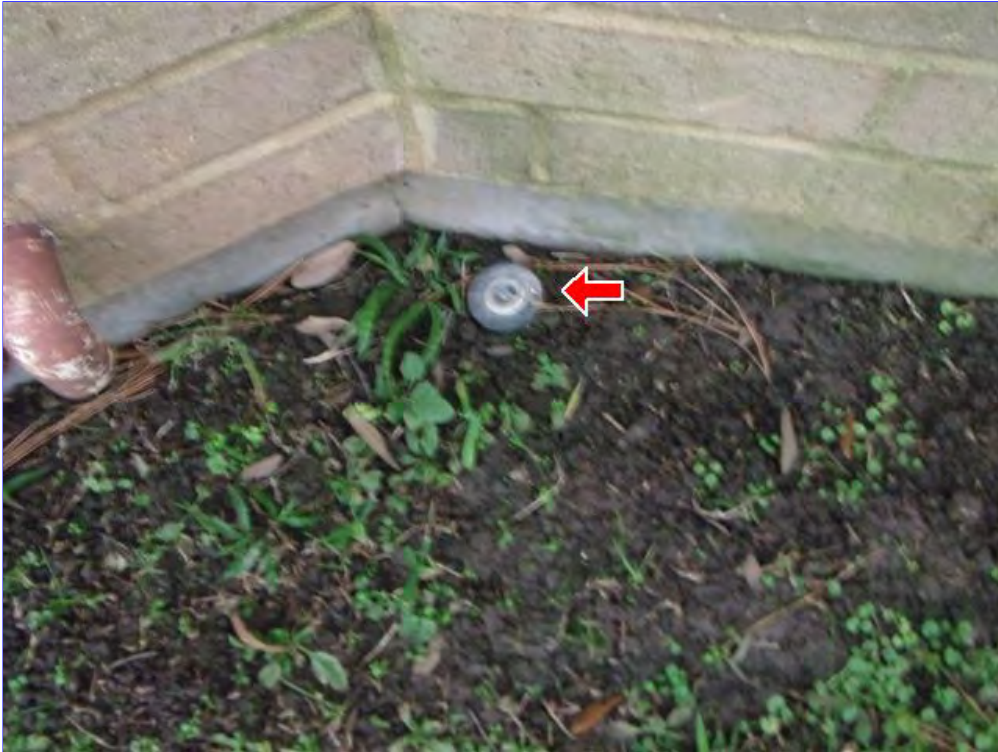
A. Item 14(Picture) Sprinklers too close to the foundation.

Sprinklers should be located a minimum of twelve inches away from the foundation so the foundation is not constantly wet.

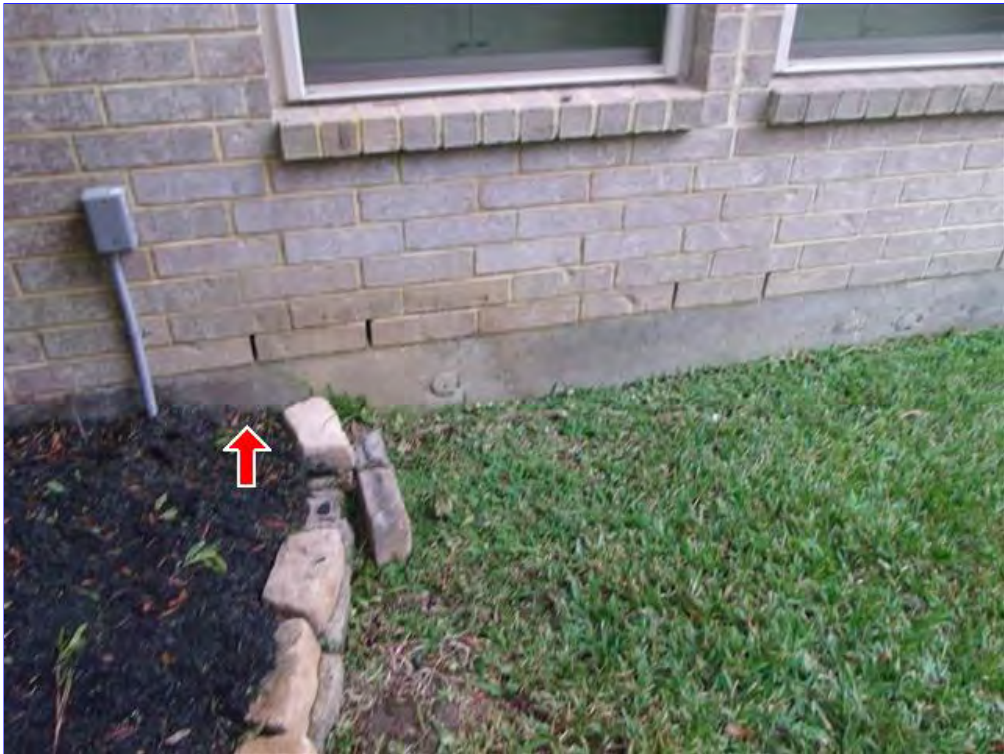
A. Item 15(Picture) Recommend having four inches of exposed slab for brick siding.

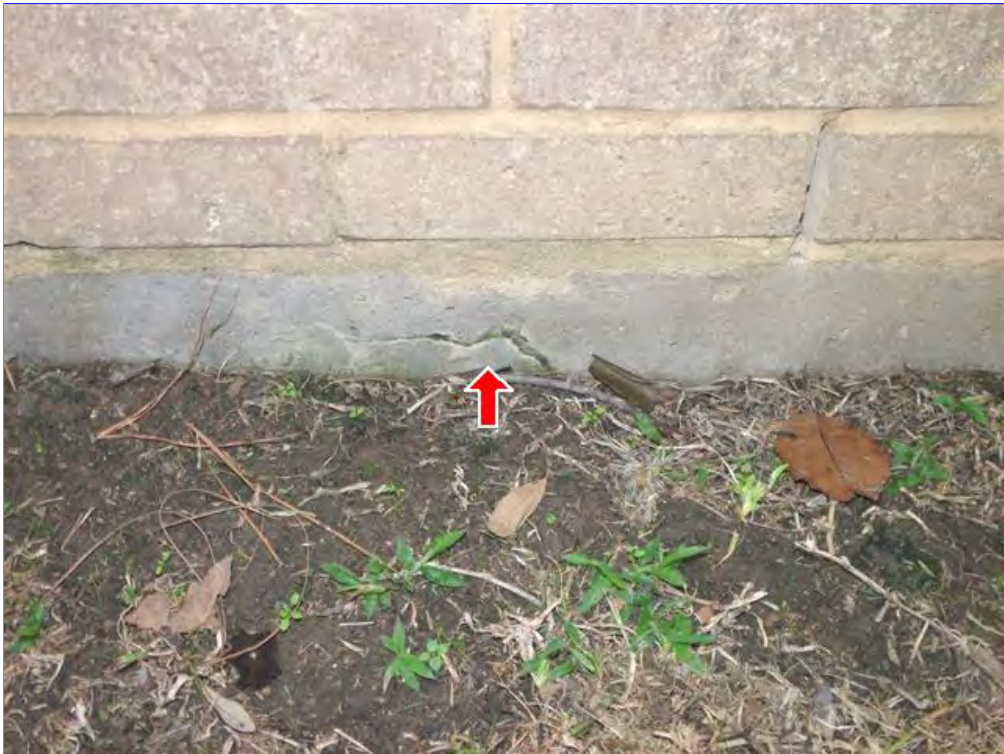
A. Item 17(Picture) Surface crack in the foundation. Recommend sealing with epoxy to prevent water intrusion.

Recommend sealing shrinkage cracks with epoxy to prevent water damage.

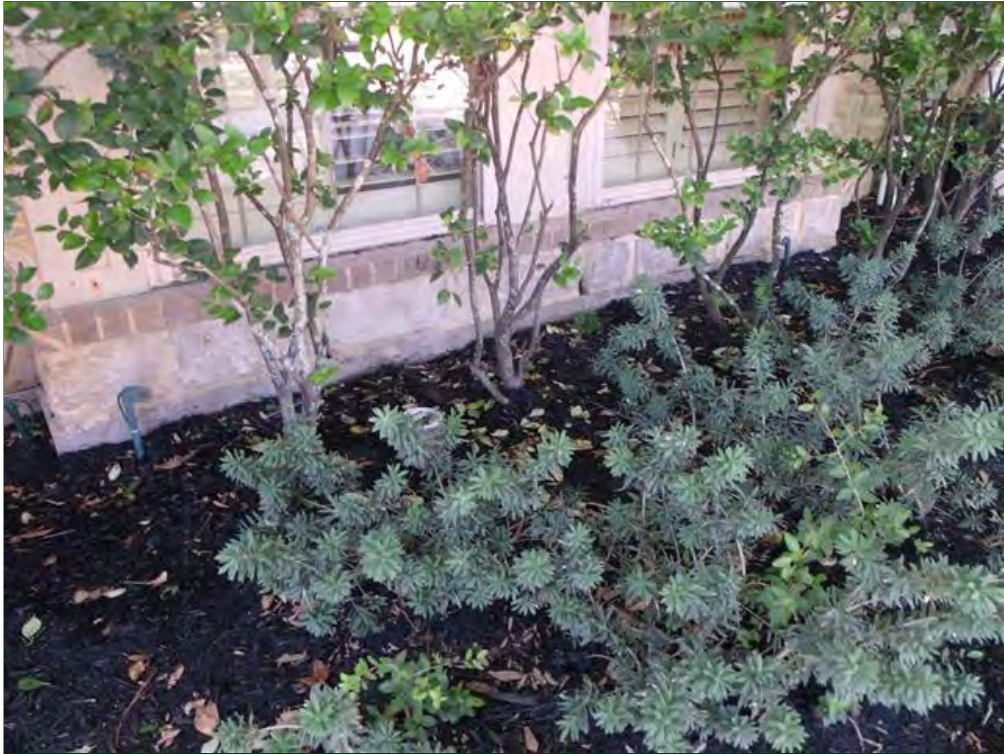
A. Item 18(Picture) It's recommend having four inches of exposed slab. Also proper grading is needed.

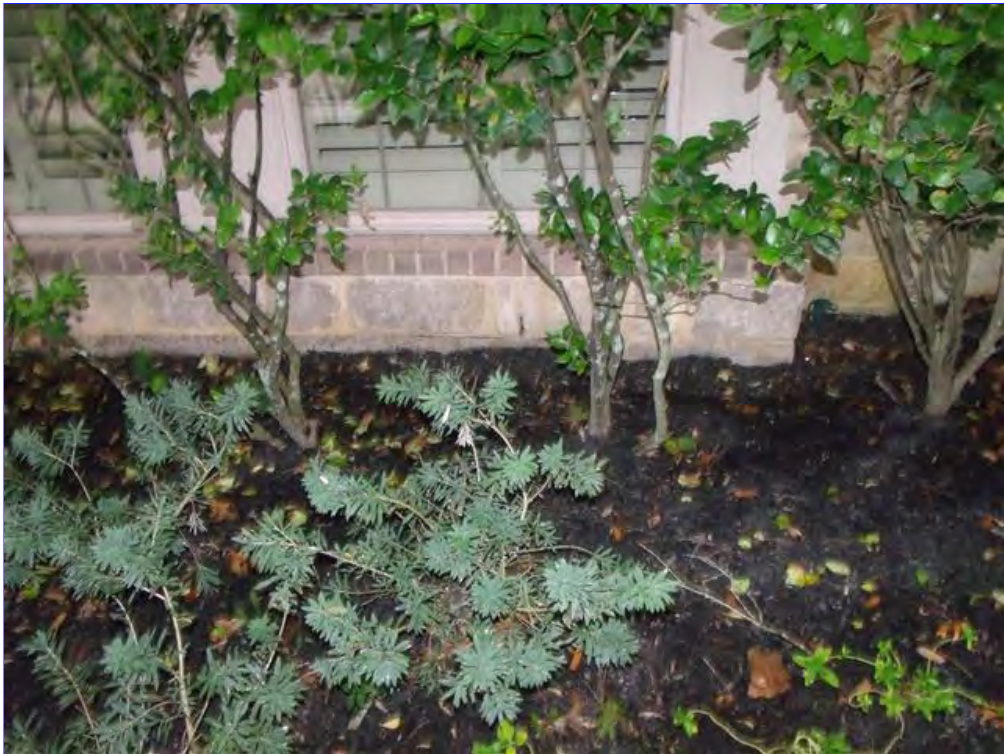
B. Item 3(Picture) Poor grading. Recommend having a six inch slope in ten inches away from the foundation.

Recommend having a six inch slope in ten inches away from the foundation to prevent ponding water around the foundation.

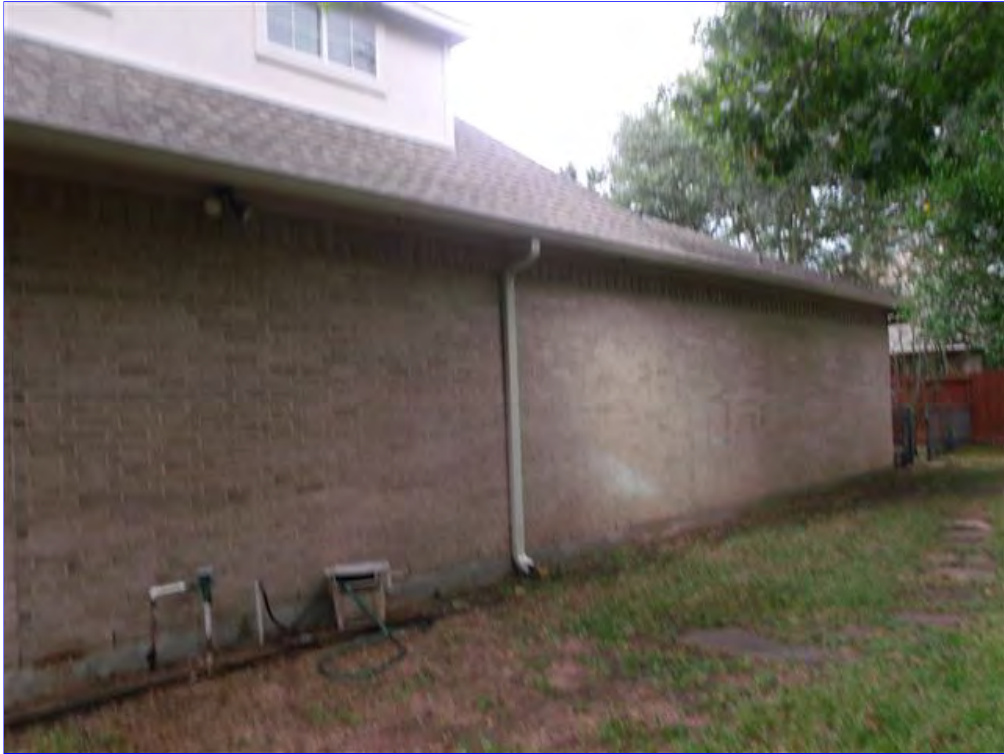
B. Item 4(Picture) Downspouts should drain water a minimum five feet away from the foundation.

Gutters should let water out into a drain system like a tube or pvc drain or grate at least five feet (5') away from foundation.

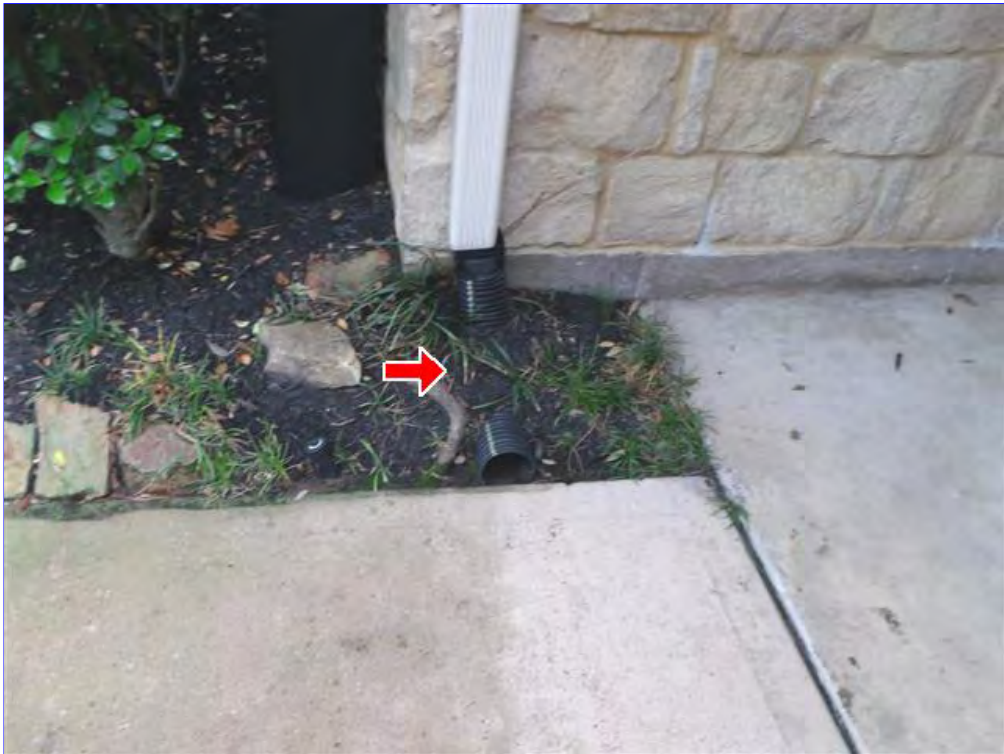
B. Item 5(Picture) Downspouts should drain water a minimum five feet away from the foundation.

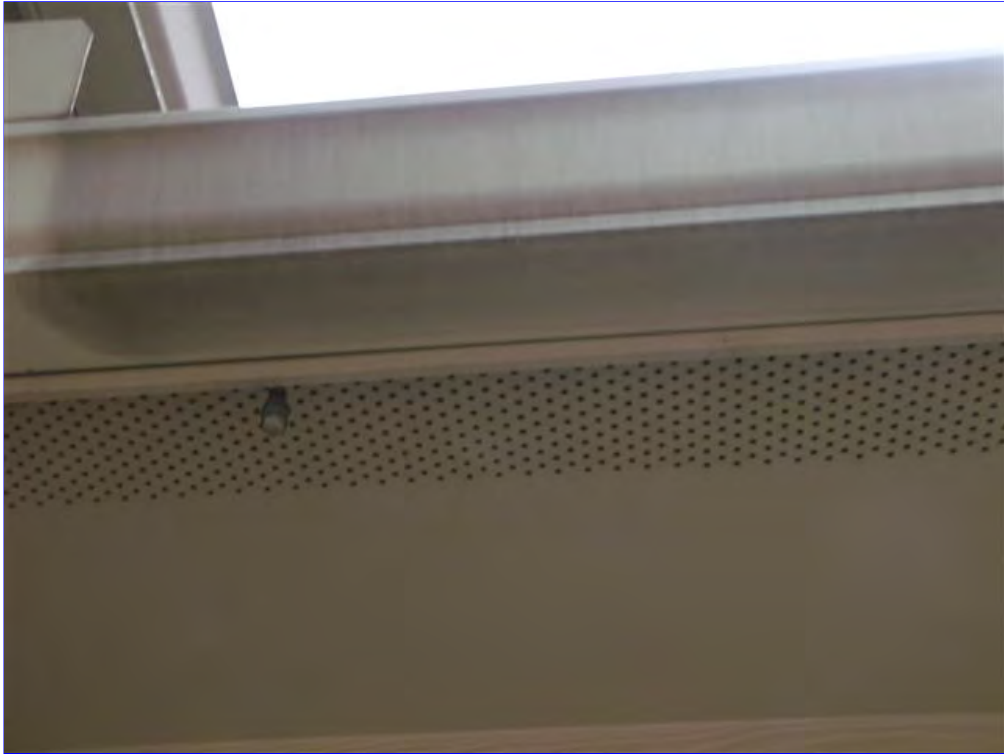
B. Item 6(Picture) Gutter is not discharging water properly.

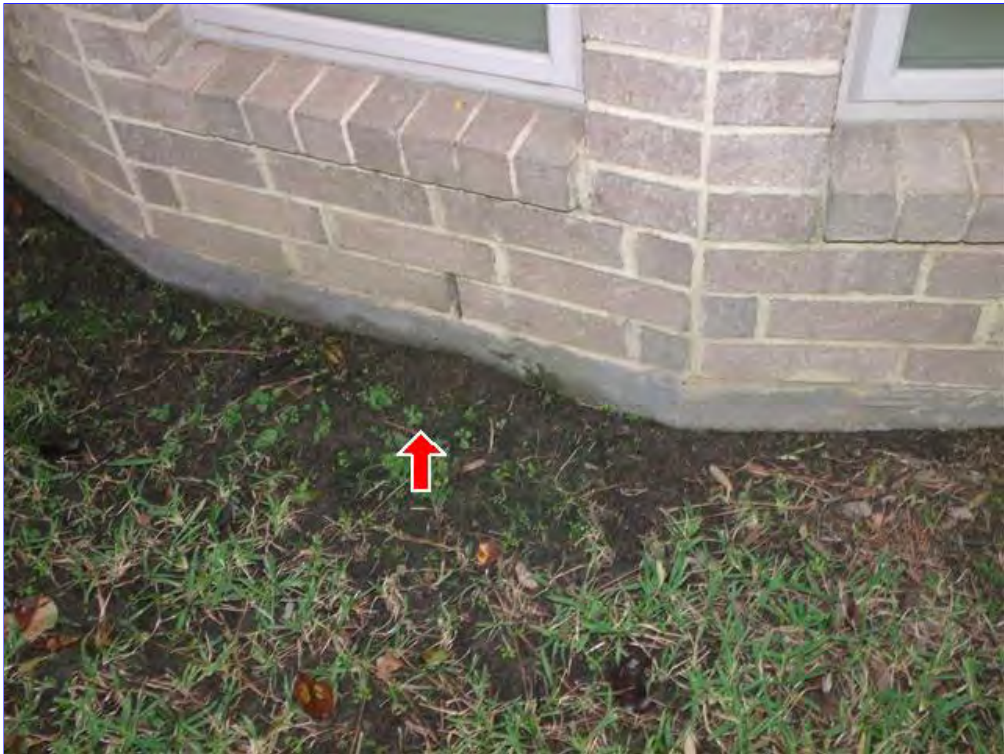
B. Item 9(Picture) Ponding water.

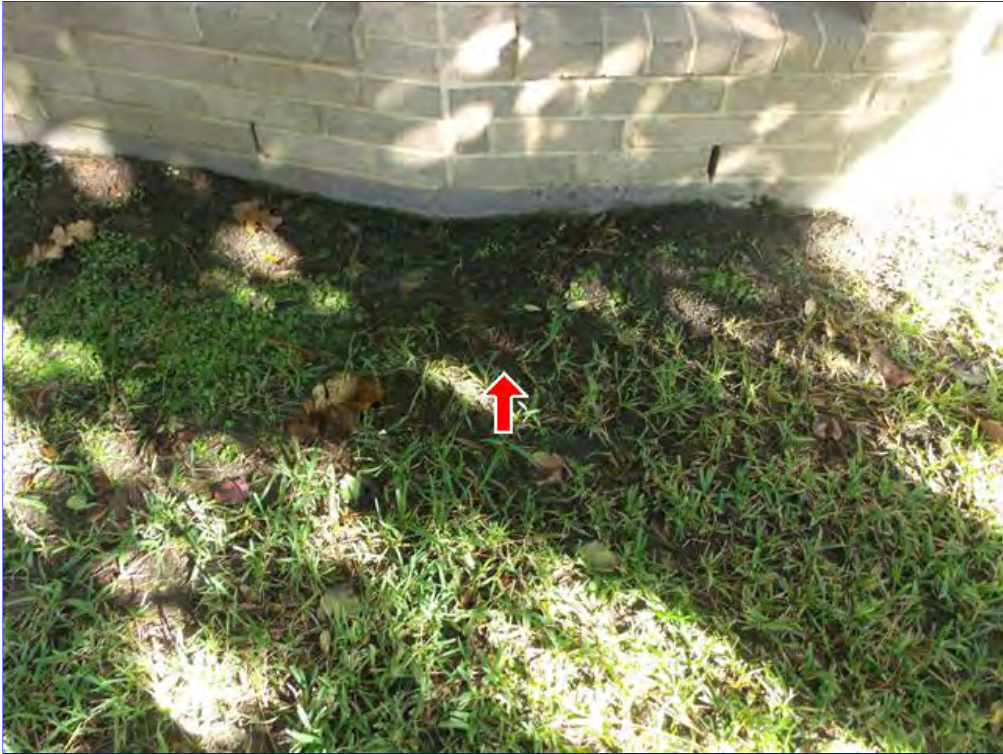
B. Item 11(Picture) Ponding water.

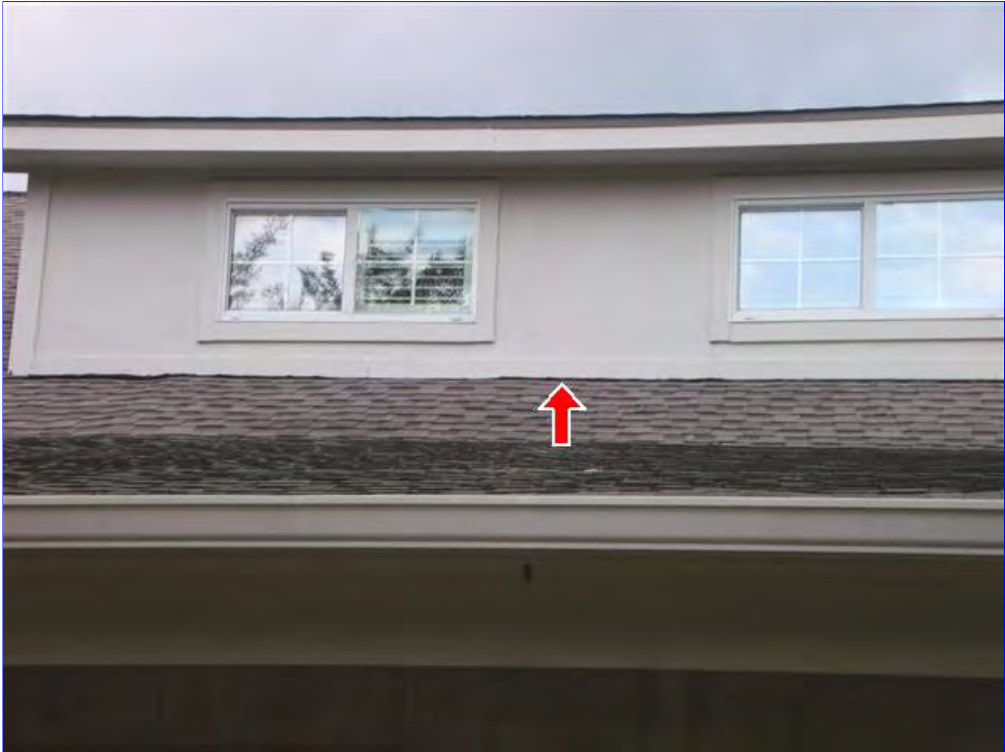
C. Item 1(Picture) Should have a one inch gap between the siding and roofing material.

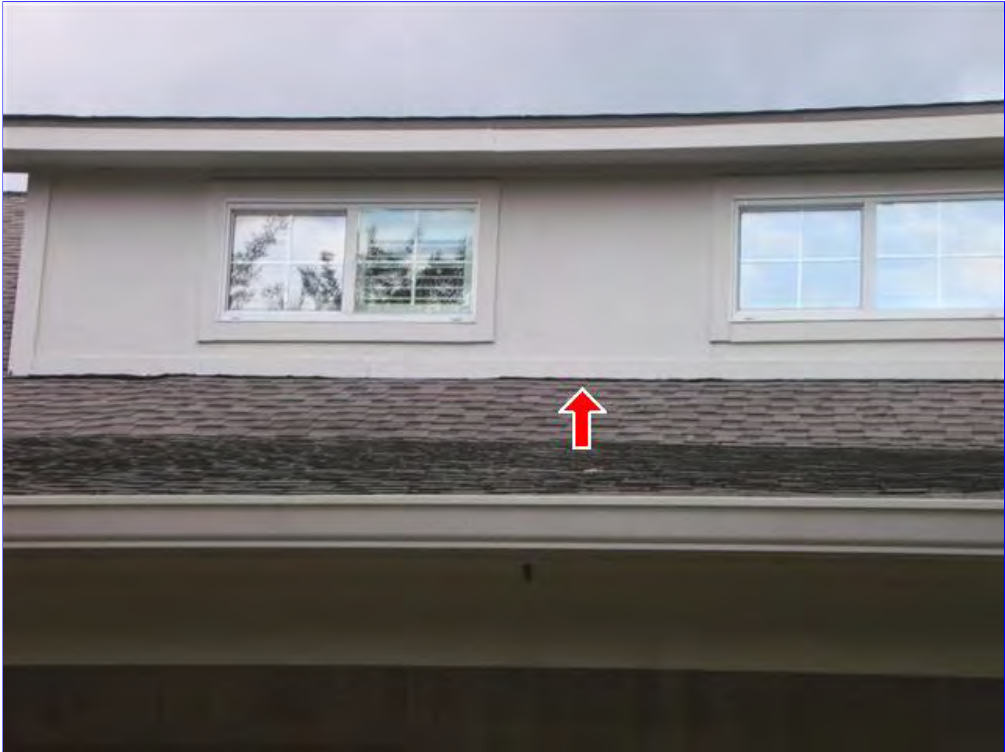
C. Item 2(Picture) Buckled flashing. In need in repair.

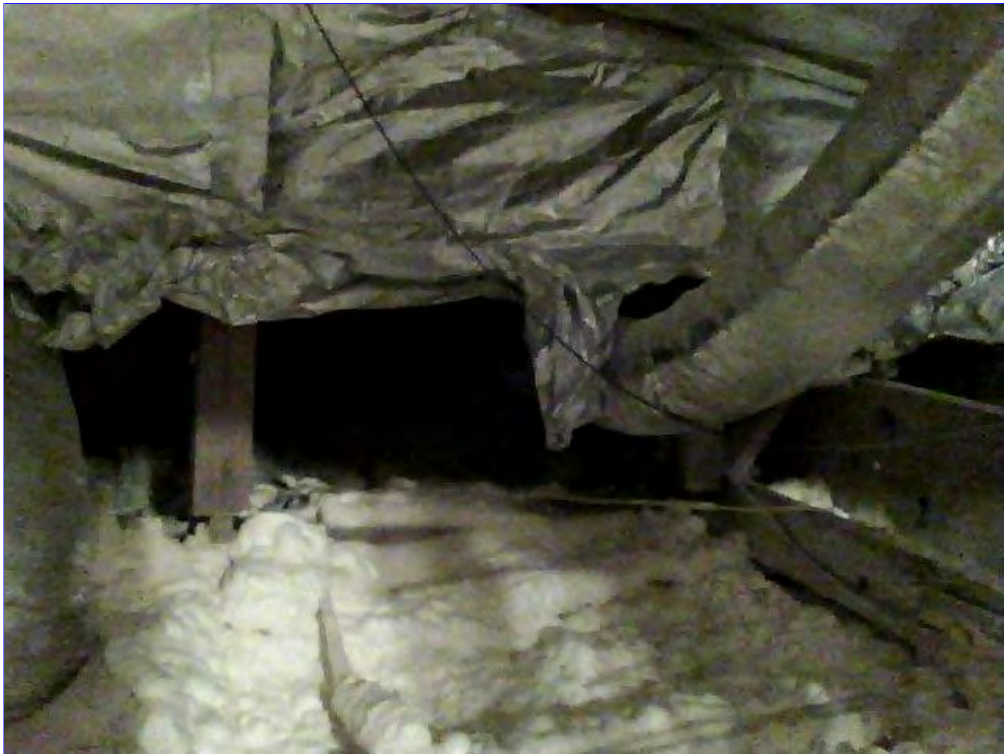
C. Item 3(Picture) blocked areas

Foam insulation is blocking the soffit intakes. Recommend cutting back insulation to allow proper ventilation of the soffits.

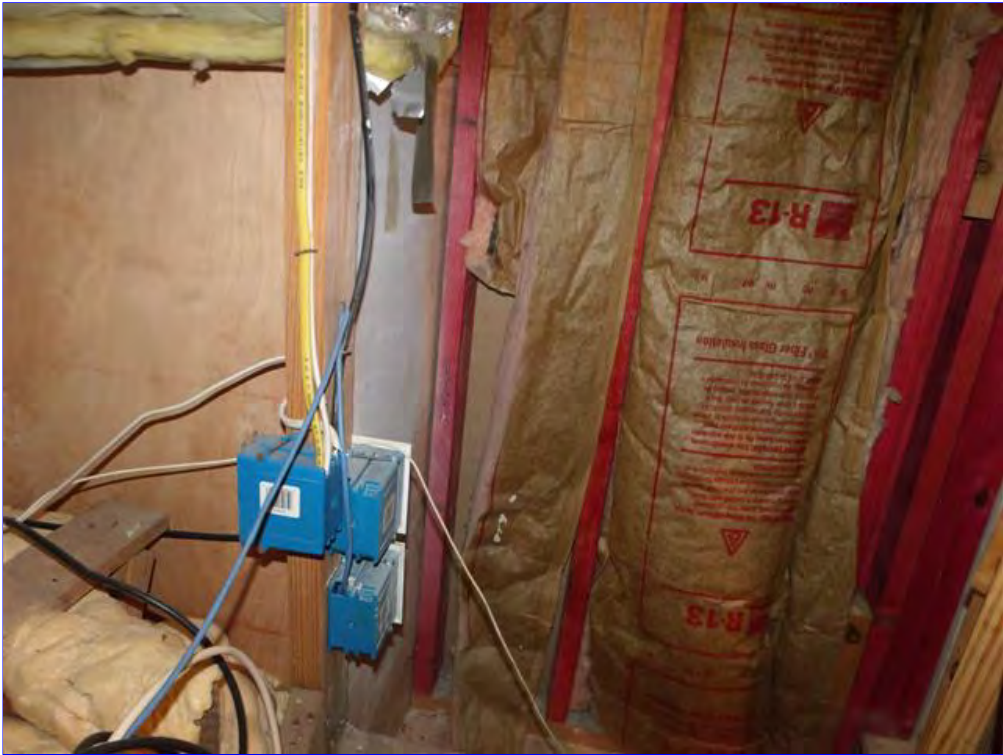
C. Item 12(Picture) Missing insulation voids in wall areas in attic after all that over kill in foam.

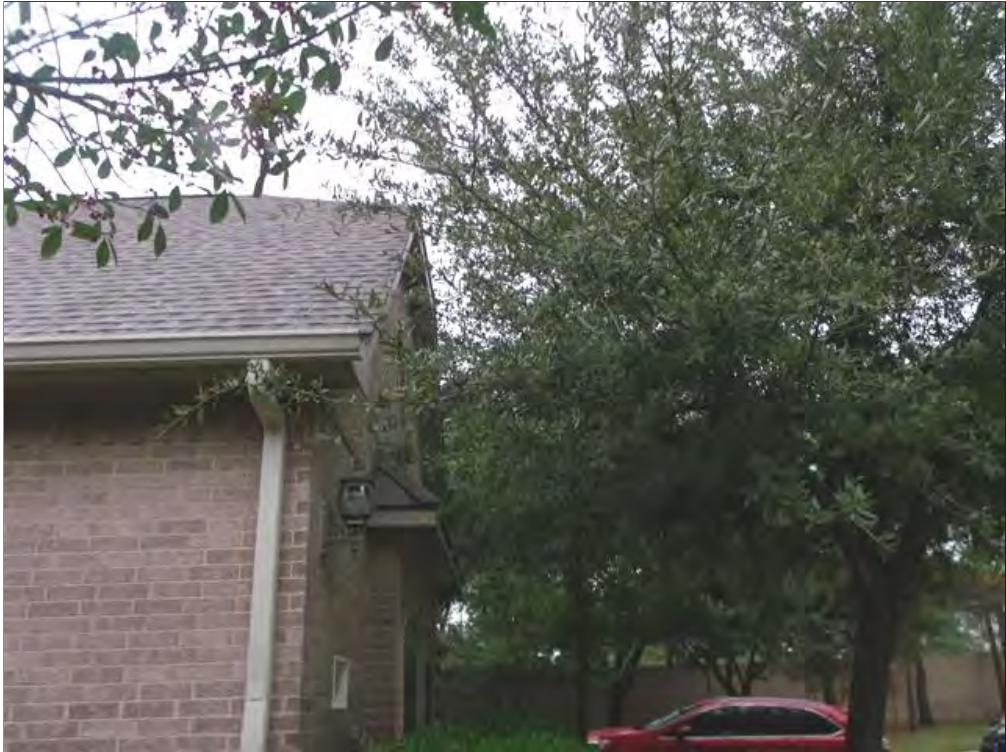
Recommend cutting back vegetation away from the house. Vegetation near the exterior cladding can reduce the drying potential of the cladding. Tree branches are rubbing against the roof shingles. This may damage the roof shingles.

D. Item 1(Picture) Recommend cutting back vegetation. Rodents climb to roof areas and carpenter ants as well can access so make sure to cut back over hangs plus they case damage to shingles siding and gutters

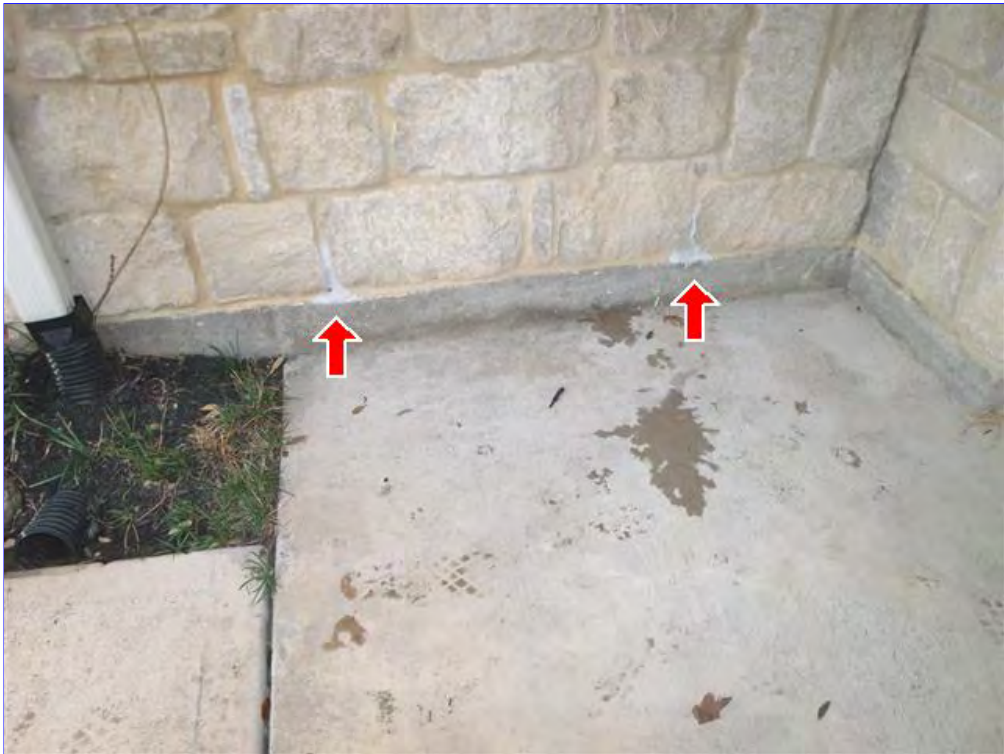
D. Item 15(Picture) Weep holes should not be sealed. Recommend repair.

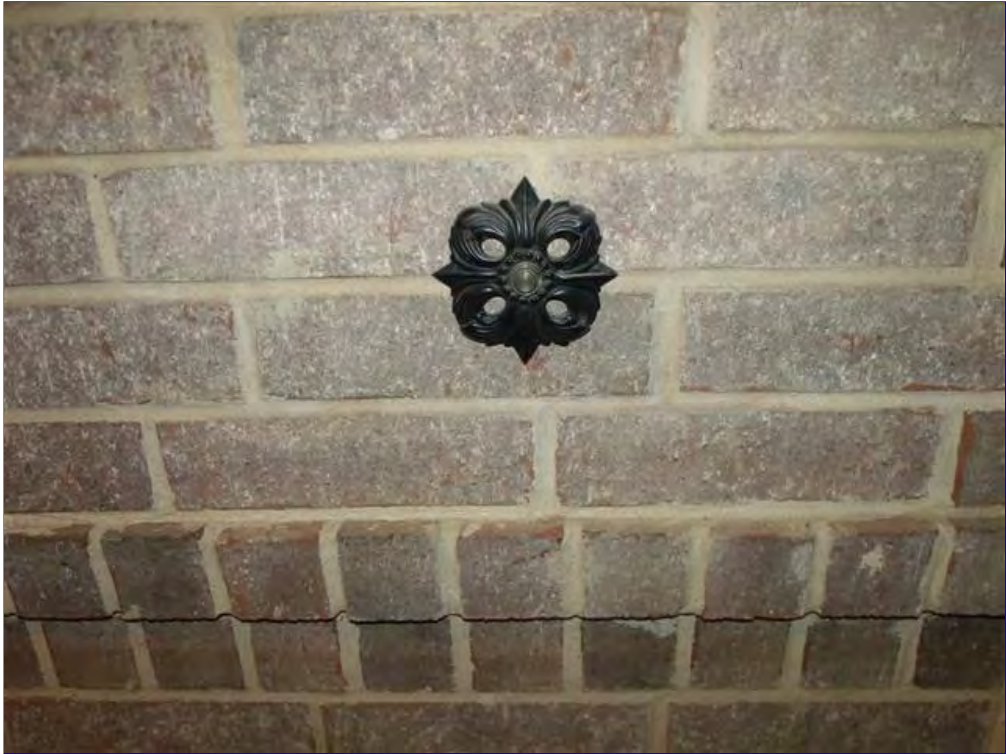
F. Item 4(Picture) Door bell was functioning at the time of inspection.

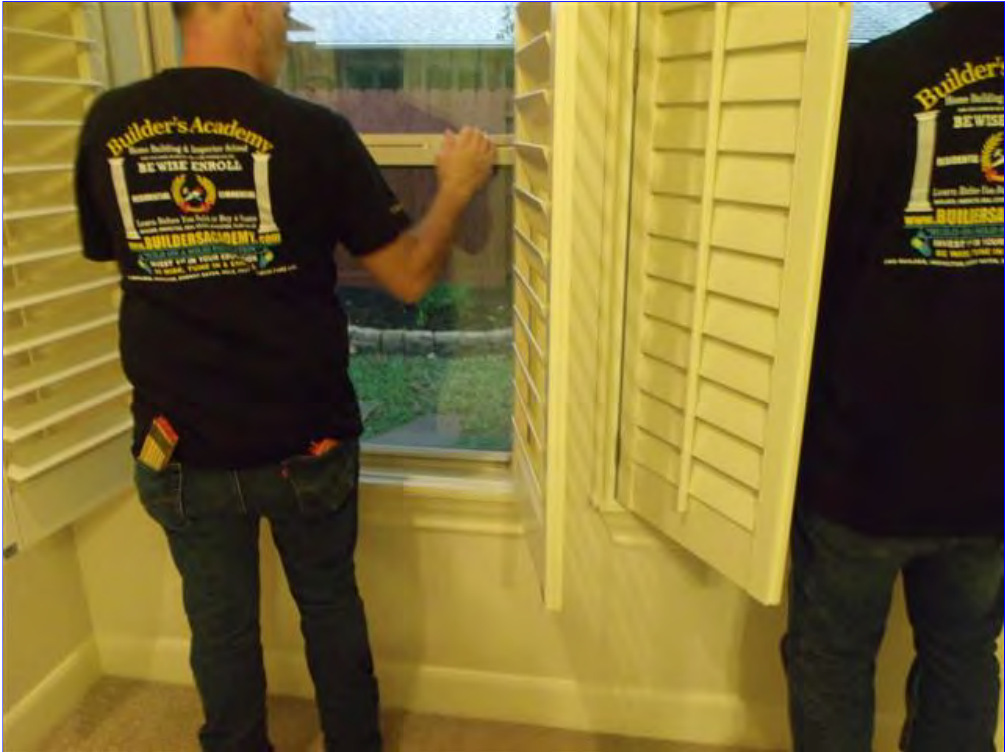
G. Item 1(Picture) Testing the window open and close well.
