InspectorTx.com®

Inspection Report

PROPERTY INSPECTION REPORT FORM

<i>Name of Client</i>	11/12/2022 <i>Date of Inspection</i>
<i>Address of Inspected Property</i> BRYON A. PARFFREY llc.	
<i>Name of Inspector</i>	Texas #7408 <i>TREC License #</i>
<i>Name of Sponsor (if applicable)</i>	<i>TREC License #</i>

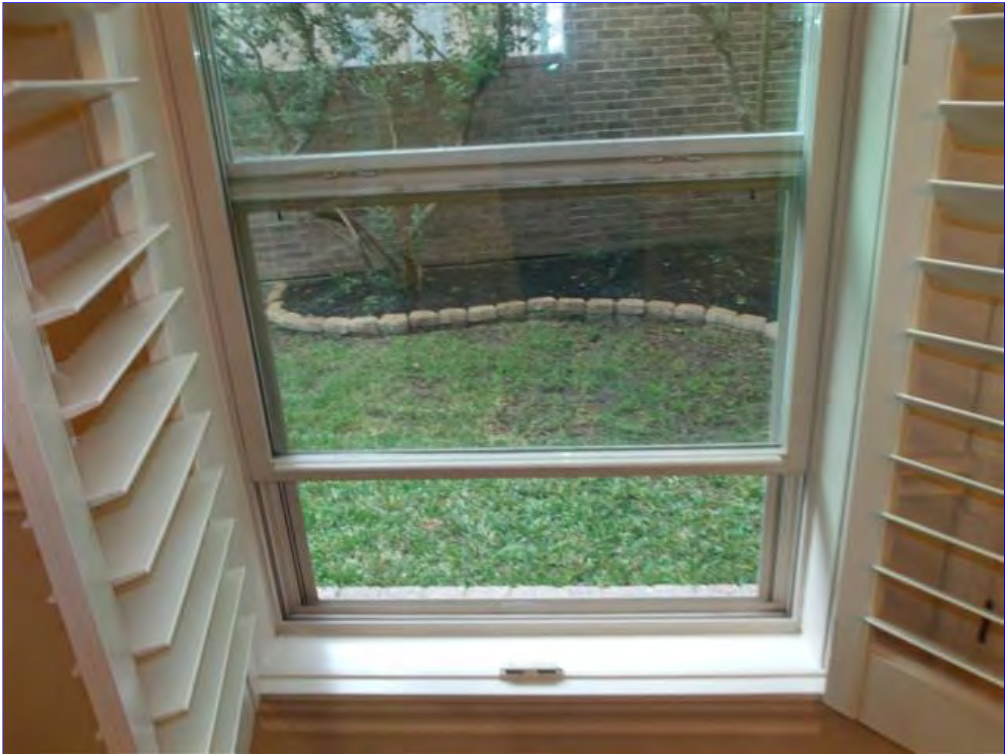
G. Item 2(Picture) Windows opened properly.

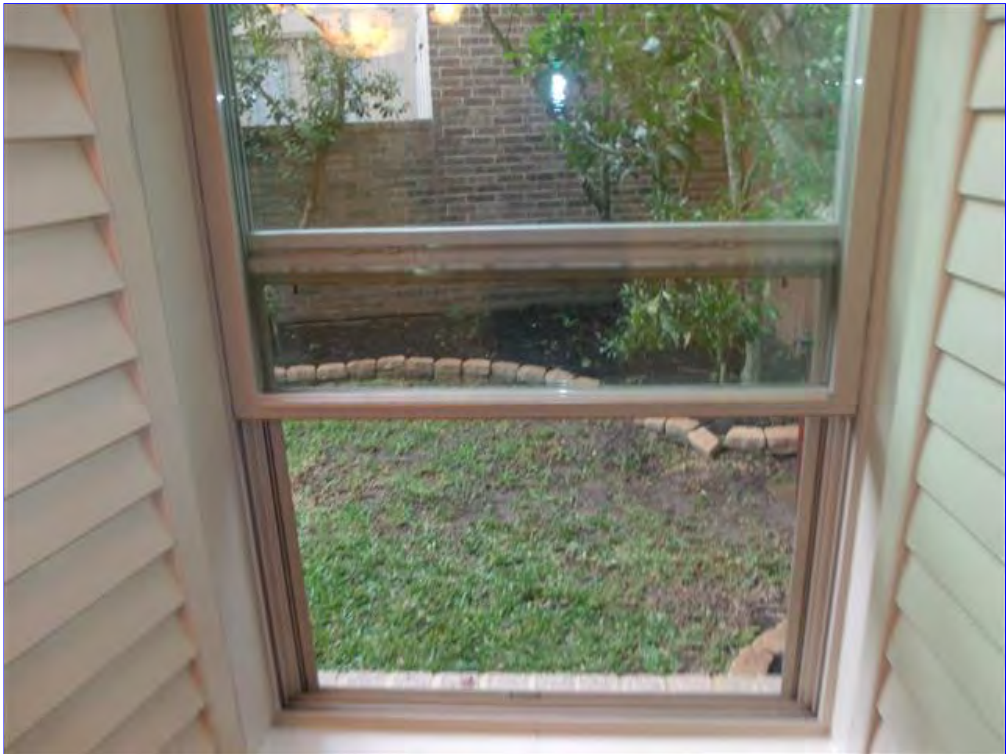
G. Item 3(Picture) Weather stripping was good around the windows at the time of inspection.

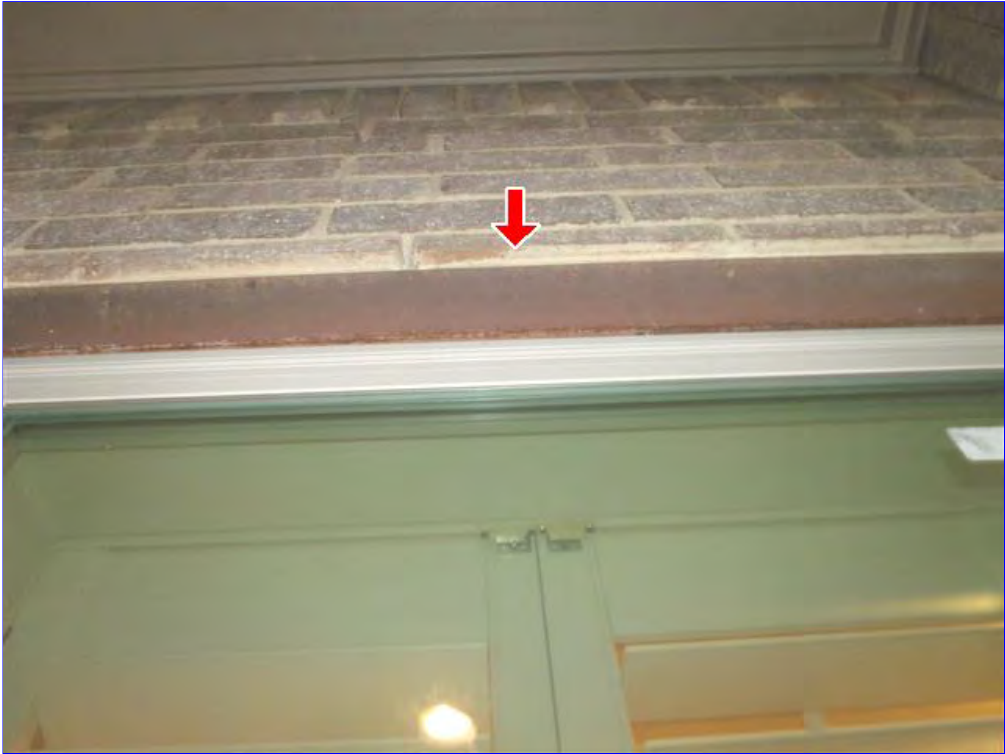
G. Item 5(Picture) Rusted lintel.

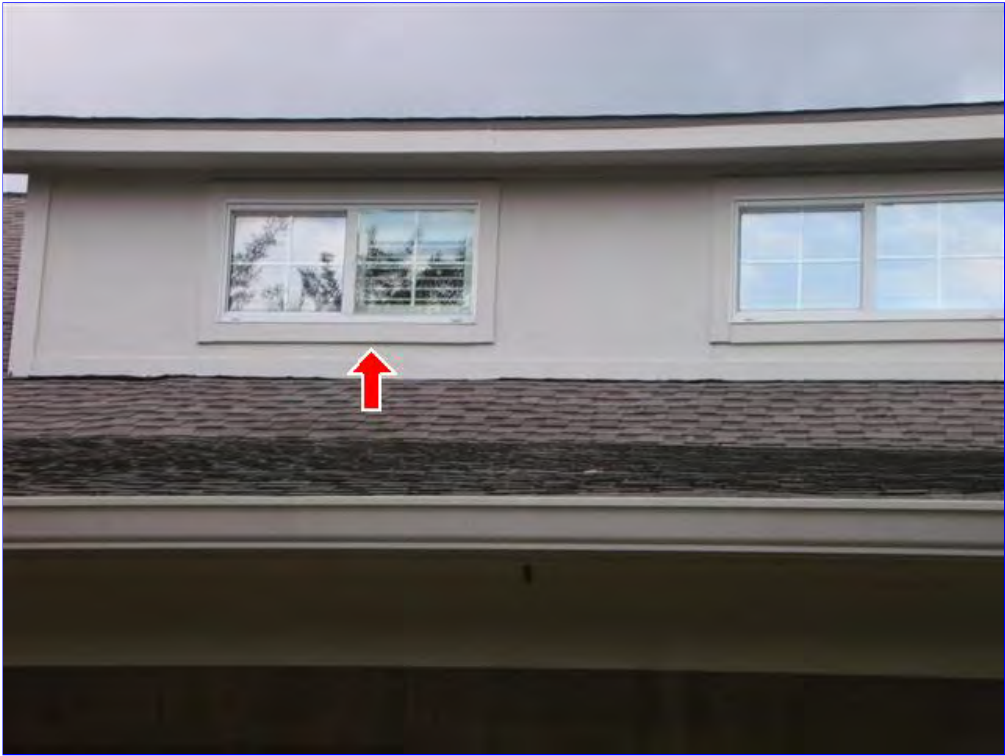
G. Item 6(Picture) Window seals greater than forty four inches above grade in the interior.

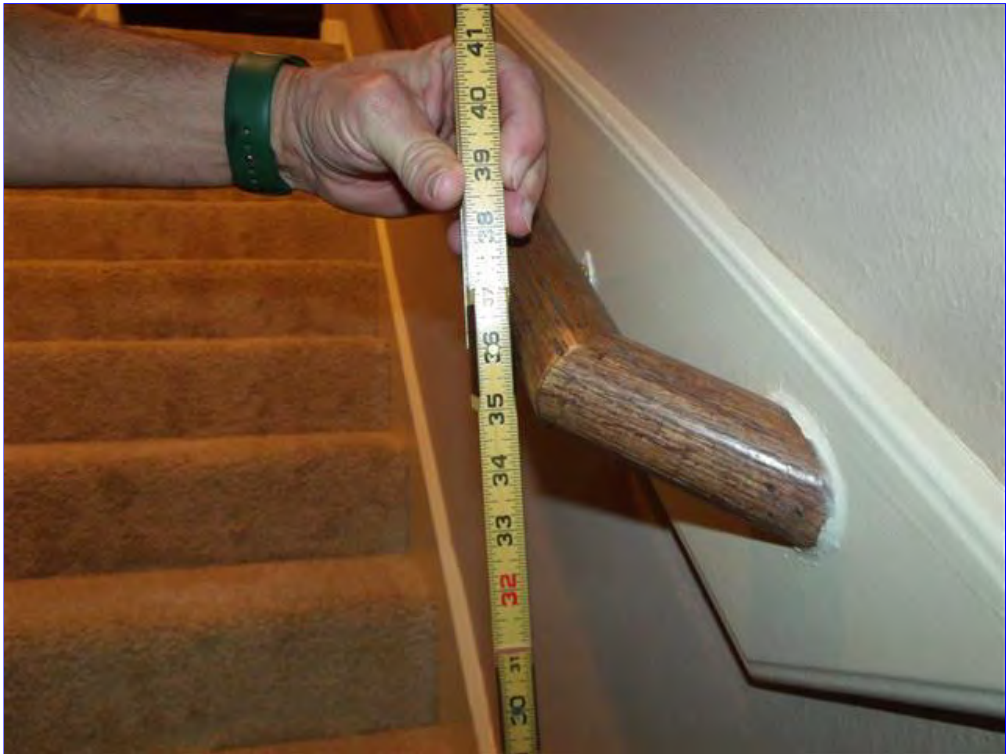
H. Item 3(Picture) Handrail is the proper height.

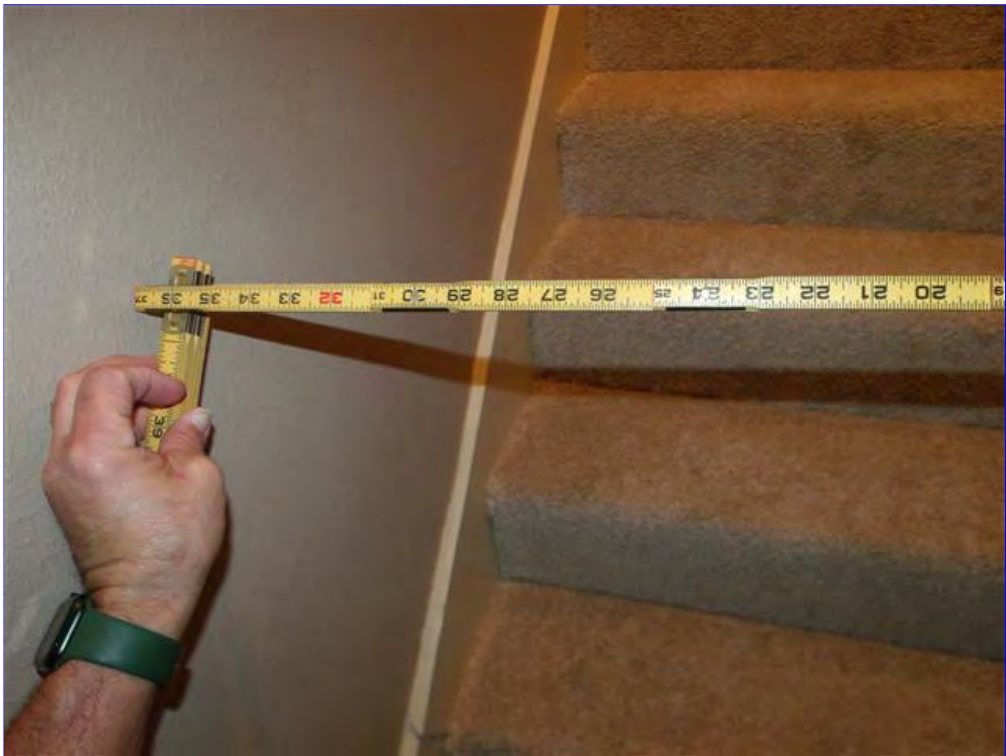
H. Item 4(Picture) Proper stairway width.

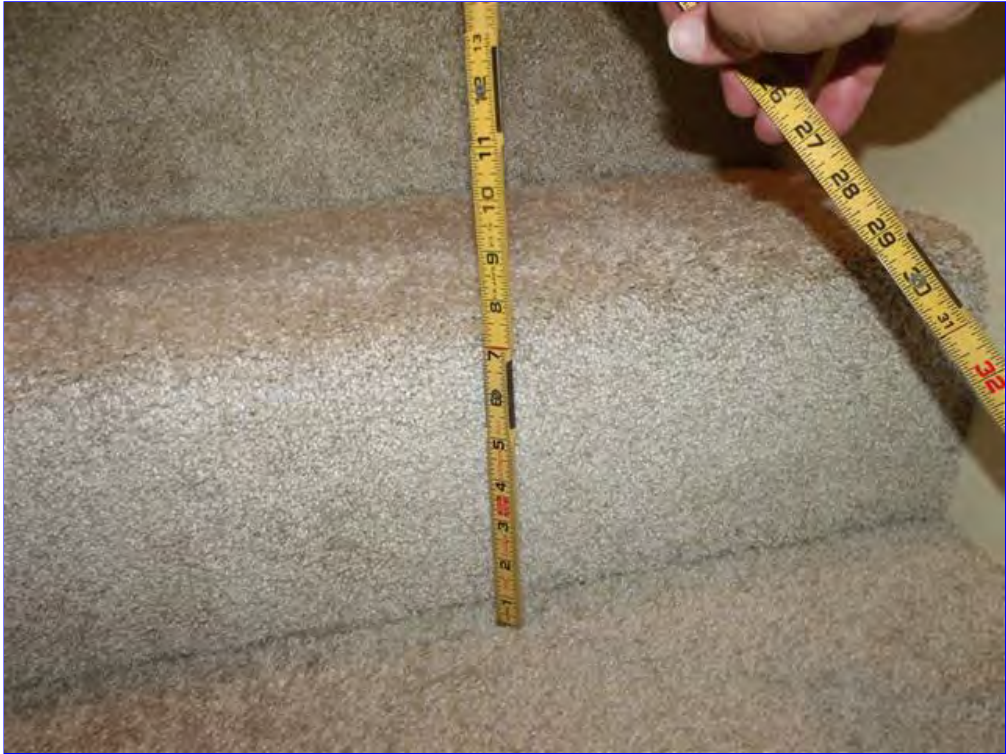
H. Item 6(Picture) Risers are in tolerance.

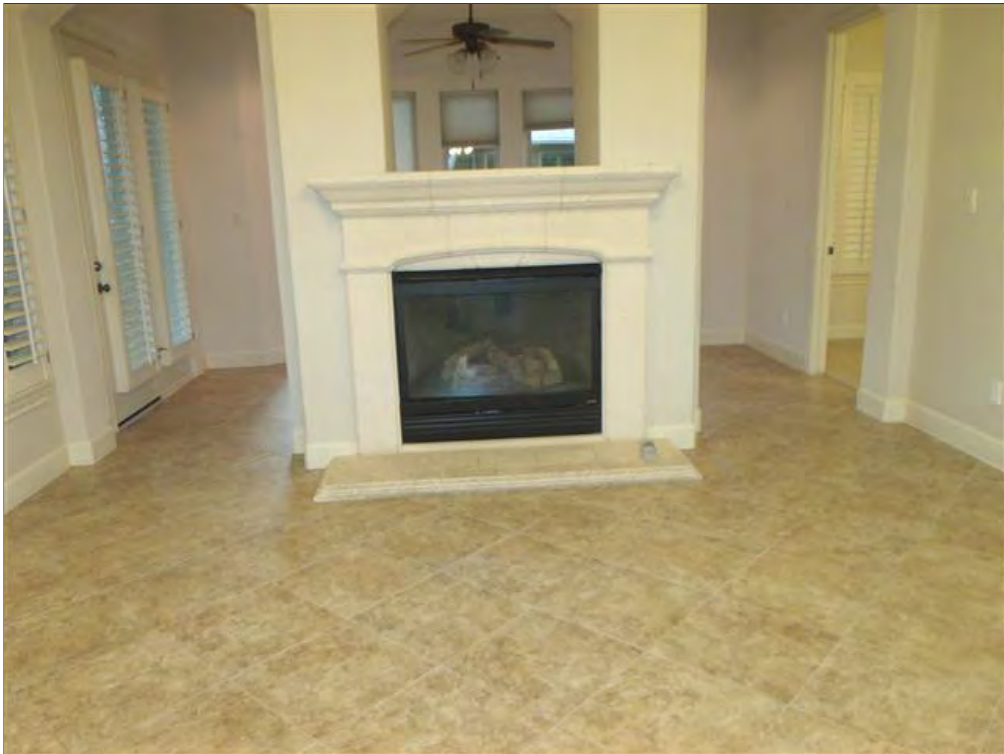
I. Item 1(Picture) Gas fireplace works well ask sellers for remote.

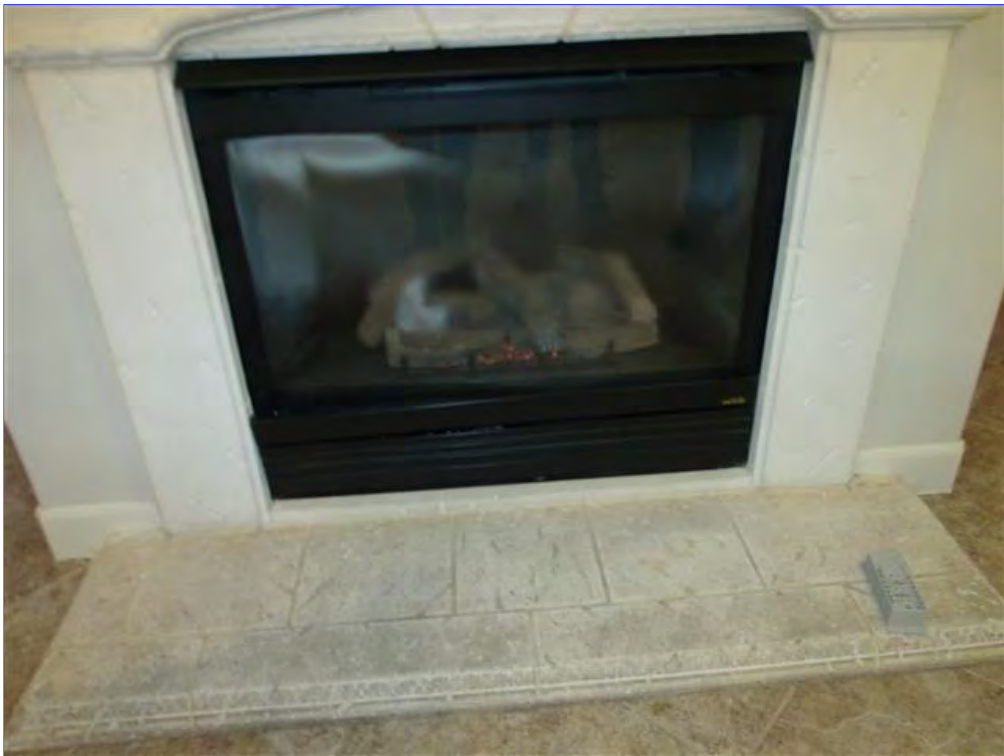
I. Item 2(Picture) Gas fireplace was operational at the time of inspection.

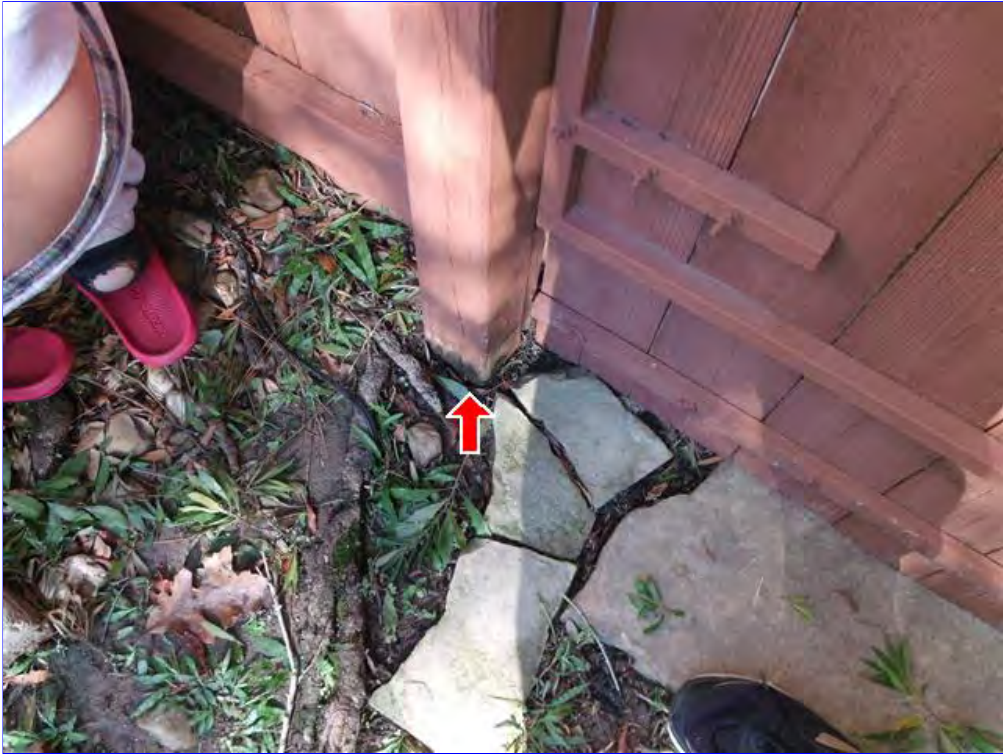
J. Item 1(Picture) Post for the fences are in need of repair.

Recommend installing new post for the fences.

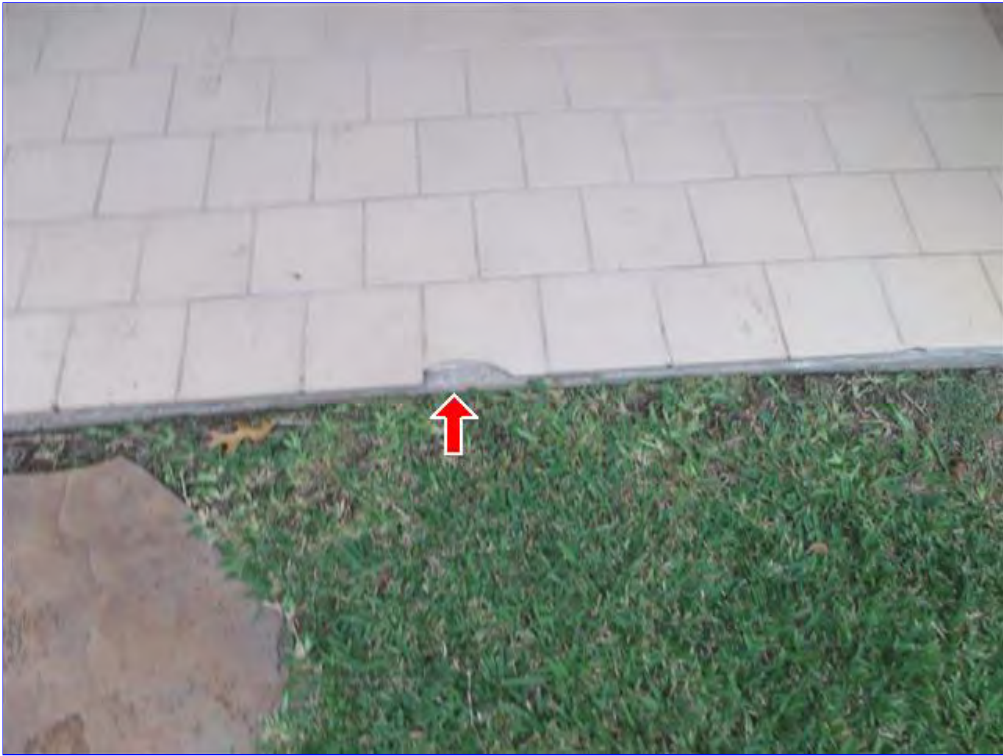
J. Item 2(Picture) Broken tile on the back porch.

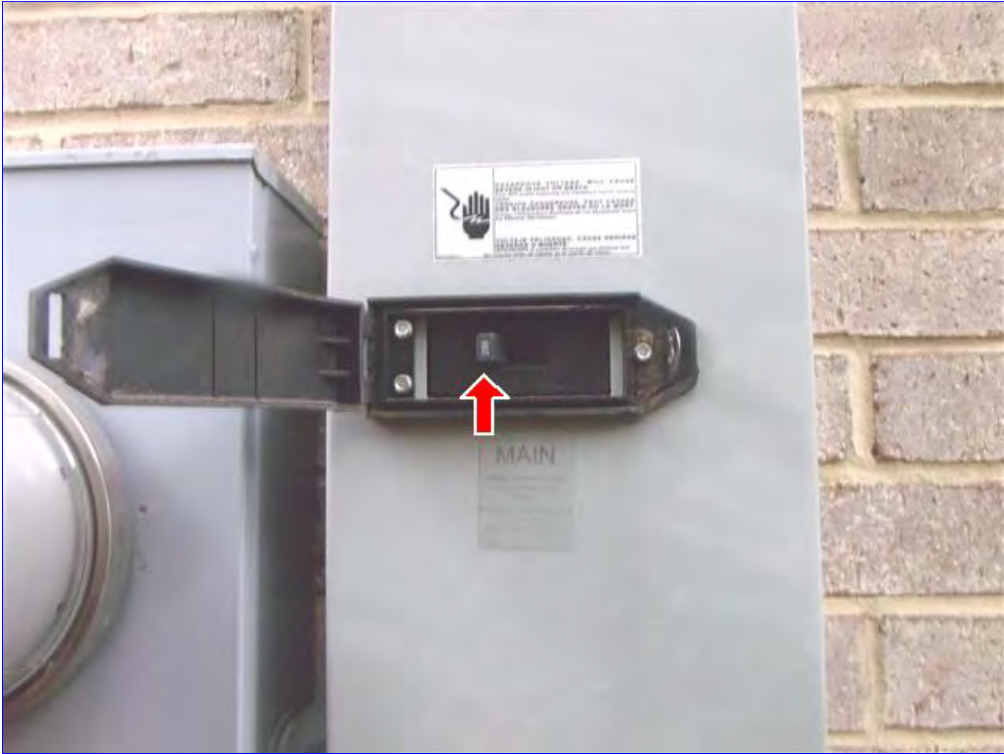
A. Item 1(Picture) Main electrical disconnect located on the right side of the house. 200 AMP power supply

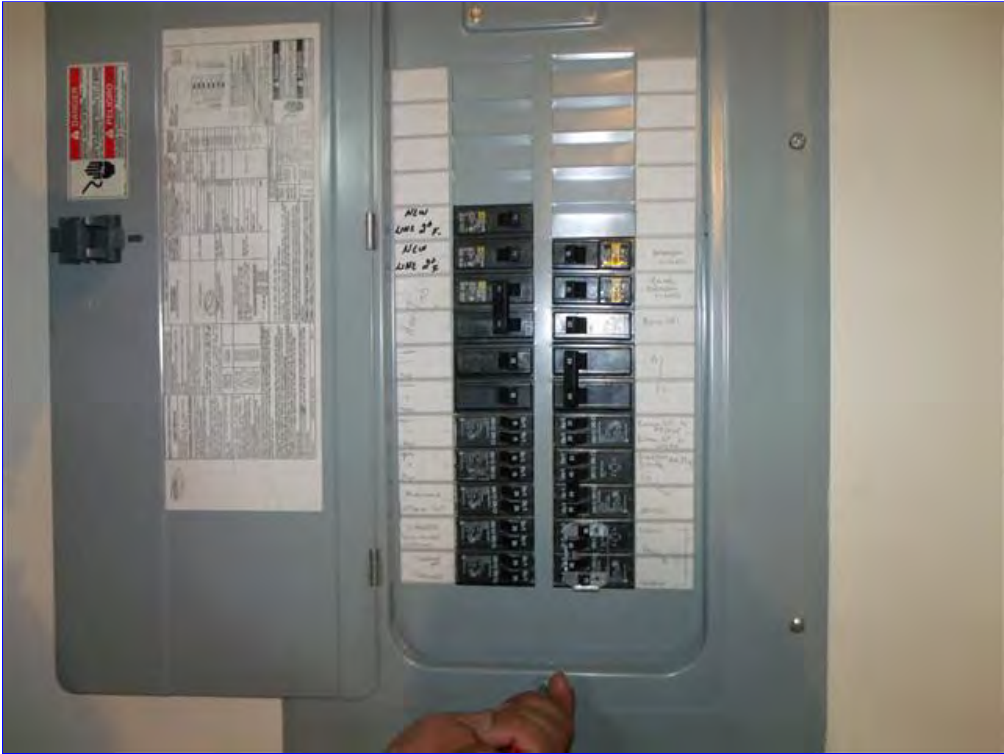
A. Item 2(Picture) Electrical panel clearly labeled.

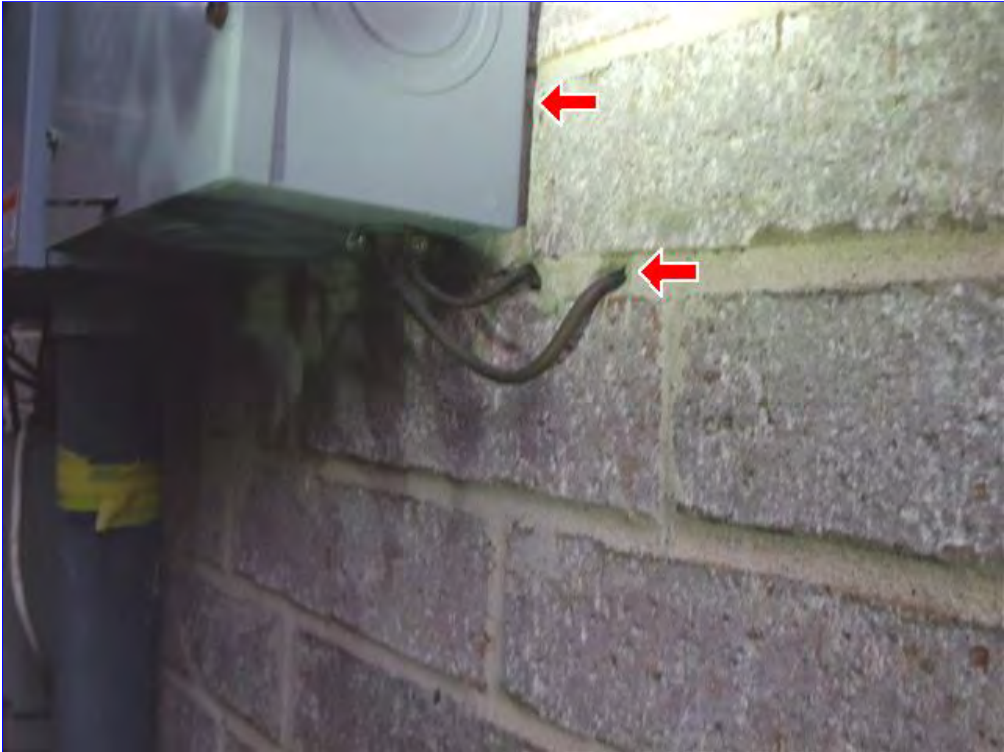
A. Item 7(Picture) Penetrations into the house need to be caulked. Electrical panel needs to be caulked to prevent water intrusion.

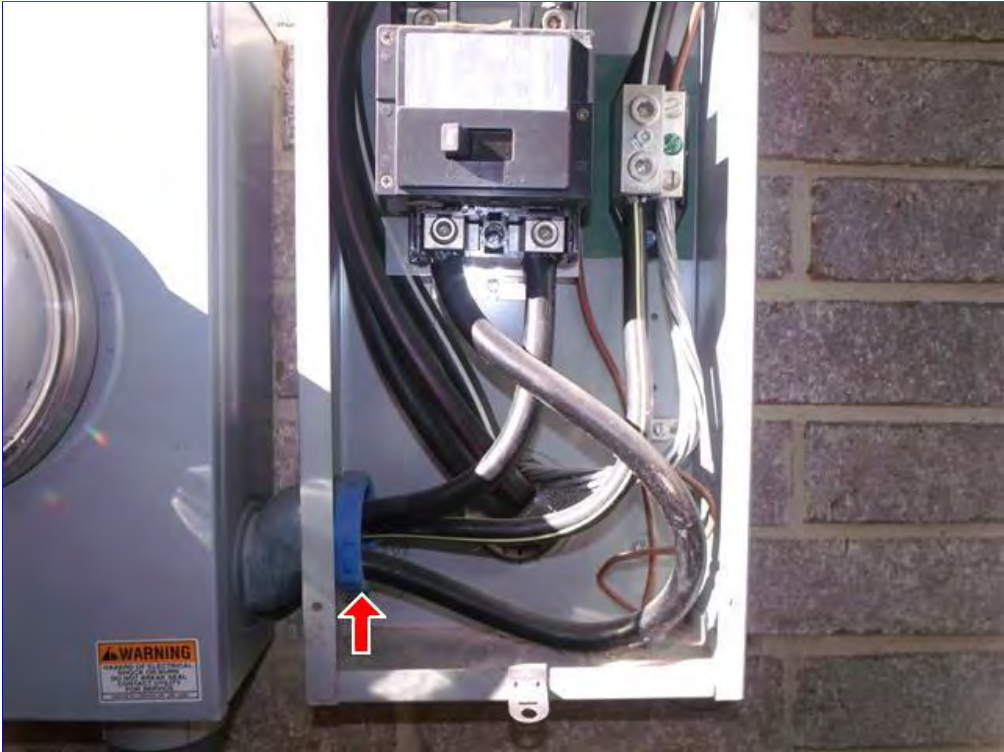
A. Item 8(Picture) Recommend bonding of electrical conduit.

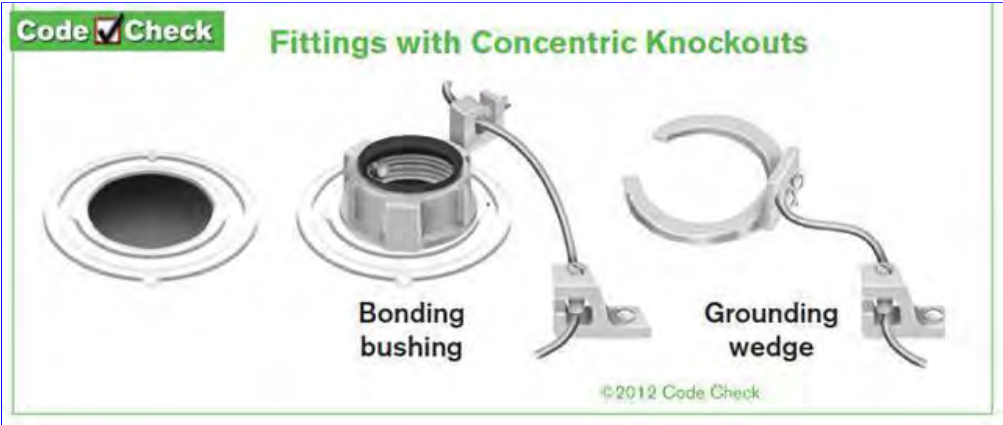
A. Item 16(Picture) Main panel is required to bonding bushing or grounding wedge.

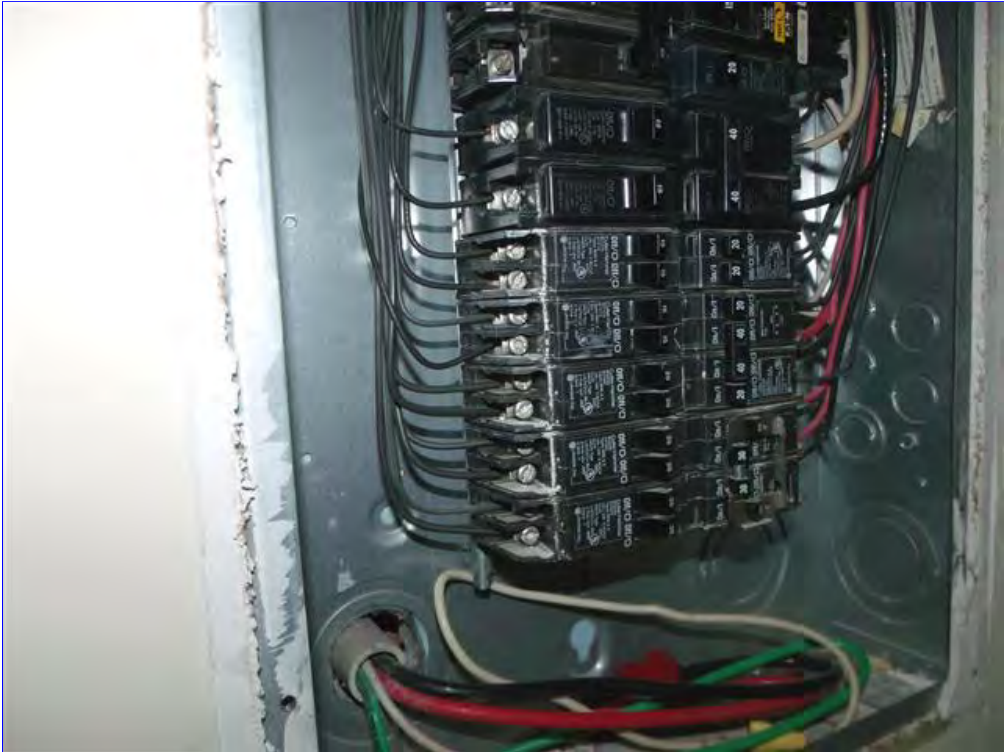
B. Item 1(Picture) Copper branch circuits.

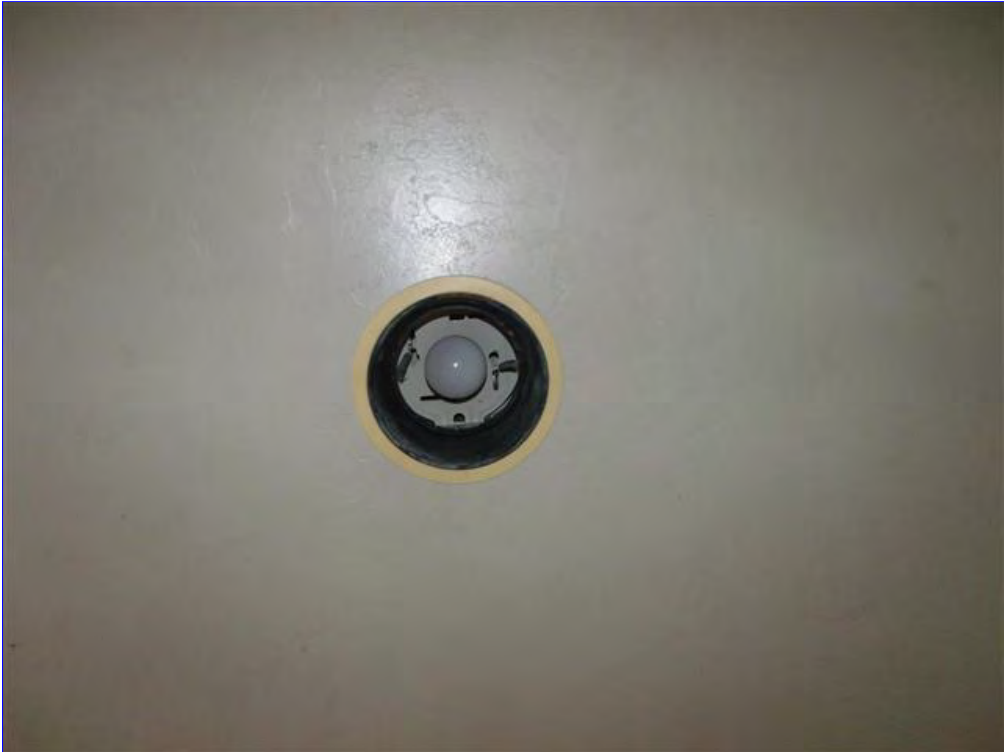
B. Item 5(Picture) Face plate for light fixture need to be installed located under the garage.

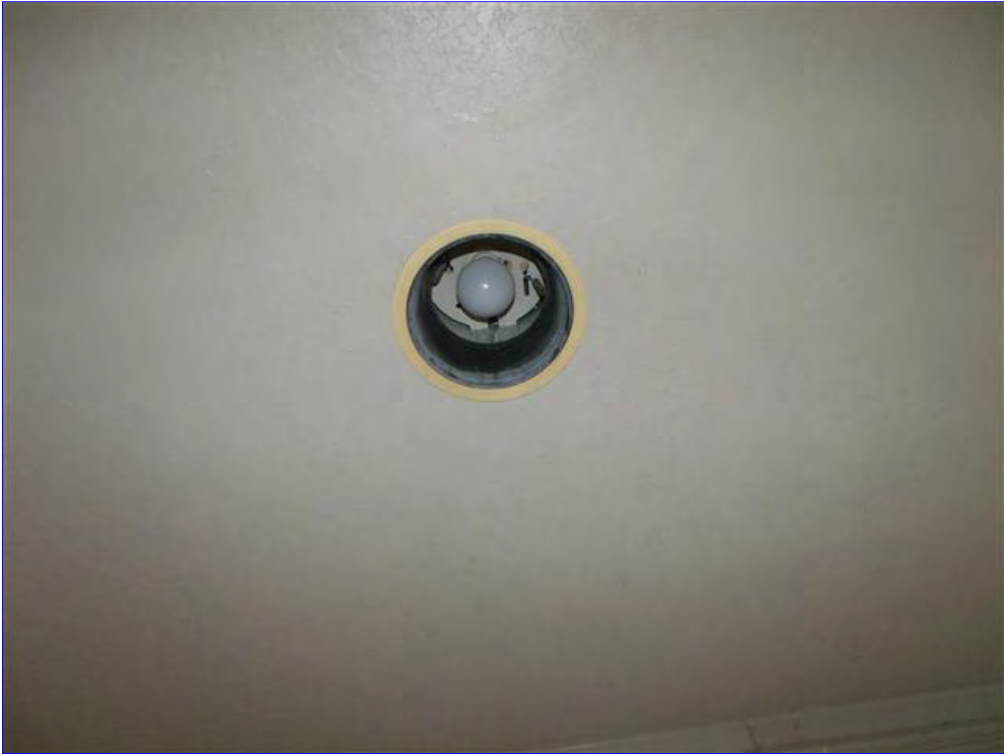
B. Item 6(Picture) Both light fixture need to be installed located under the garage need face plates.

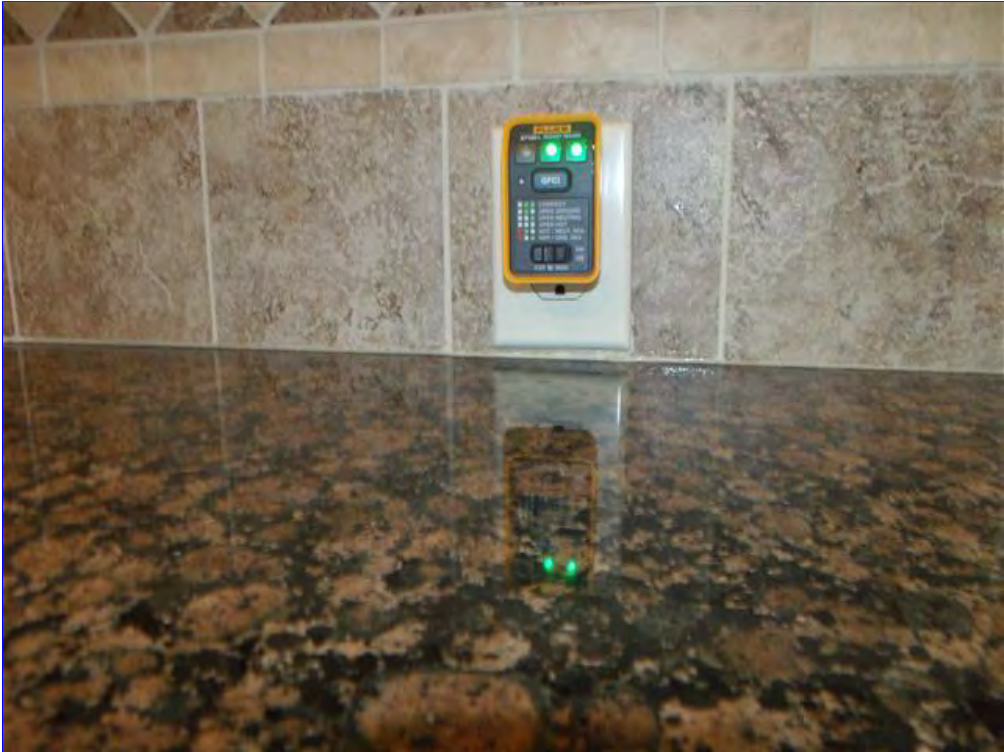
B. Item 7(Picture) Electrical outlets tested in the kitchen.

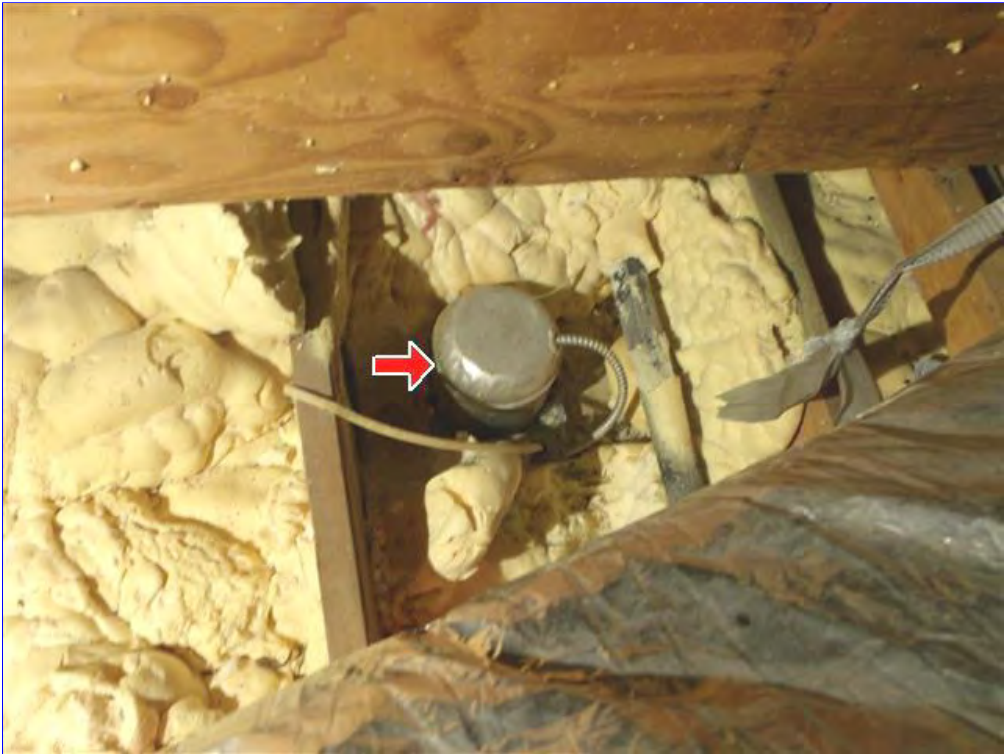
B. Item 8(Picture) Insulated LED cans.

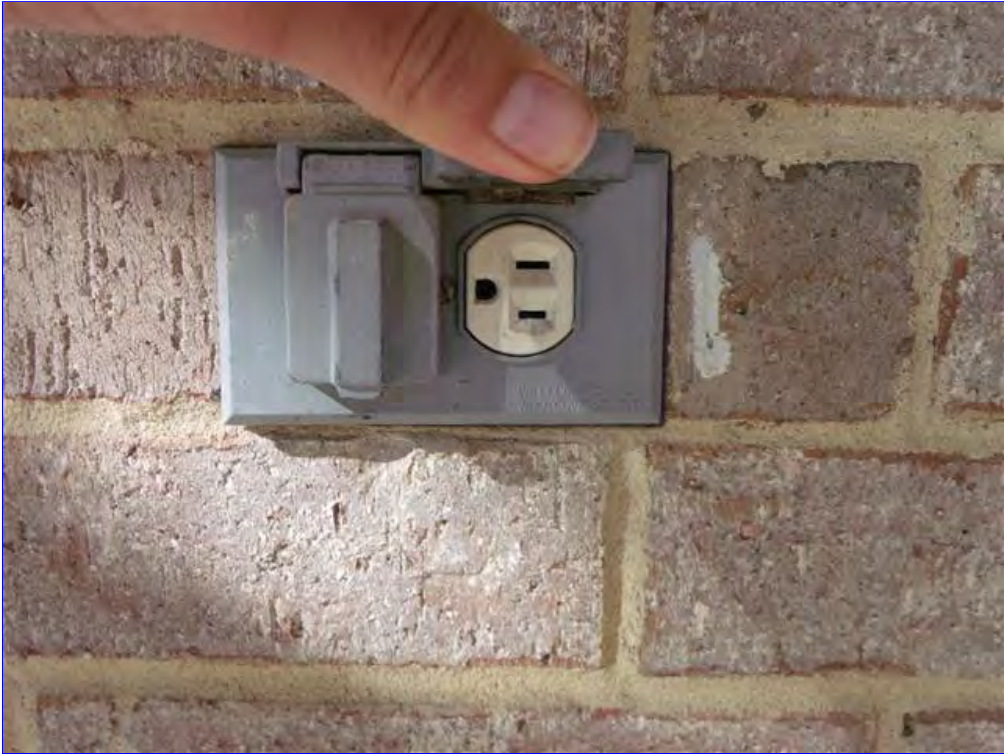
B. Item 9(Picture) IRC requires outdoor receptacles to be GFCI rated.

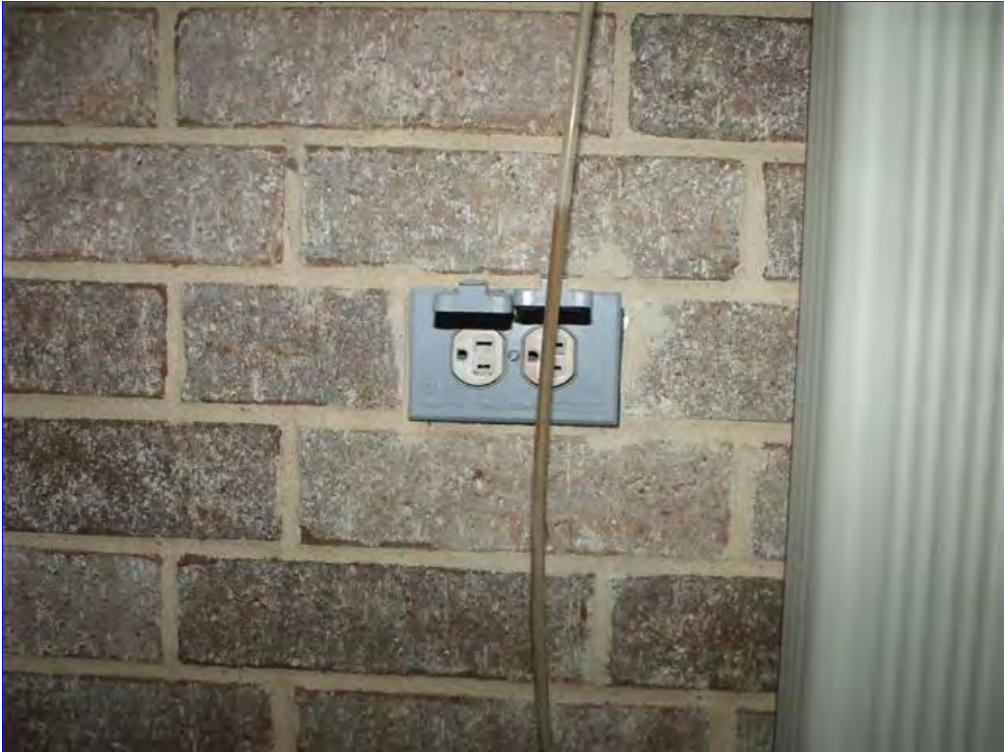
B. Item 11(Picture) outdoor electrical outlets to be GFCI.and prefer to have a water proof cover not water resistant.

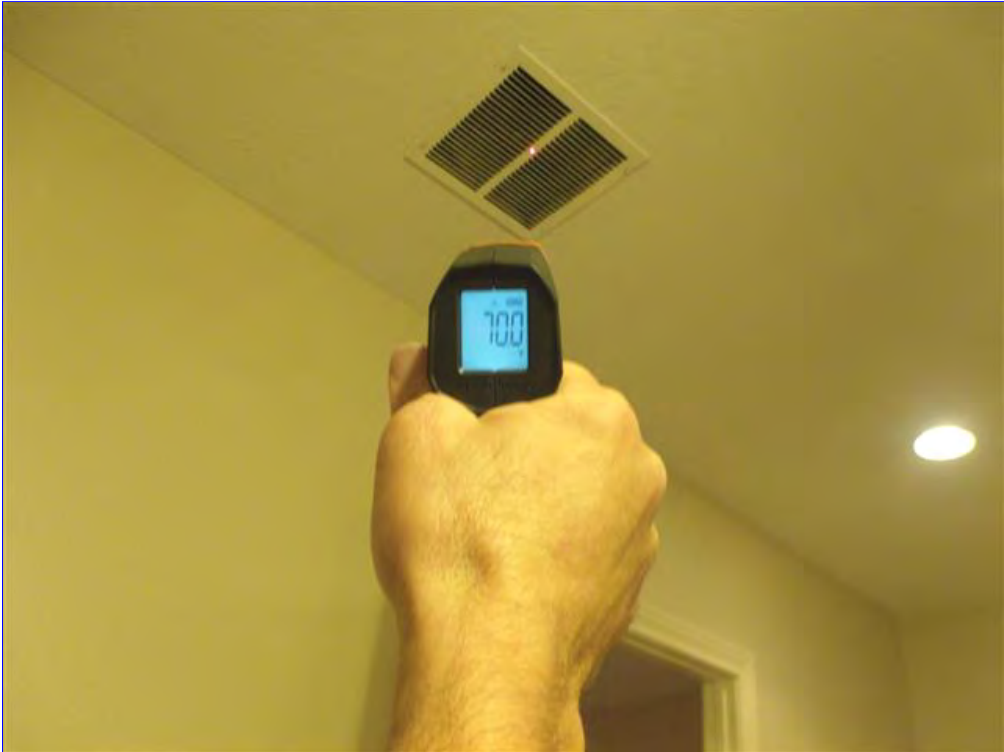
A. Item 1(Picture) Return vent 70° Air balanced OK

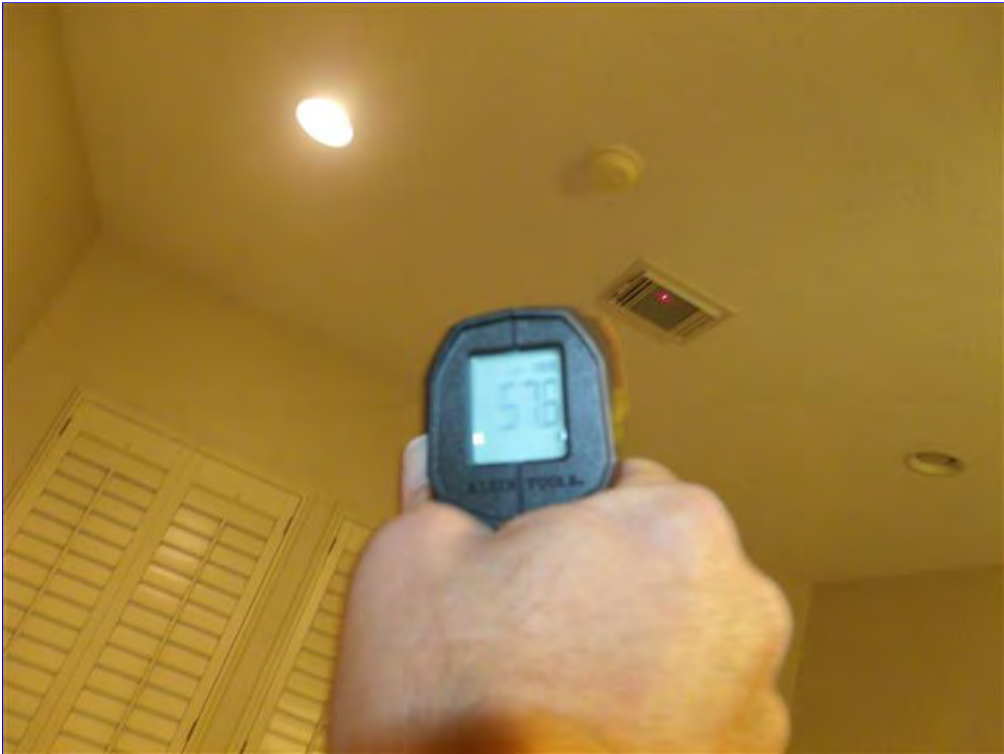
A. Item 2(Picture) Supply vent is 57.6°

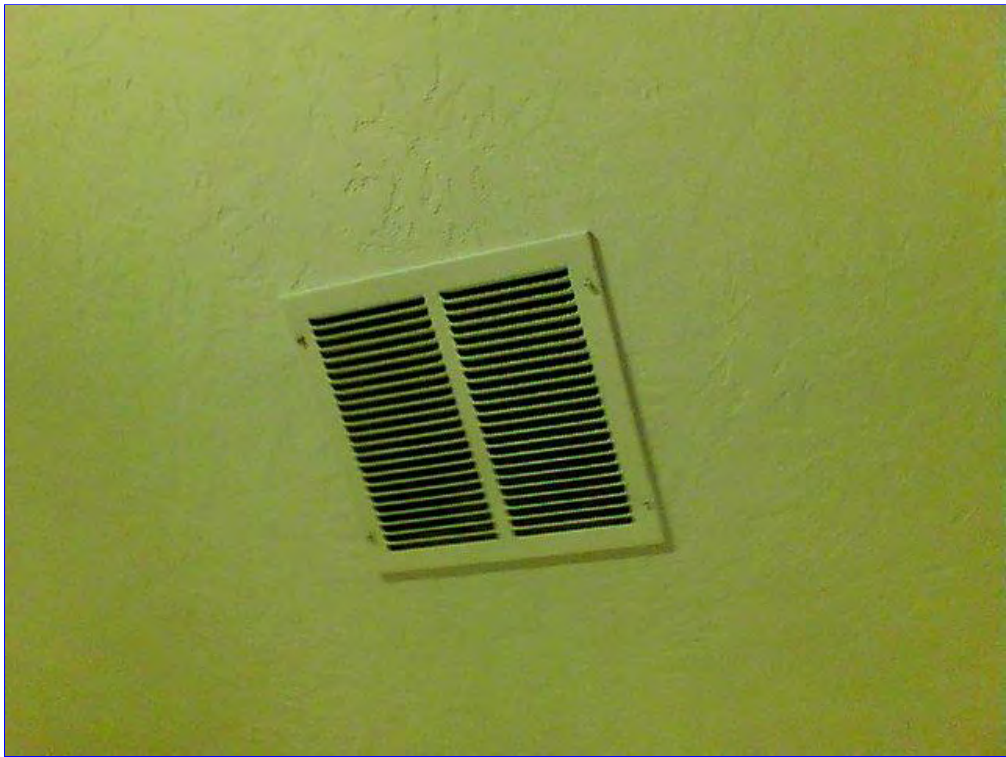
A. Item 6(Picture) Return air make sure to remove filters from inside since you have a media filter in attic that you cahange out every 4-6 months. Much better system having media filters we recommend germicidal lights as well.

Recommend changing media filter every six months with a HEPA 13 filter.

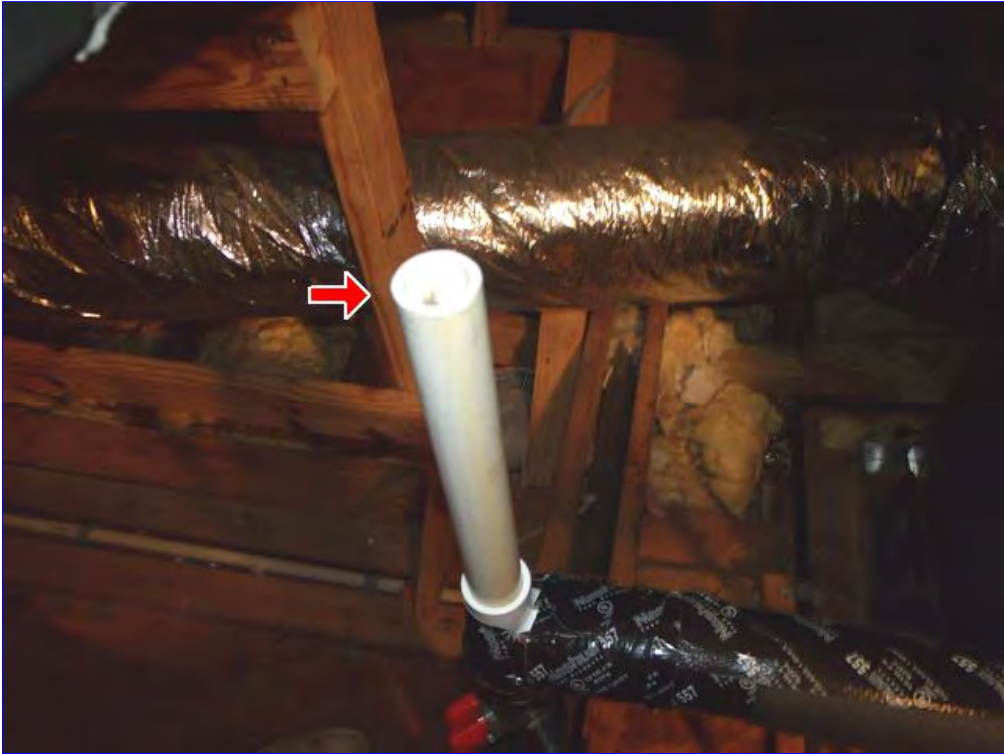
A. Item 11(Picture) Condensate line needs to be capped.

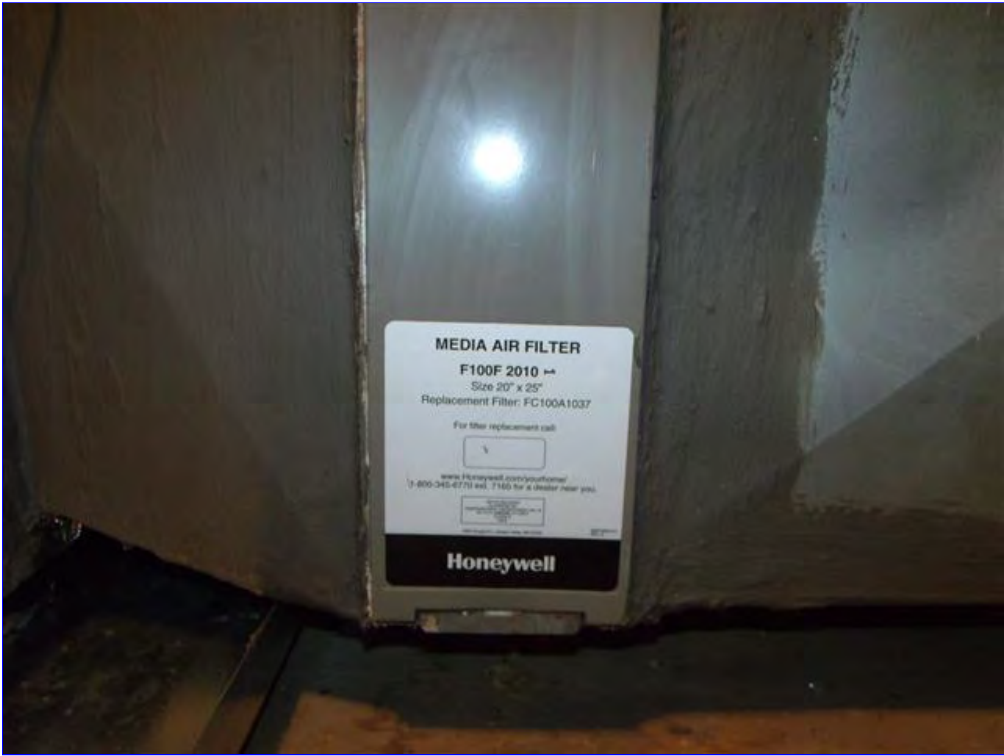
A. Item 12(Picture) Media filter provided for whole house filtration system.

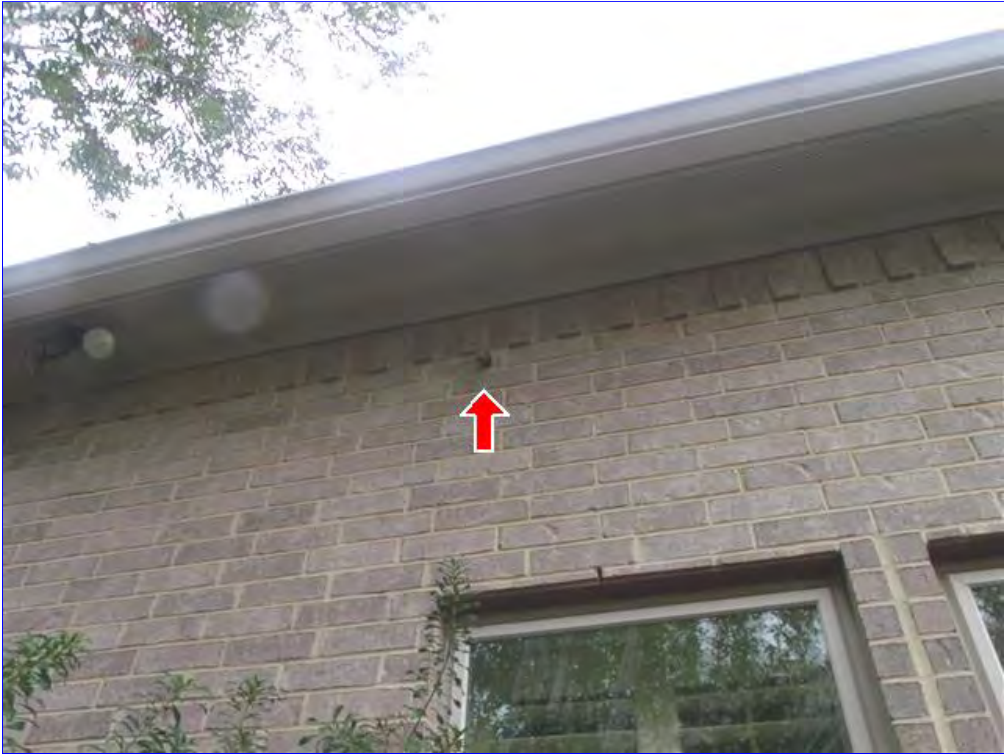
A. Item 13(Picture) Secondary drain located on the left side of the house.

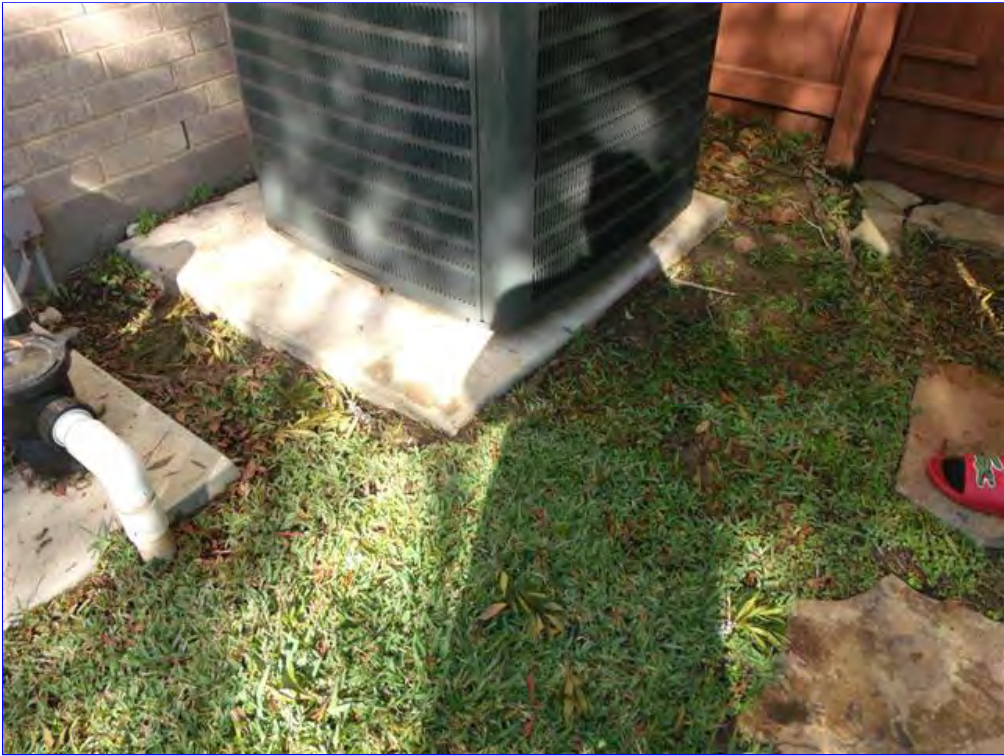
A. Item 14(Picture) A.C. unit should be three inches above grade.

Air conditioner pad should be a minimum of three inches above grade and level.
