InspectorTx.com®

Inspection Report

PROPERTY INSPECTION REPORT FORM

<i>Name of Client</i>	11/12/2022 <i>Date of Inspection</i>
<i>Address of Inspected Property</i> BRYON A. PARFFREY llc.	
<i>Name of Inspector</i>	Texas #7408 <i>TREC License #</i>
<i>Name of Sponsor (if applicable)</i>	<i>TREC License #</i>

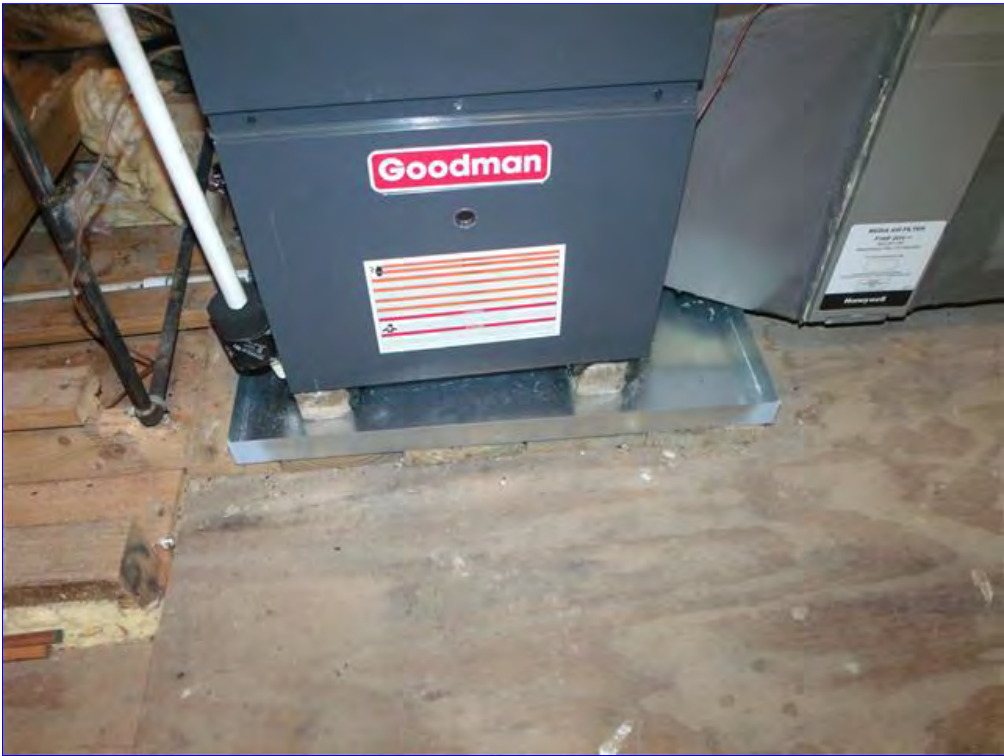
B. Item 1(Picture) Goodman furnace.

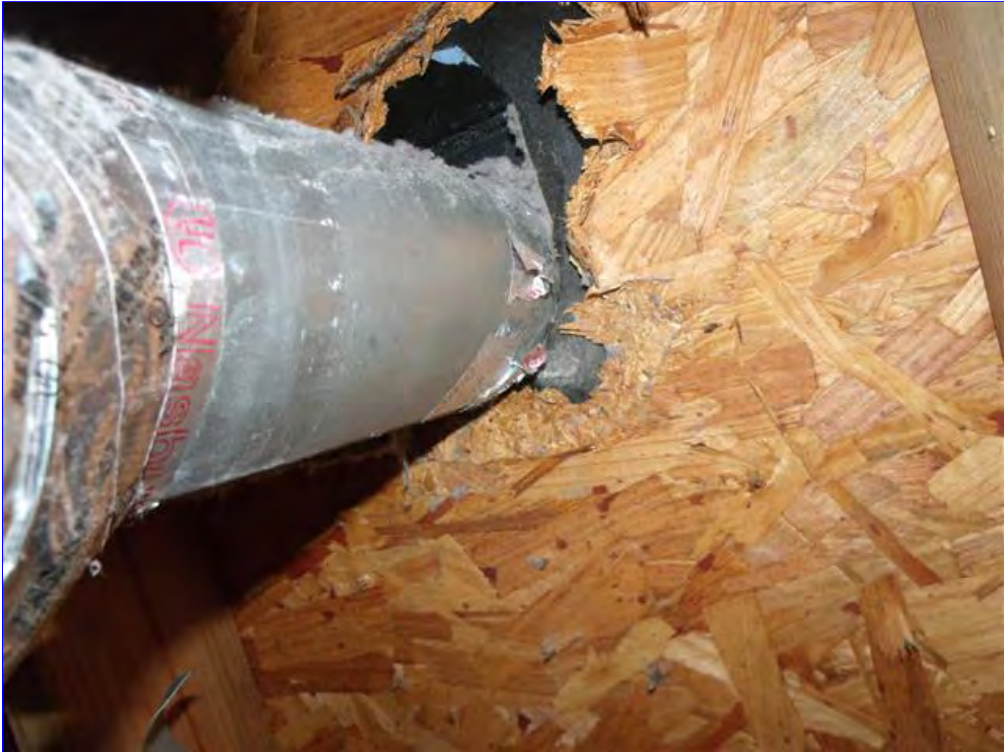
B. Item 5(Picture) IRC requires a one inch clearance for B vents.

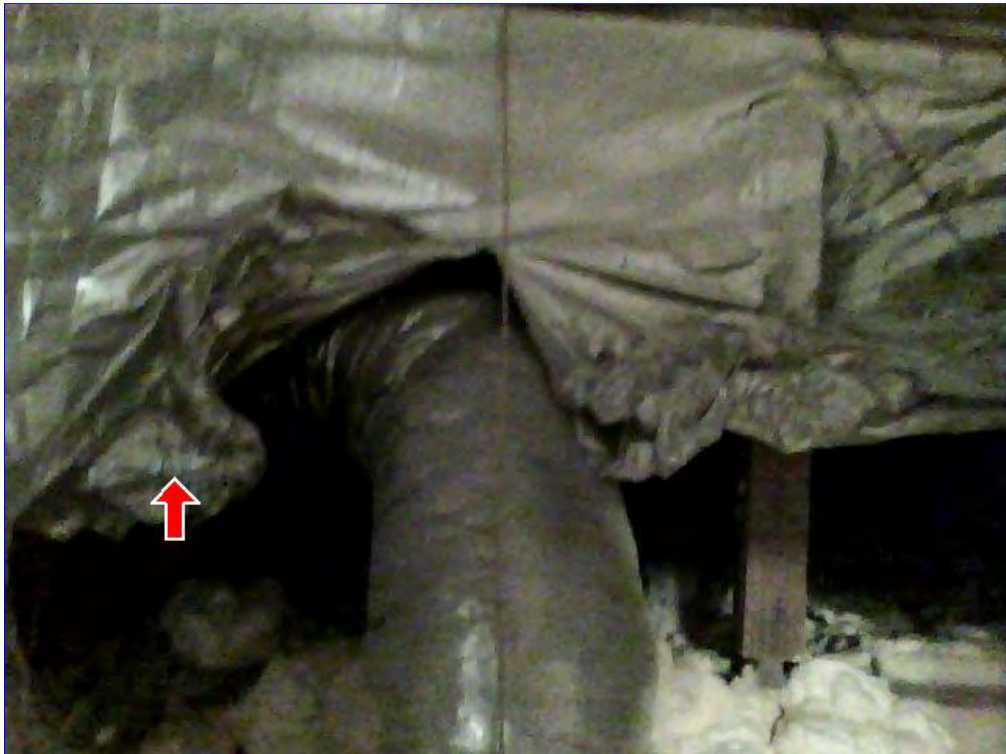
C. Item 1(Picture) Double radiant barrier installed.

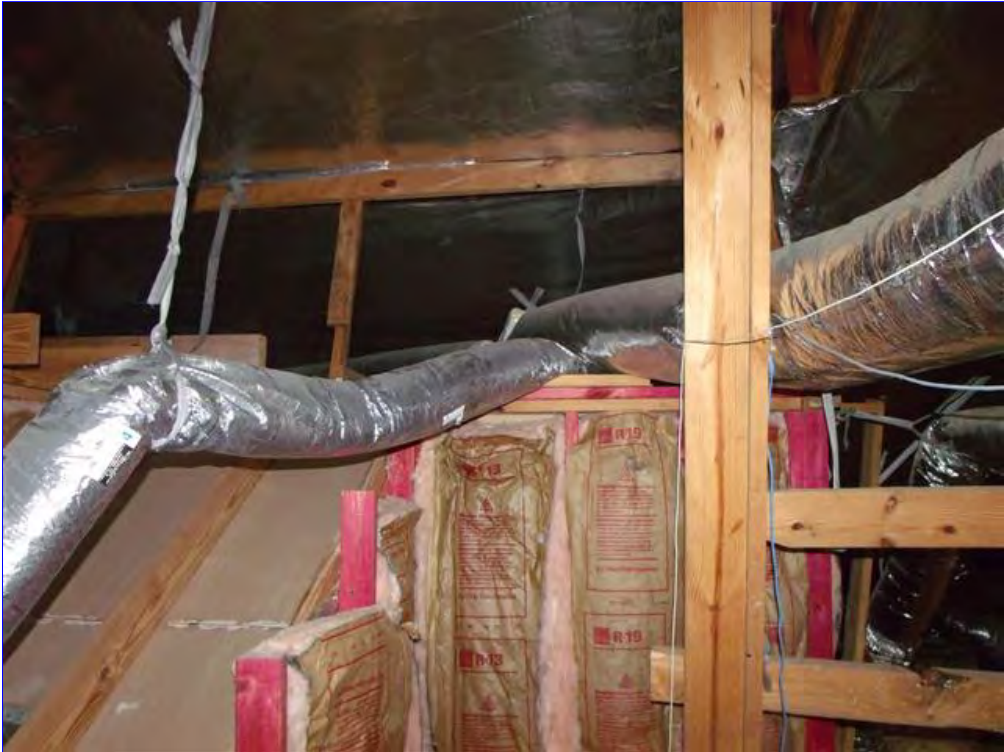
C. Item 3(Picture) Ducts should be strapped every five feet.

Recommend properly strapping ducts every five feet.

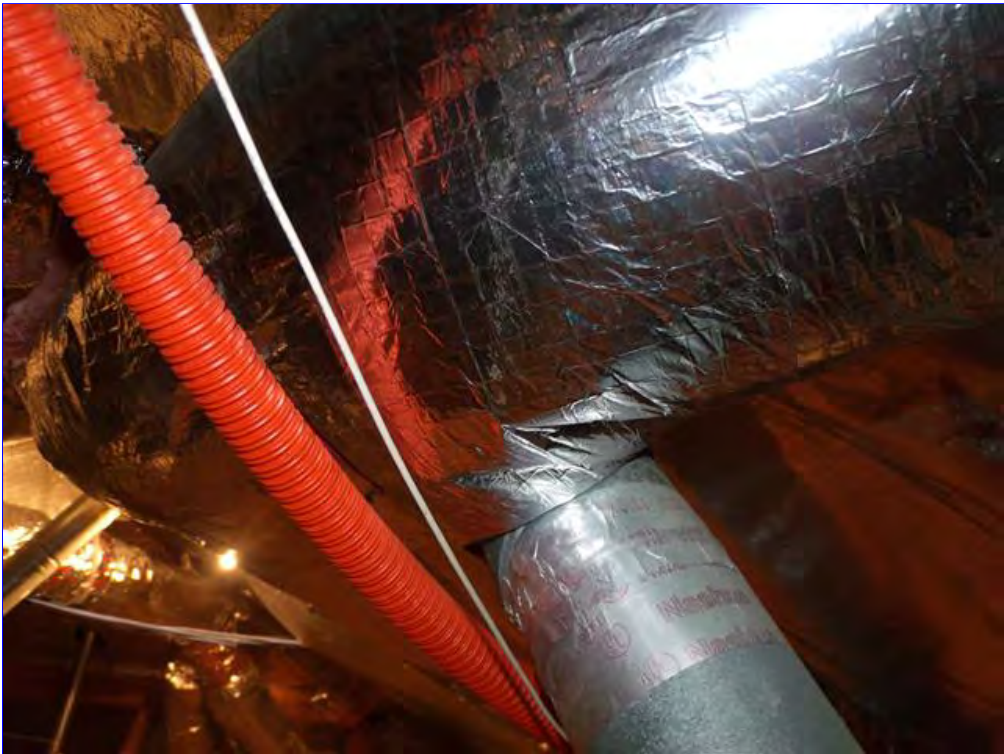
C. Item 21(Picture) Insulation should be installed between the ducts to prevent condensation.

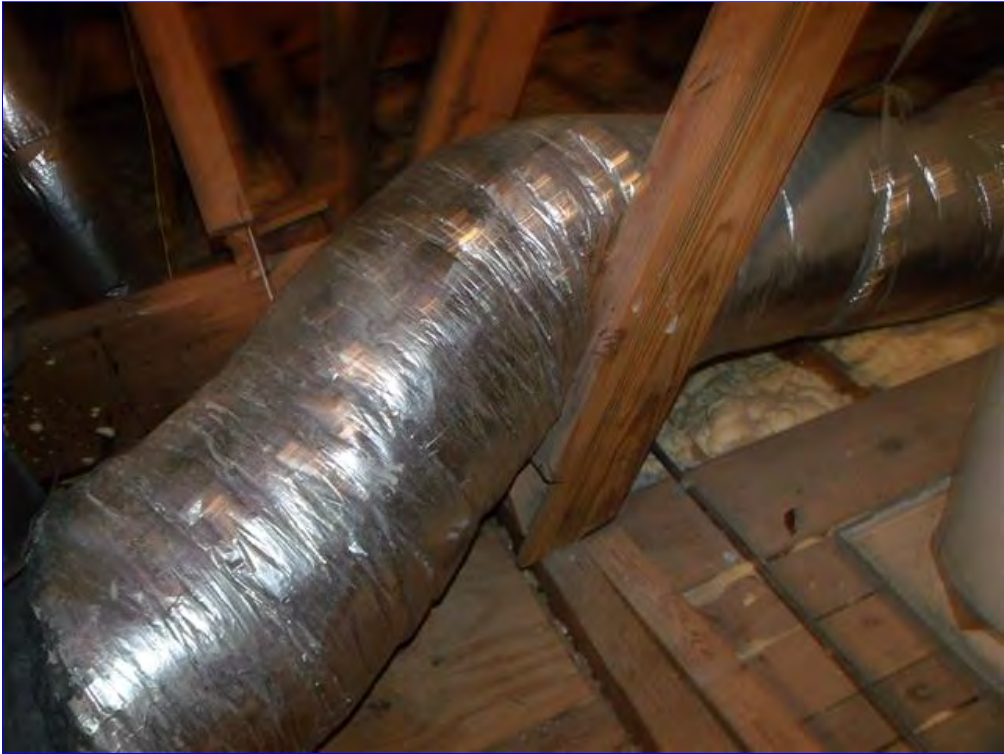
C. Item 22(Picture) Ducts need to be properly strapped.

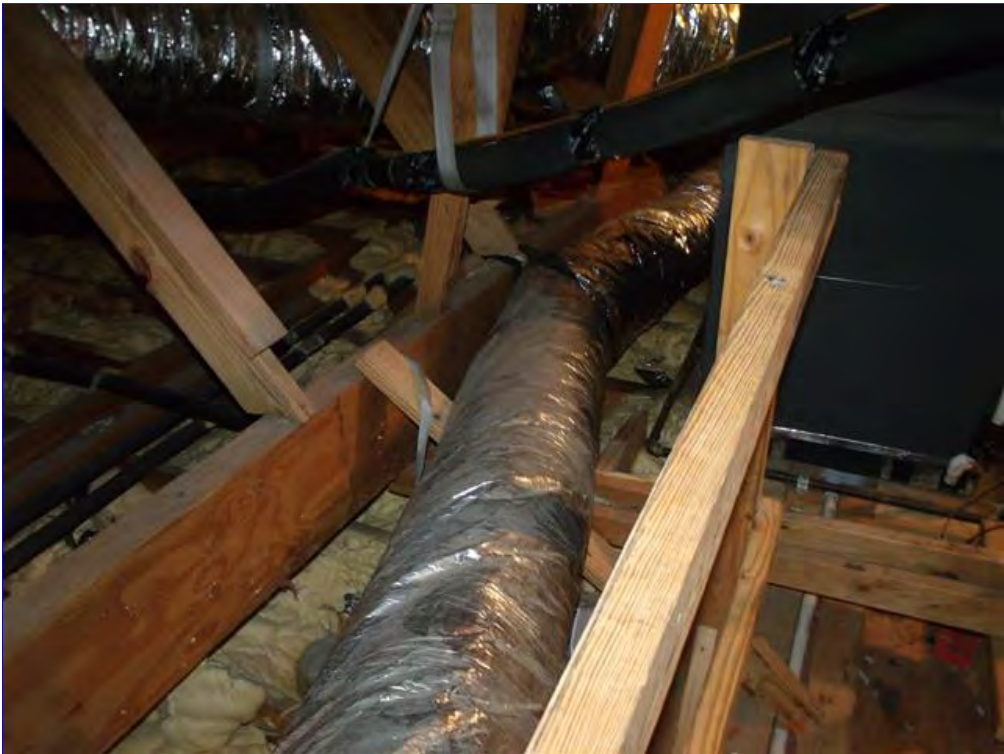
C. Item 23(Picture) Ducts should not be laying on the floor. Recommend strapping every five feet.

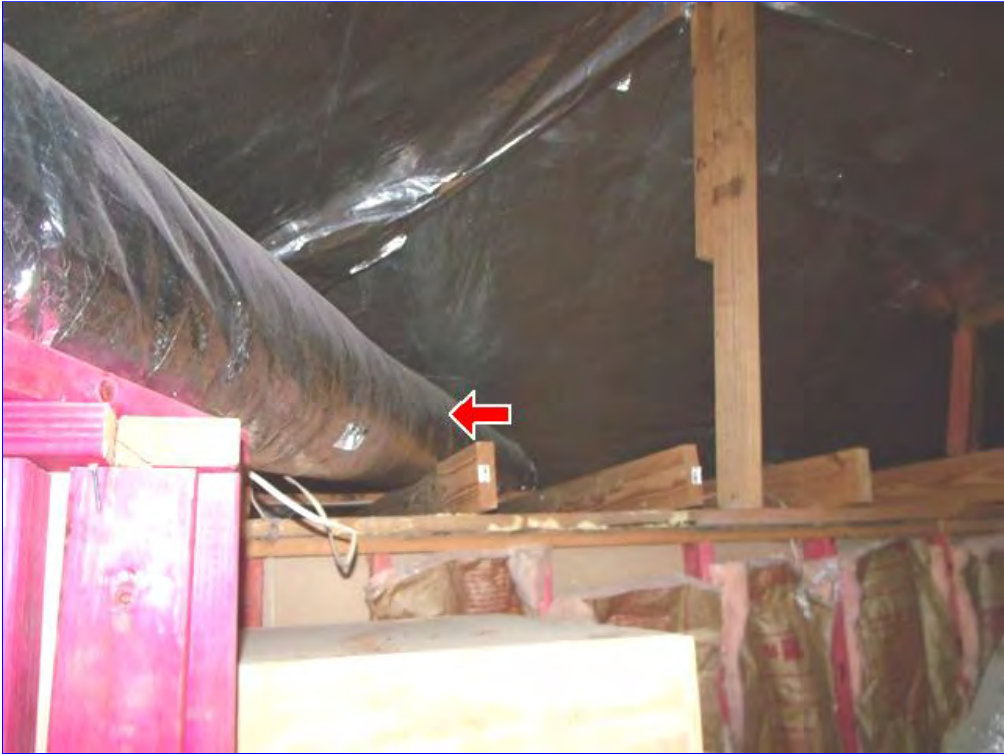
C. Item 24(Picture) Ducts need to be properly strapped.

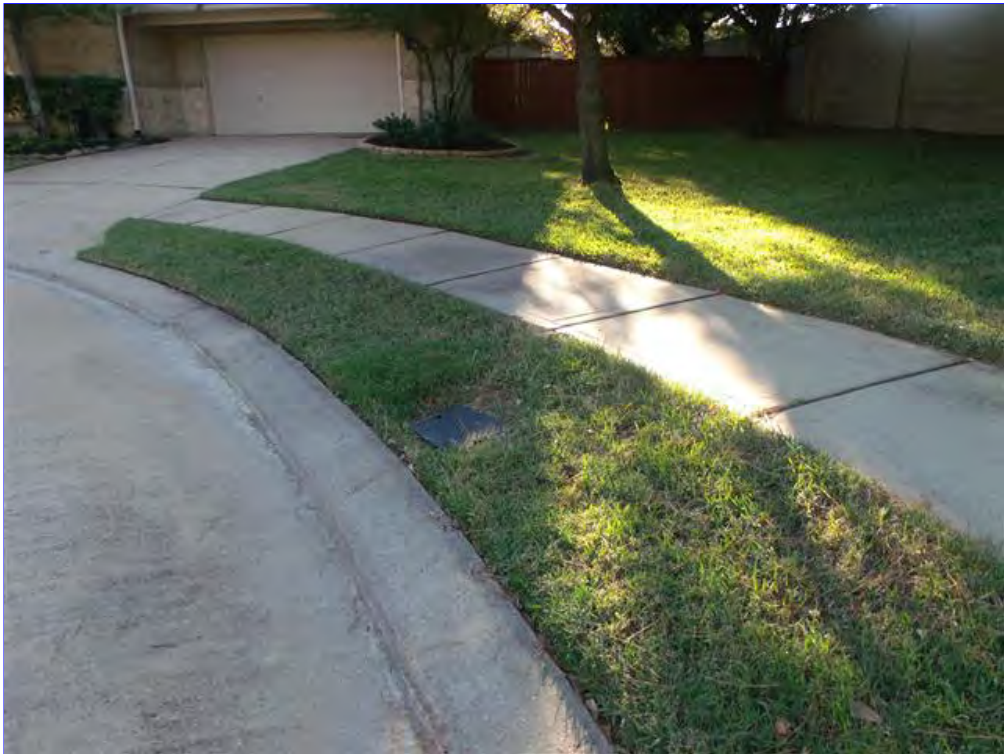
A. Item 1(Picture) Water meter located on the right side of the house.

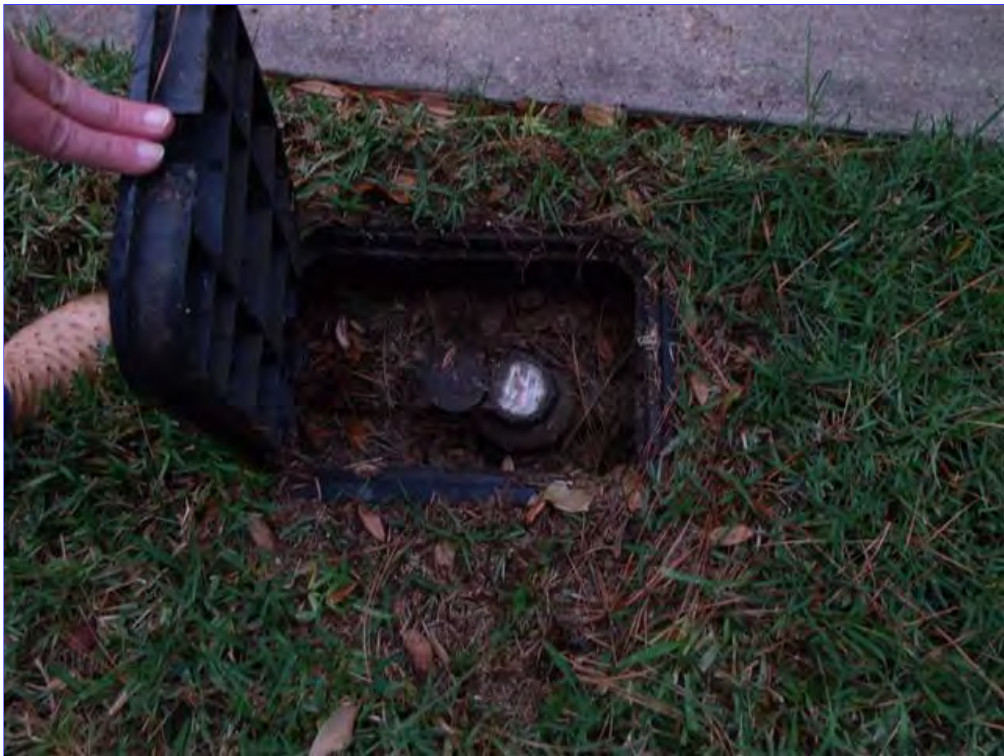
A. Item 2(Picture) Water meter located on the right in the front yard.

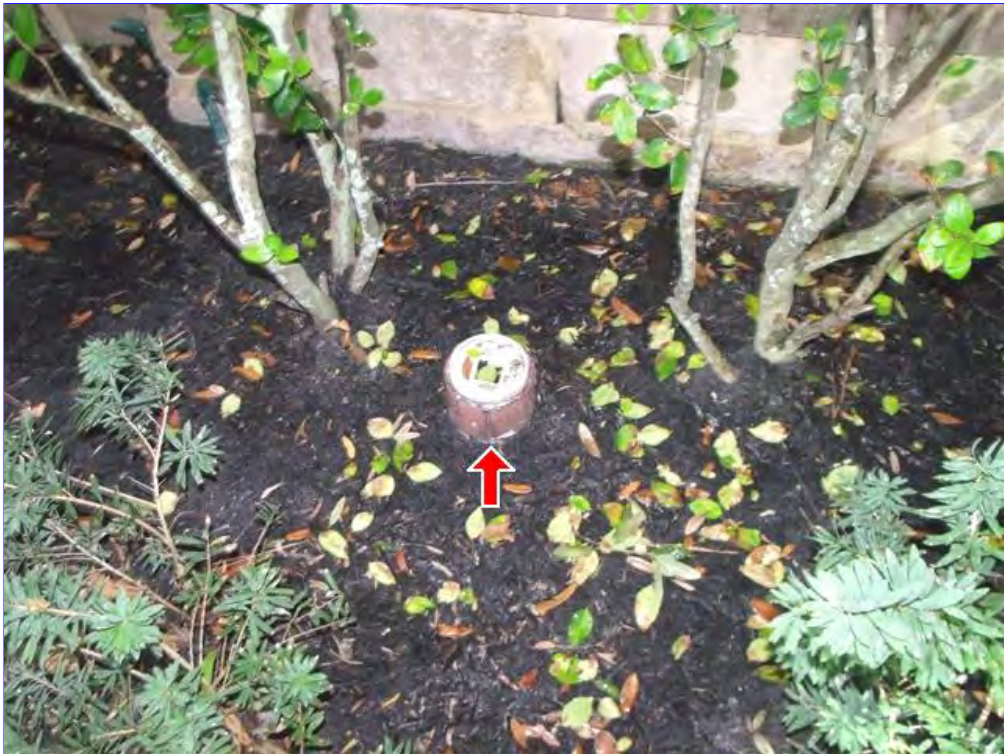
A. Item 5(Picture) Clean out located in front flower bed.

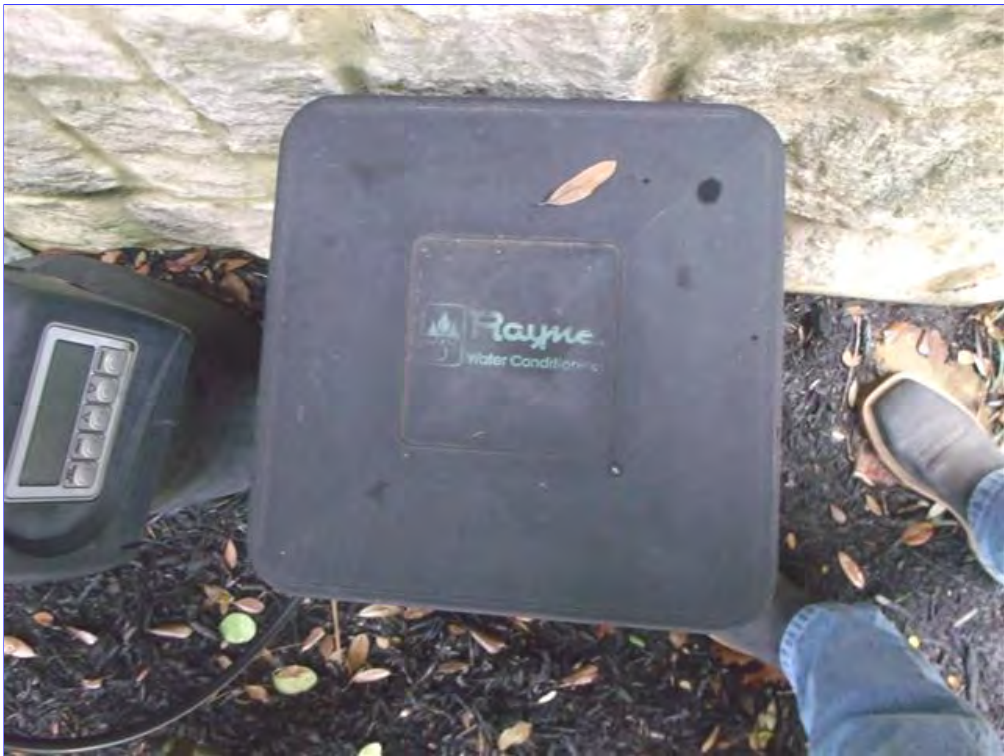
A. Item 6(Picture) Water conditioner for the pond. Its \$249.00 for a service call and how to operate unit. Recomend a lockable salt dispenser on unit

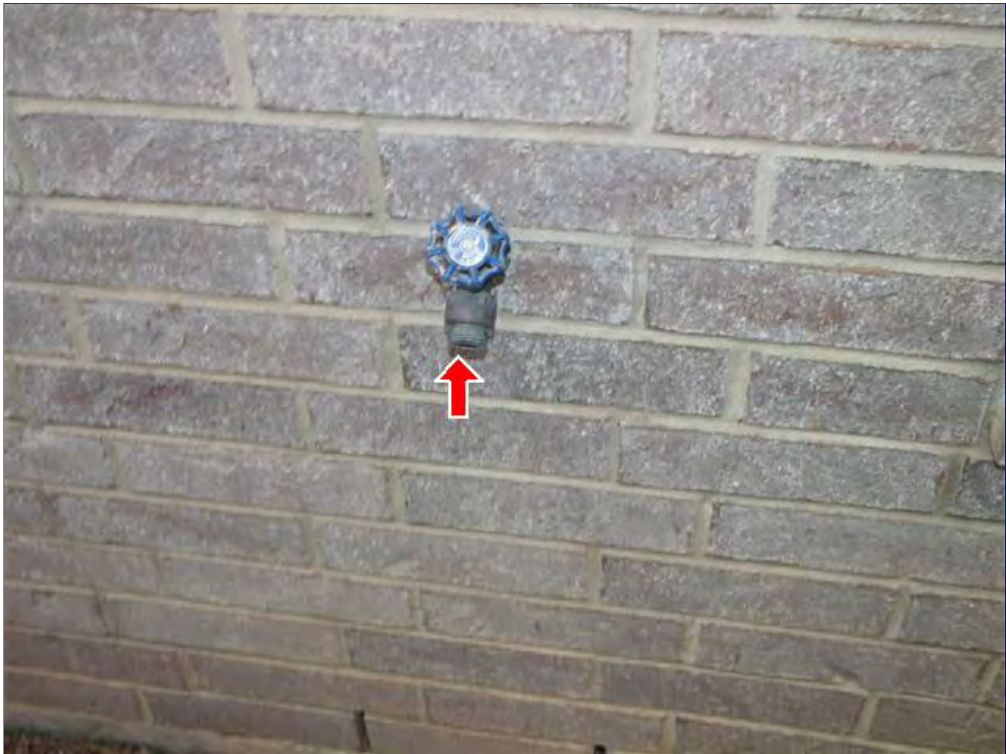
A. Item 9(Picture) Anti-siphon devices installed on outdoor plumbing fixtures.

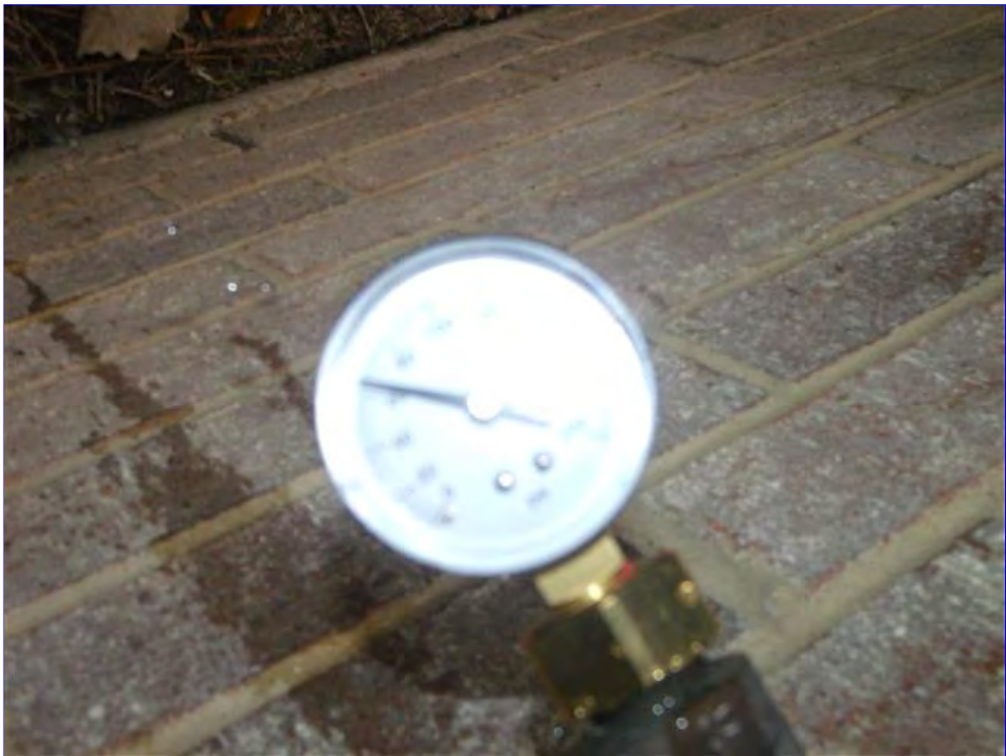
A. Item 10(Picture) Static water pressure reading approximately 60 PSI.

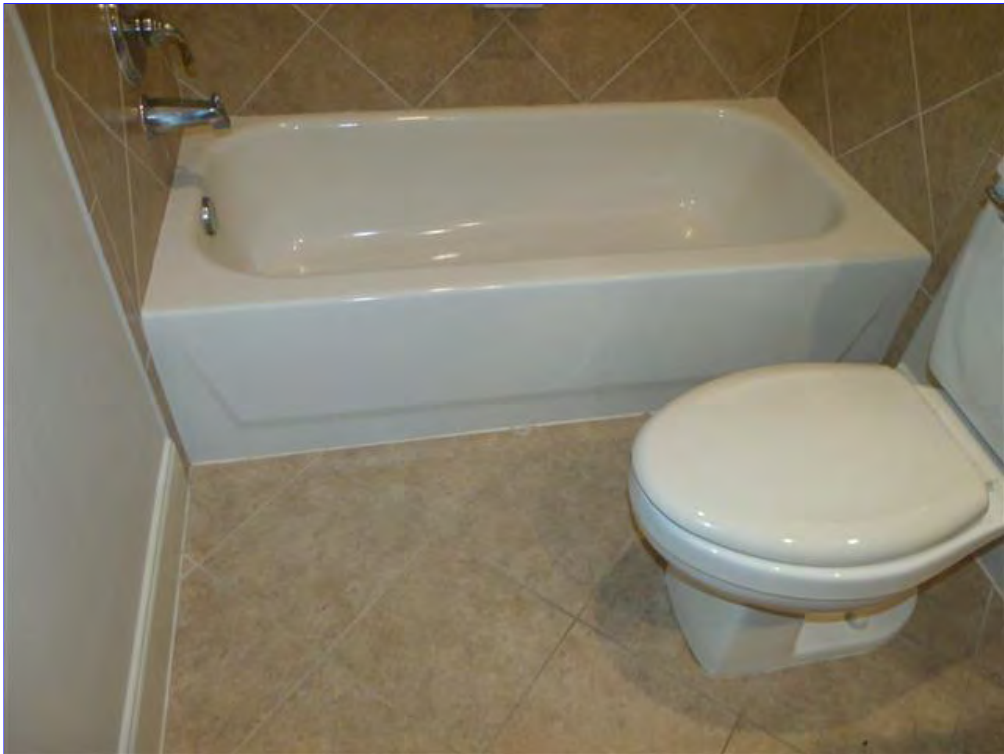
A. Item 11(Picture) No access panel is provided for the bathtub.

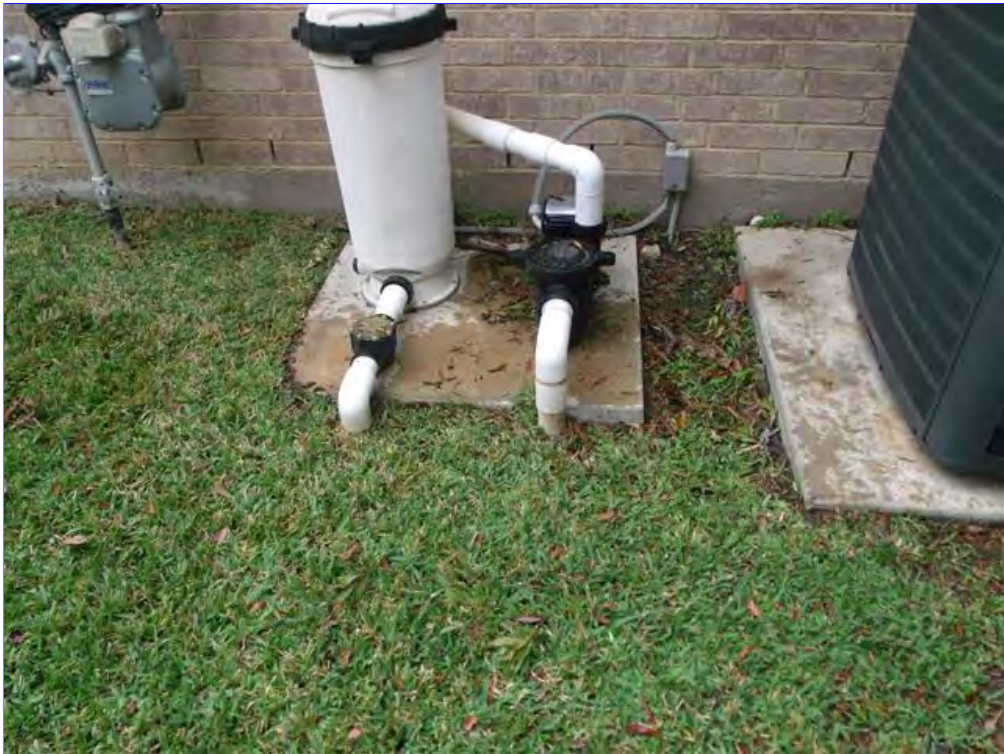
A. Item 13(Picture) Pump for the pond is leaking.

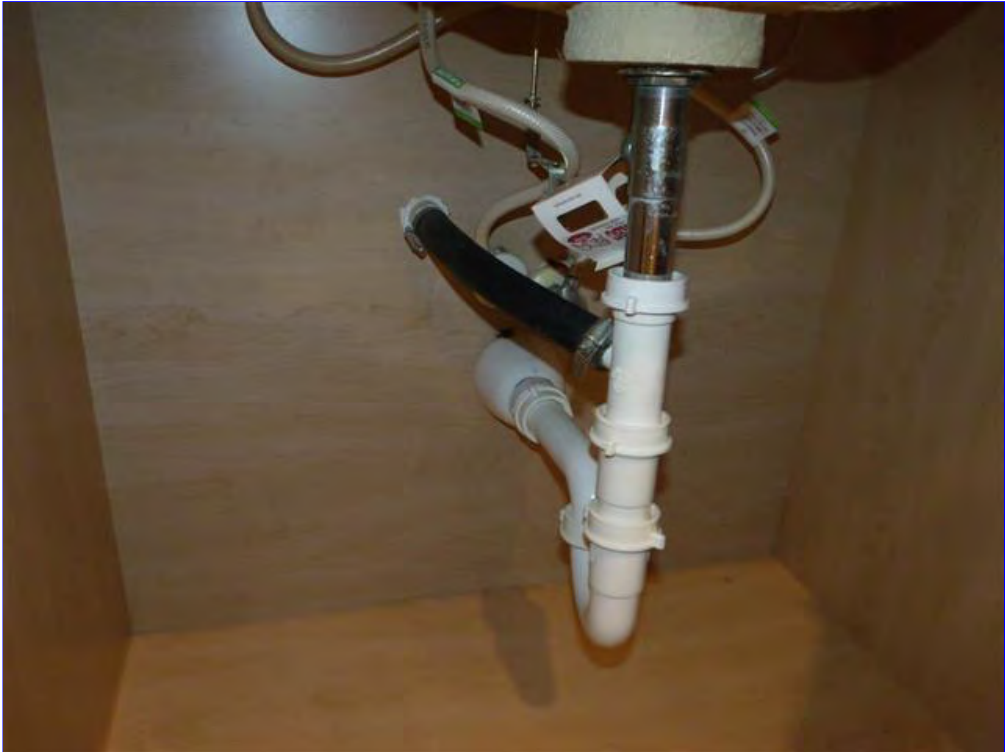
B. Item 1(Picture) No leaks observed at the time of inspection.

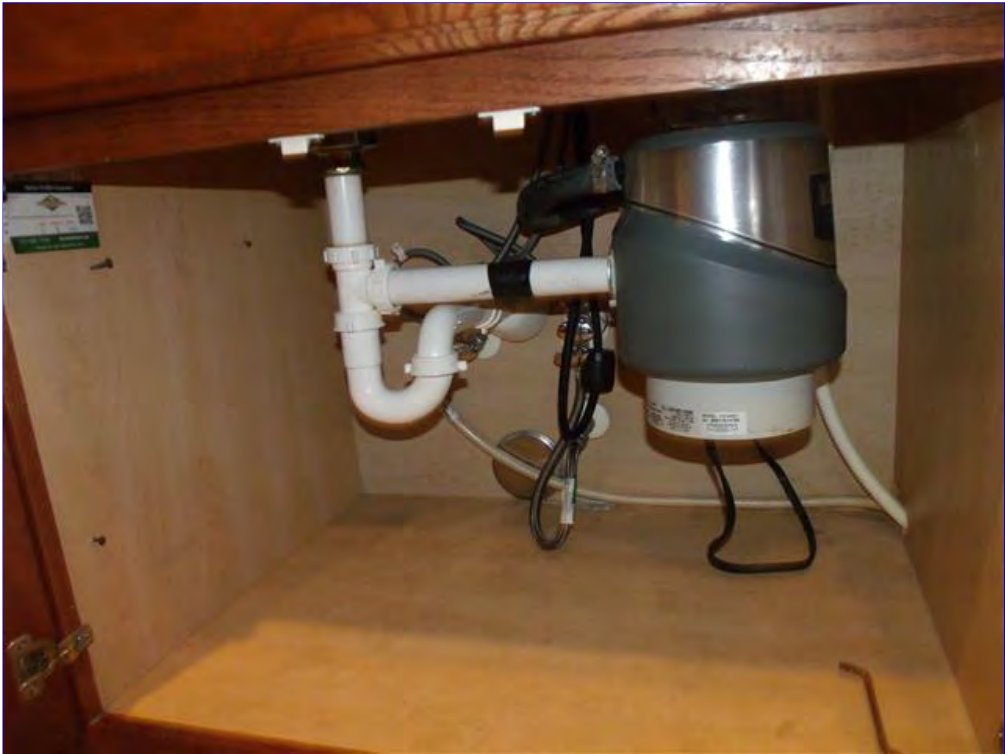
B. Item 2(Picture) No leaks observed at the time of inspection.

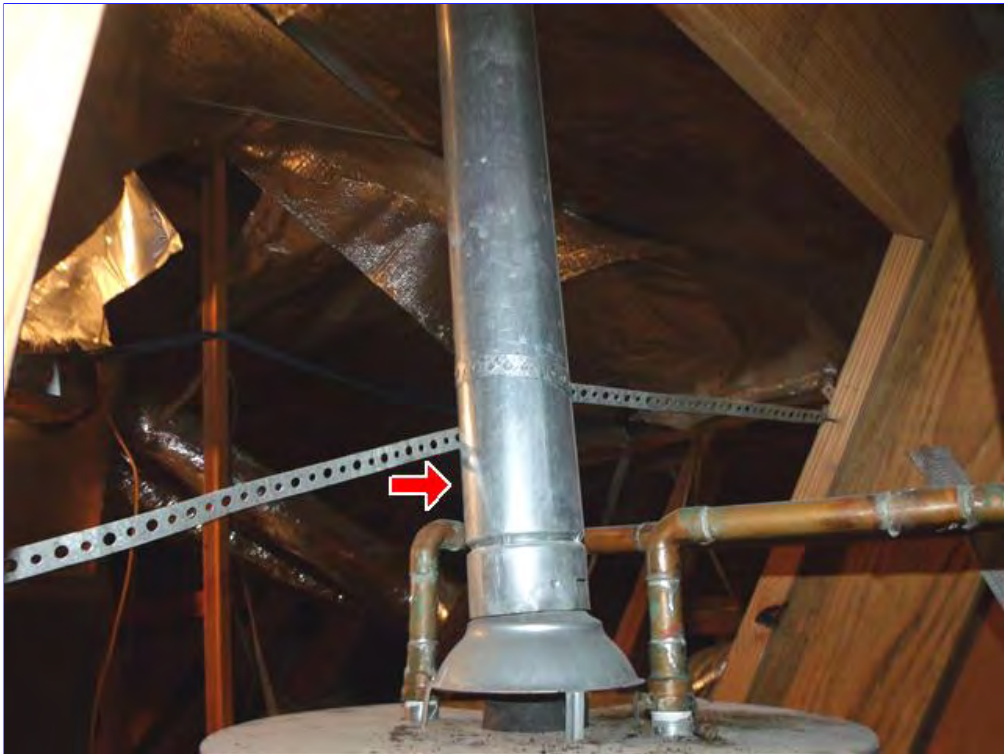
C. Item 1(Picture) Flue for the water heater should be a double walled B vent.

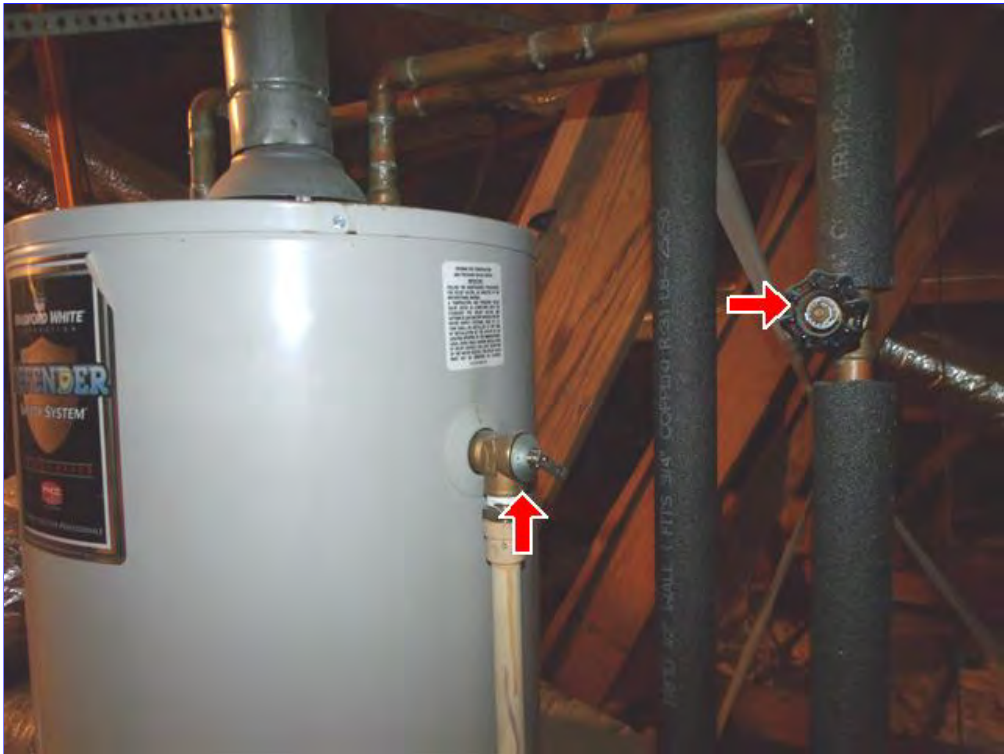
C. Item 3(Picture) T&PV was in good condition at the time of inspection. Cold water shutoff valve correctly installed.

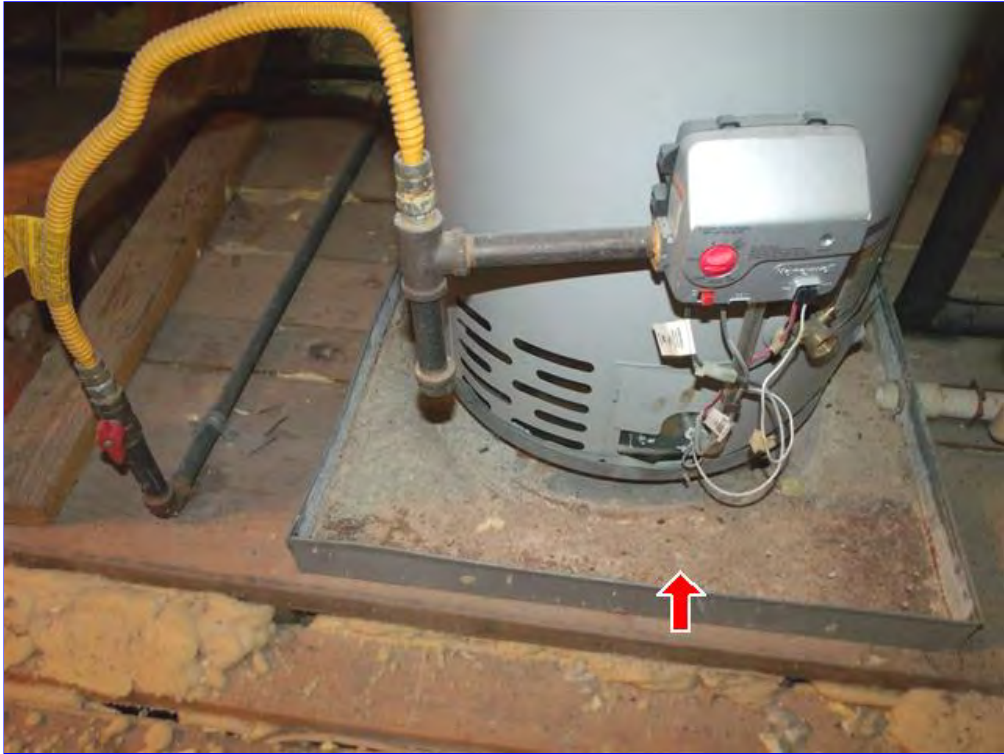
C. Item 4(Picture) Surface rusting in the drainage pan.

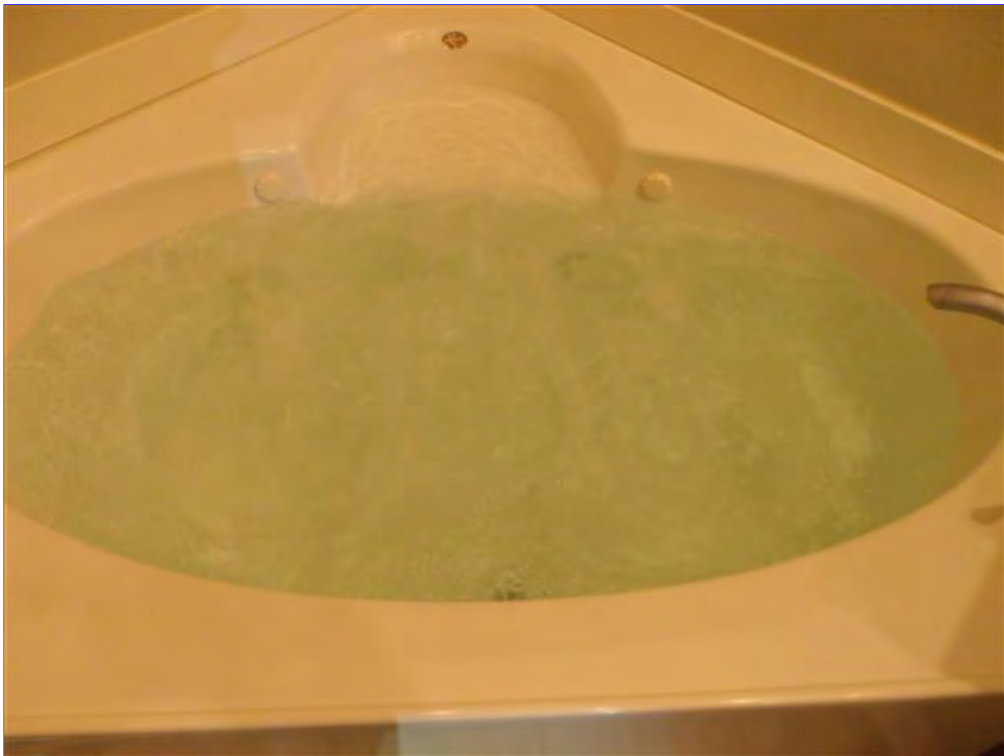
D. Item 2(Picture) Jets were operational at the time of inspection.

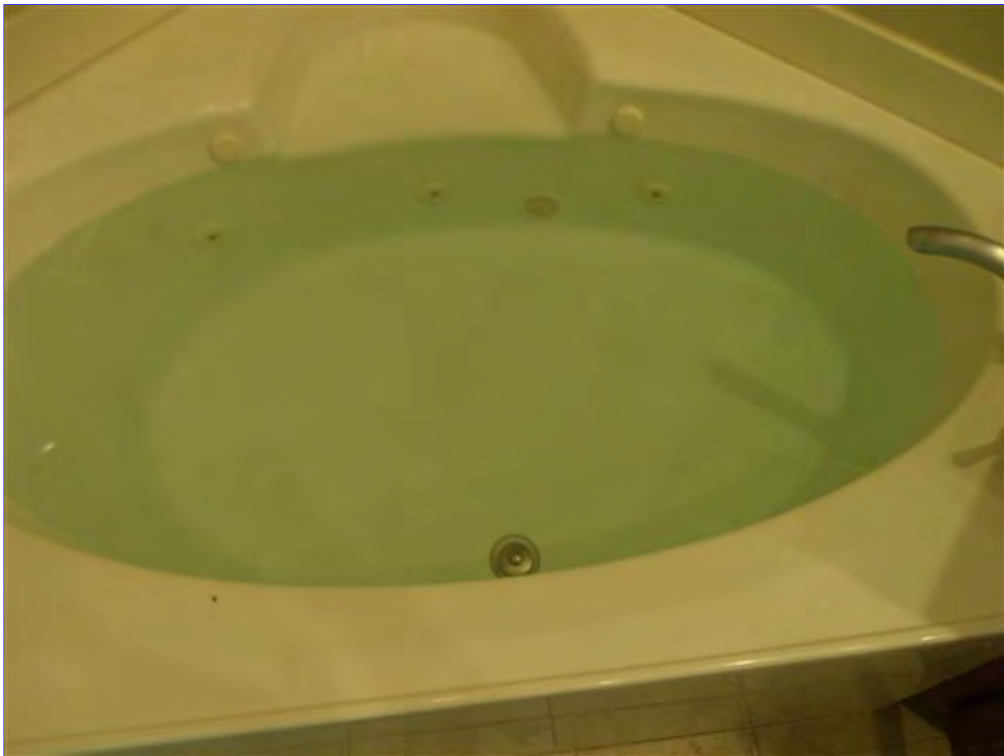
D. Item 4(Picture) Hydro-massage tub had functional drainage at the time of inspection.

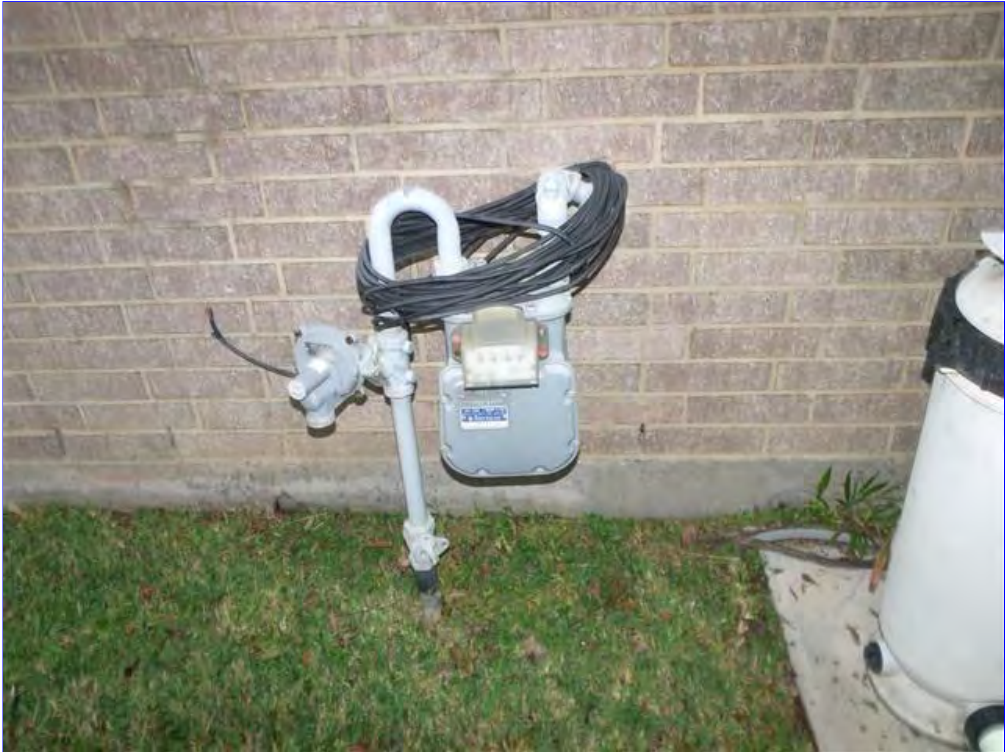
E. Item 1(Picture) Gas meter is located on the left side of the house in the backyard.

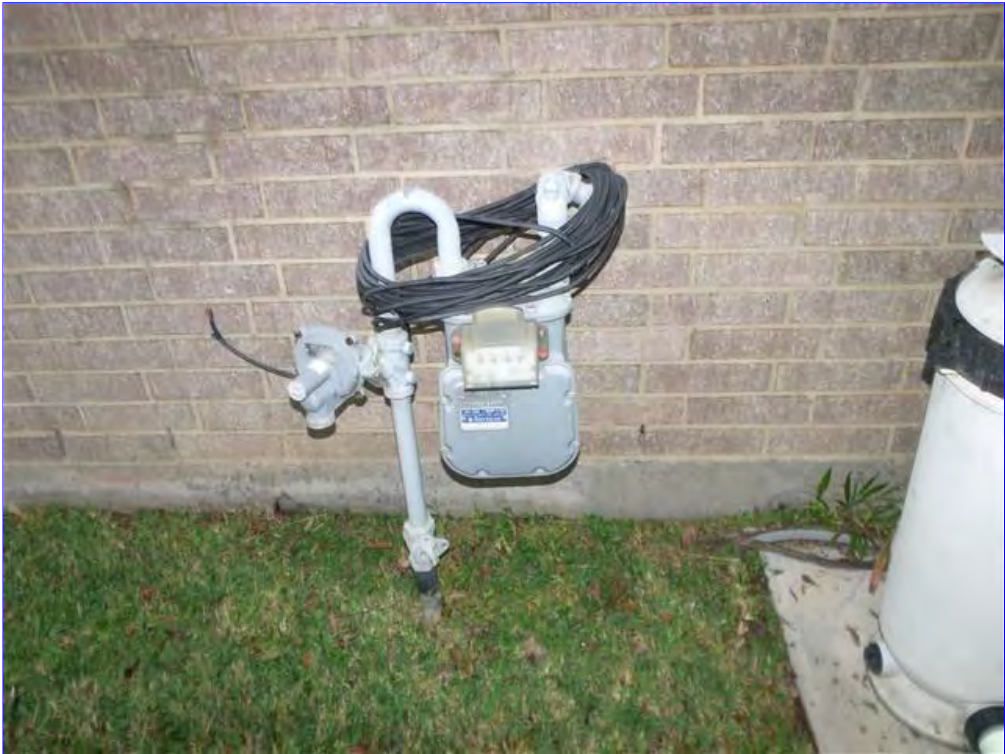
E. Item 2(Picture) Gas meter should be bonded and grounded.

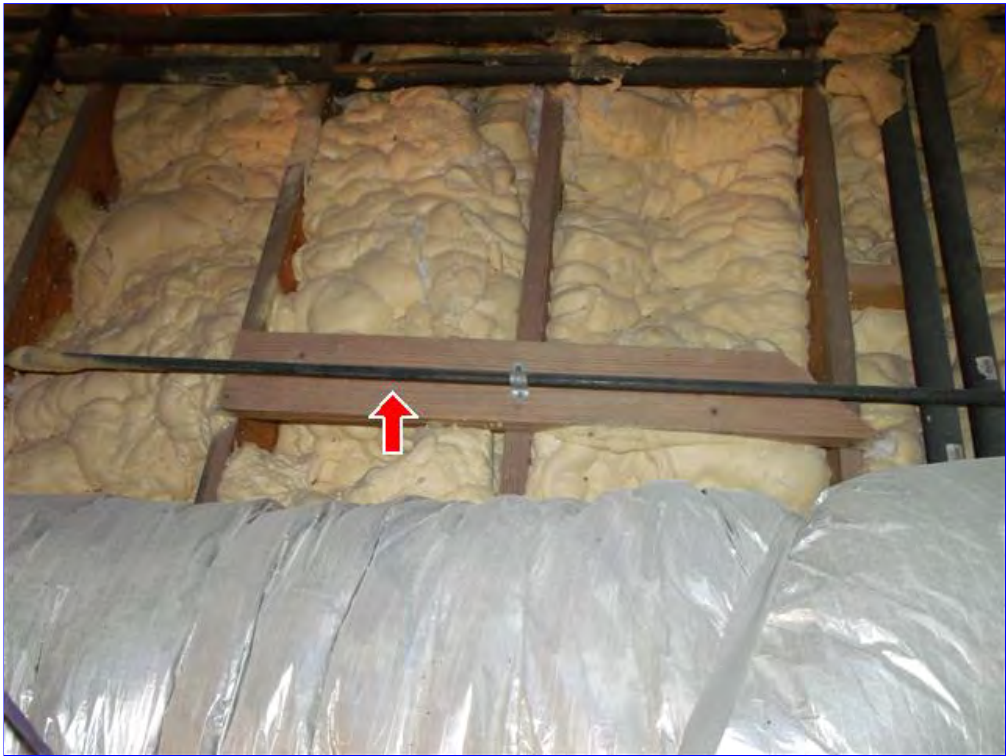
E. Item 3(Picture) Gas line.

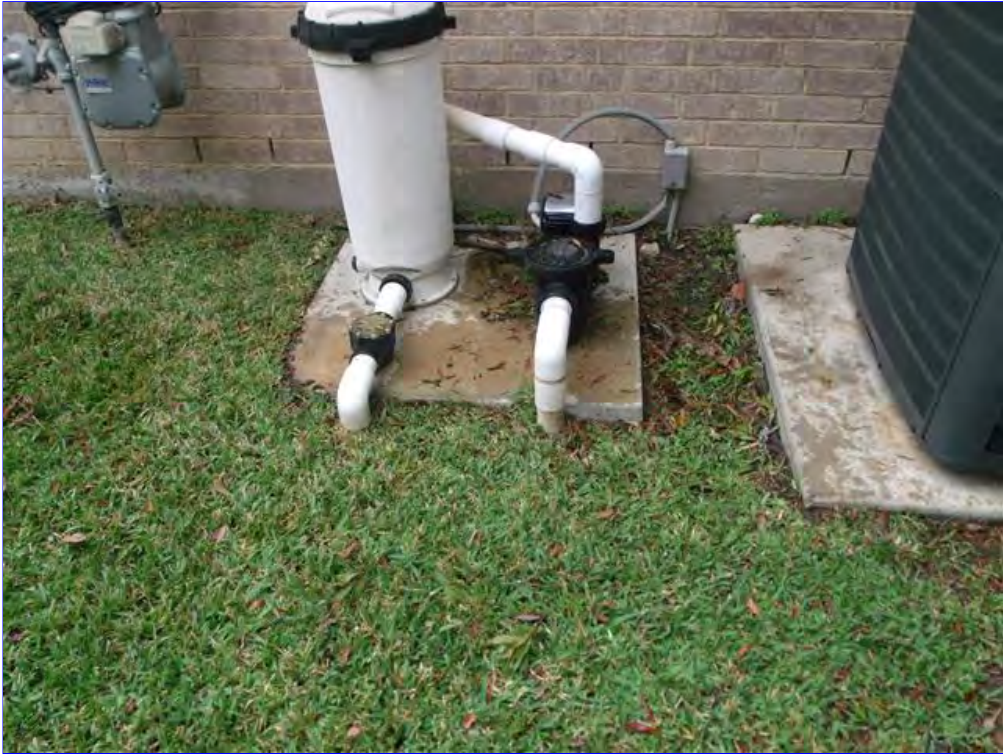
F. Item 1(Picture) Pump needs to be three inches above grade.

It is recommend to have the pump a minimum of three inches above grade and level.

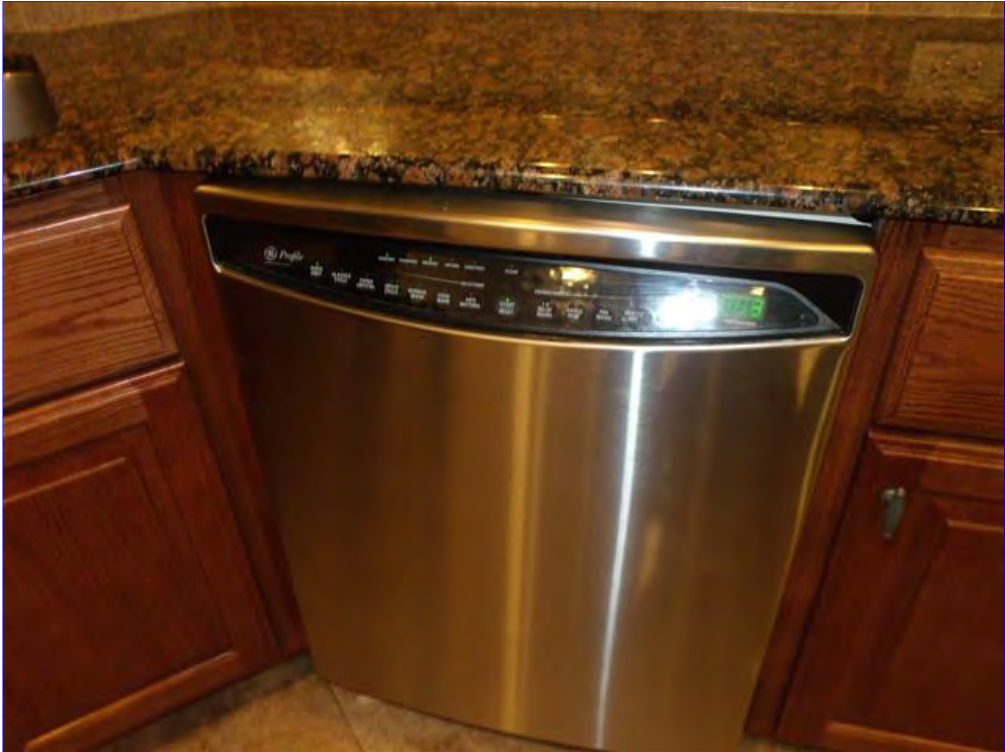
Dishwasher was operational at the time of inspection. No leaks were observed at the time of inspection.

A. Item 1(Picture) Inspecting the dishwashers.

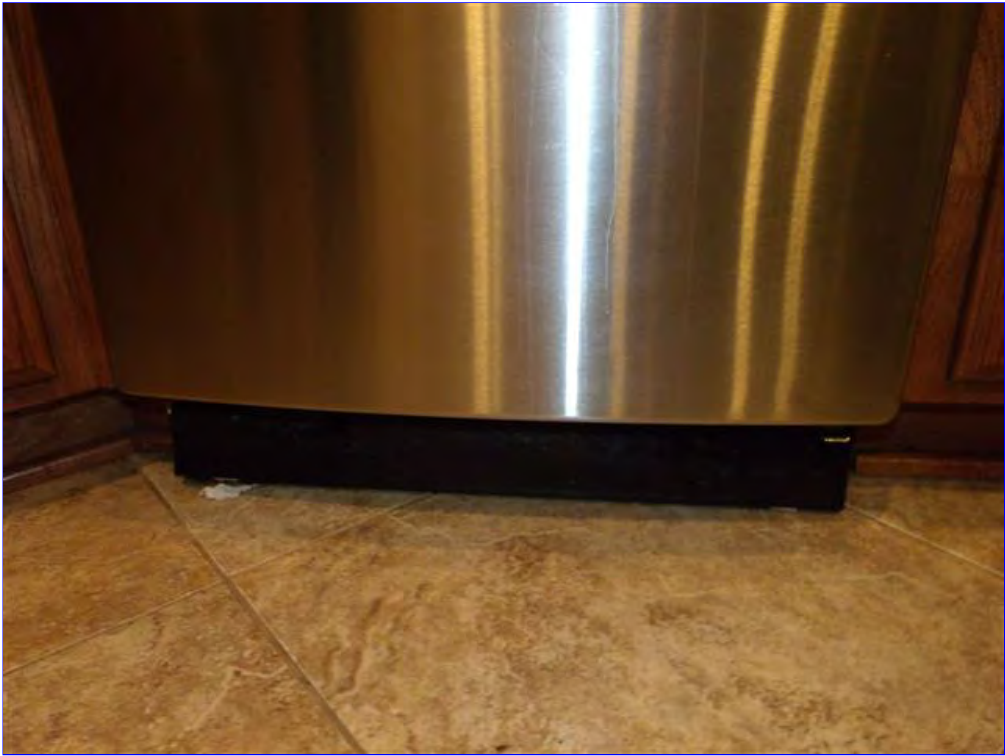
A. Item 2(Picture) No leaks observed while dishwasher was running.
