InspectorTx.com®

Inspection Report

PROPERTY INSPECTION REPORT FORM

<i>Name of Client</i>	11/12/2022 <i>Date of Inspection</i>
<i>Address of Inspected Property</i> BRYON A. PARFFREY llc.	
<i>Name of Inspector</i>	Texas #7408 <i>TREC License #</i>
<i>Name of Sponsor (if applicable)</i>	<i>TREC License #</i>

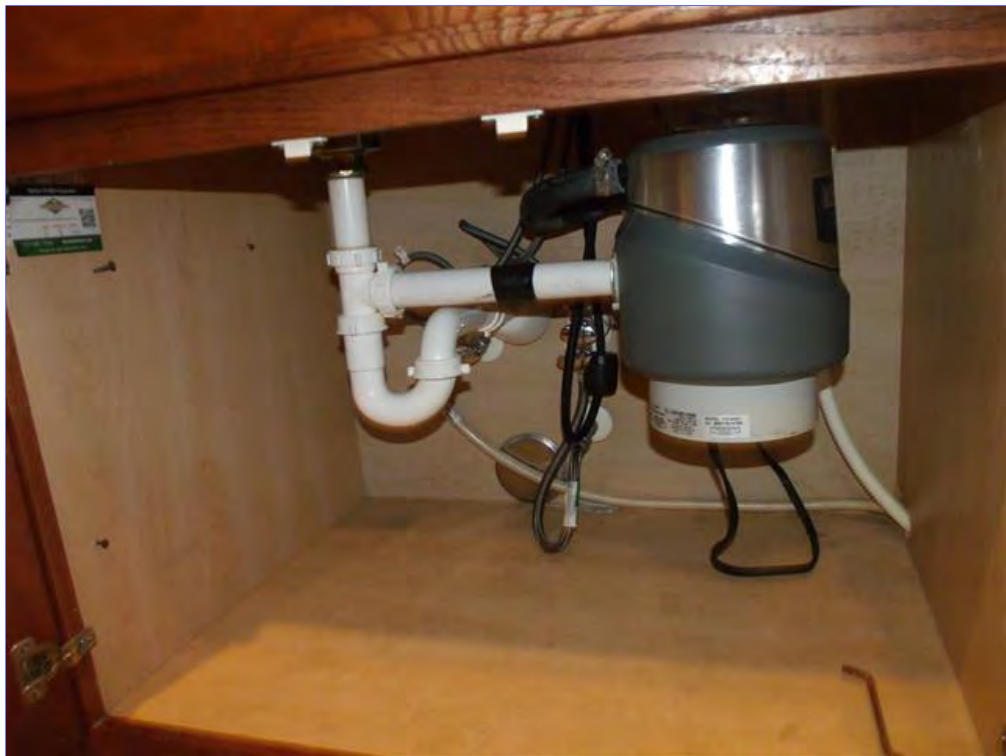
Food waste disposal was operational at the time of inspection. No leaks were observed at the time of inspection.

B. Item 1(Picture) Inspecting the food waste disposal.

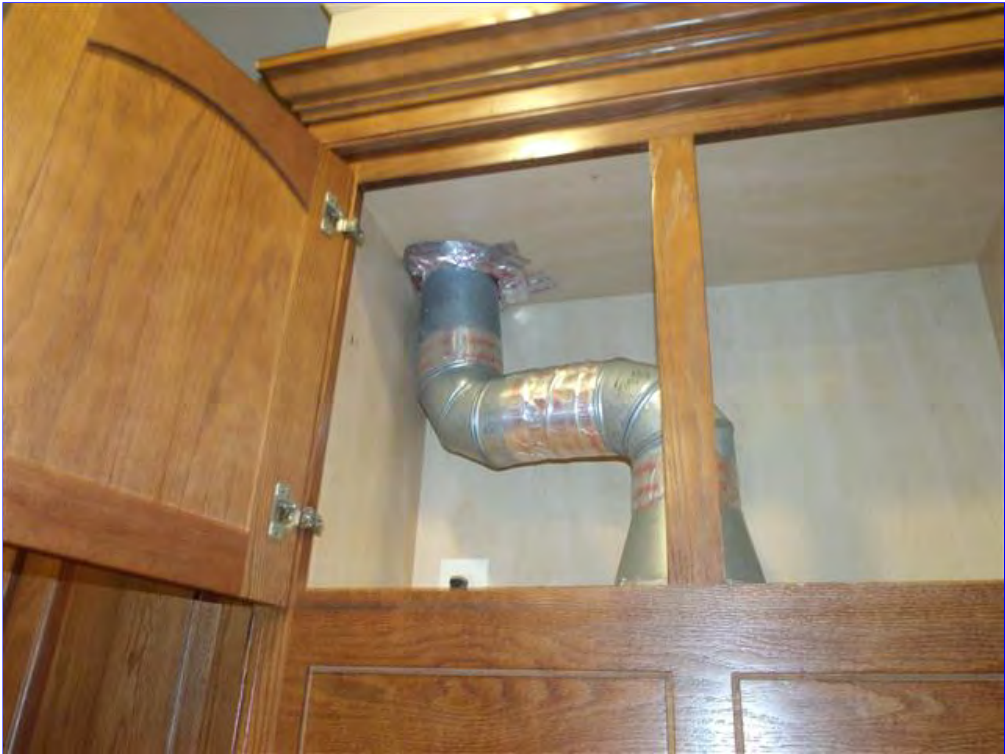
C. Item 2(Picture) Recomend adding a heat shield at top of vent and cabinet

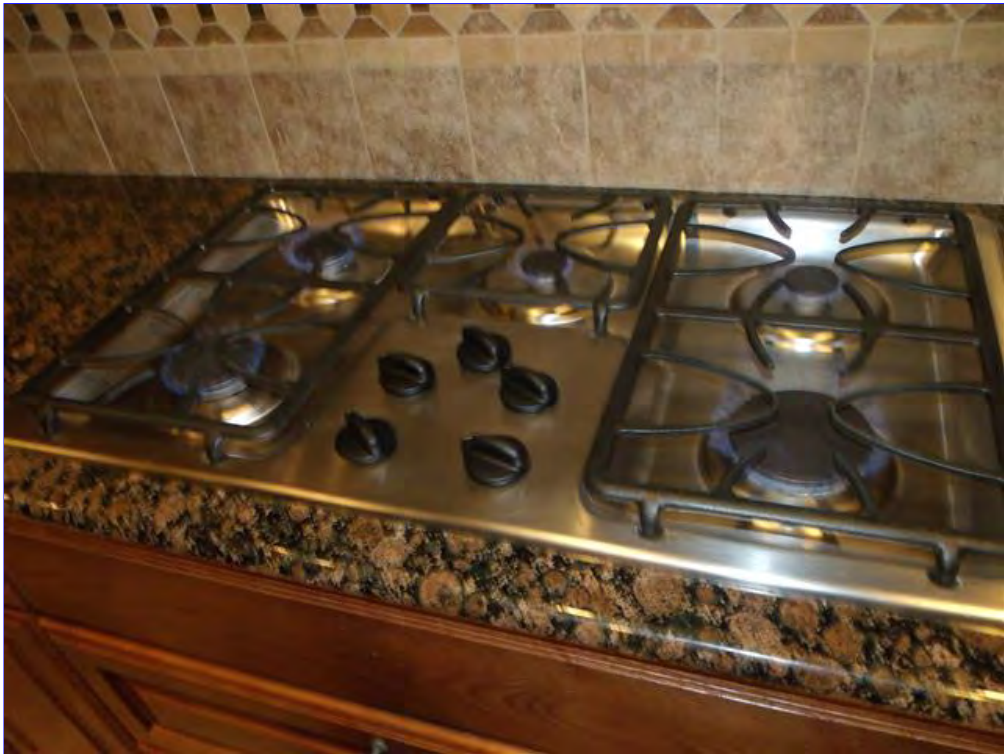
D. Item 1(Picture) Inspecting the cook top.

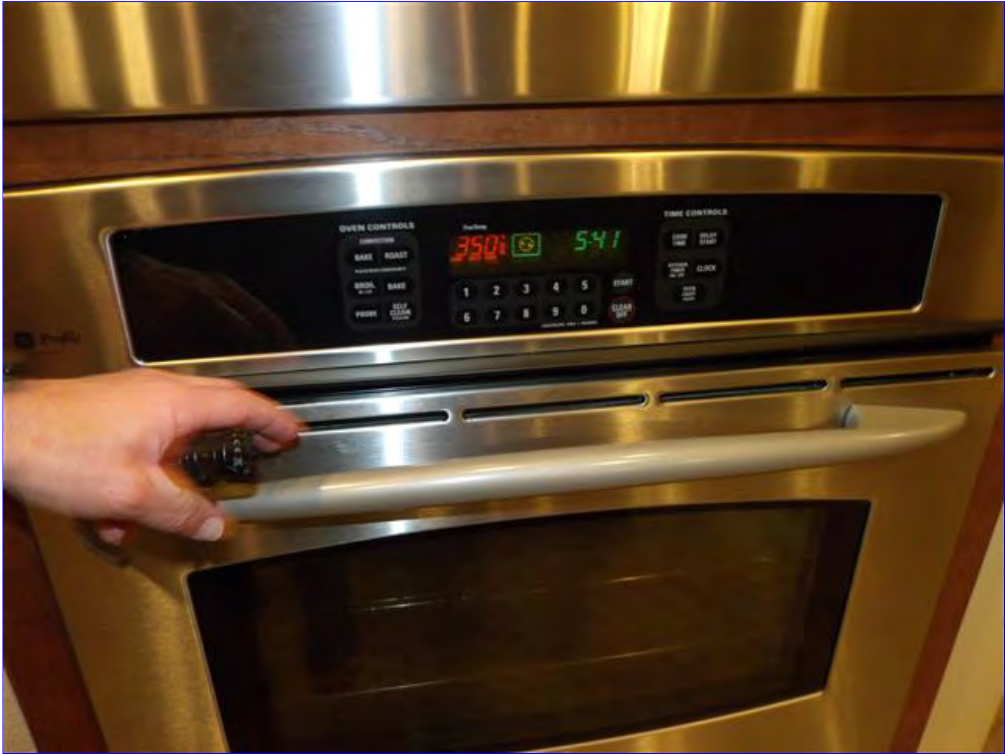
E. Item 1(Picture) Inspecting the oven.

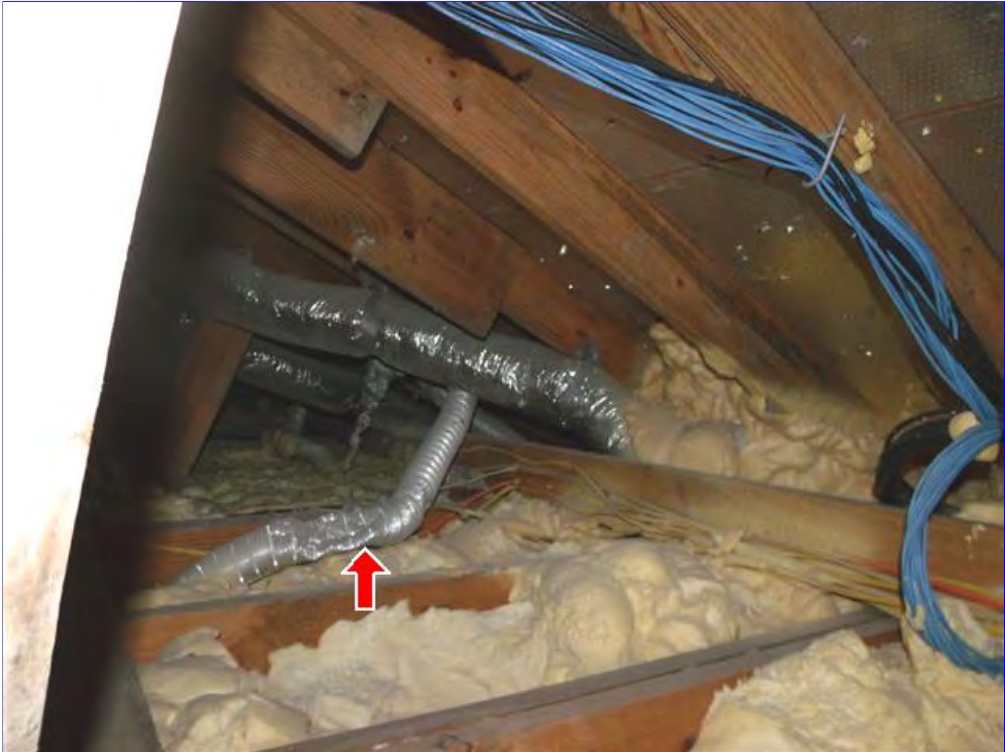
G. Item 1(Picture) Bathroom exhaust is crushed and it venting into the attic. In need of repair.

Exhausts should vents through the roof to prevent moisture buildup in the attic.

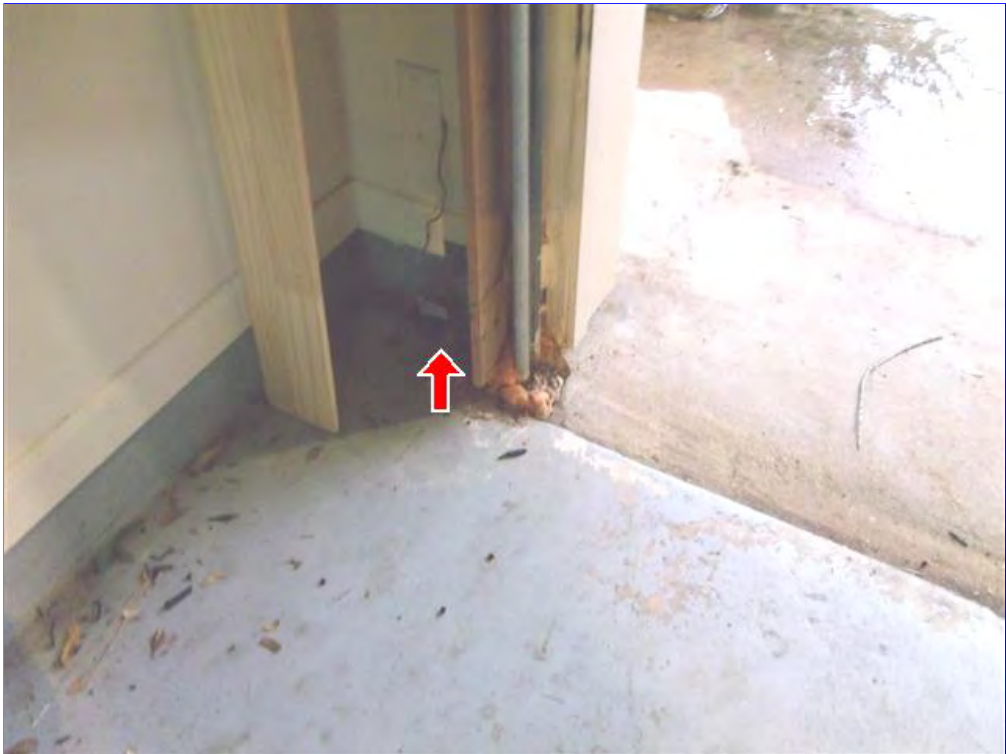
H. Item 1(Picture) Photoelectric sensor needs to be properly secured and be set six inches above the floor. Recommend diverter flashing or screens noted as cloth wire

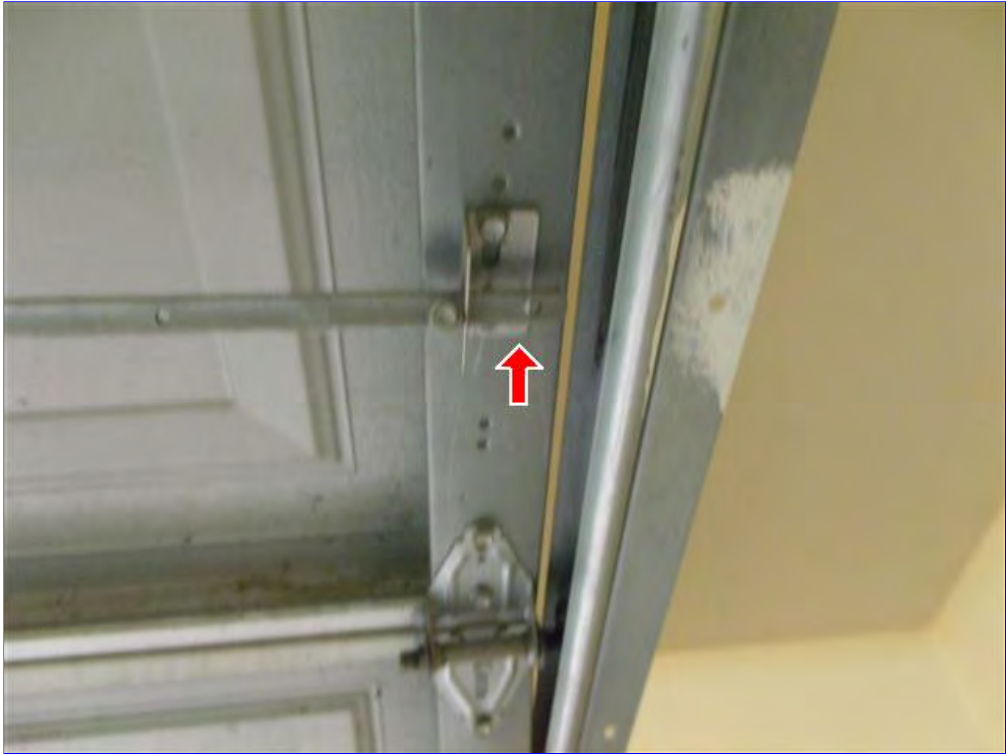
H. Item 2(Picture) Recommend disabling garage door lock.

Recommend disabling garage door lock to prevent damage to the garage door if the garage door is locked and the garage door is then opened.

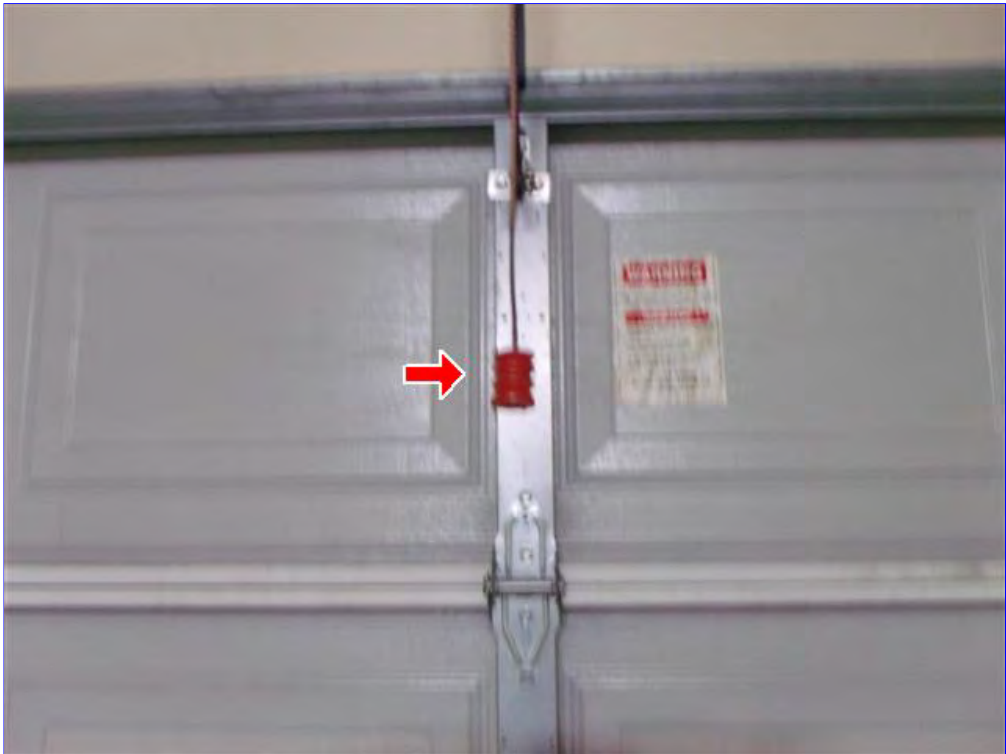
H. Item 3(Picture) Disconnect for the garage door was tested and was operational at the time of inspection.

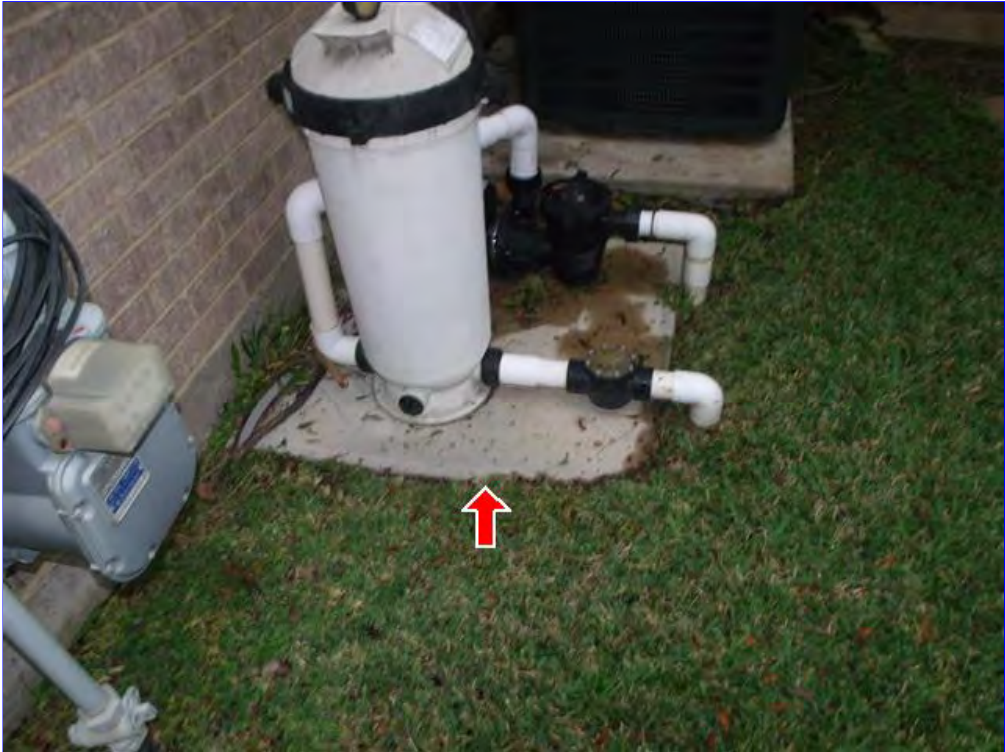
J. Item 1(Picture) Pump needs to be located on a platform at least three inches above grade.
